People – Flood Resiliency & Public Safety Road Culvert and Bridge Crossings over Streams

What's Good for Fish is Good for Us and Good for our Budget!

Todd Menees, River Management Engineer

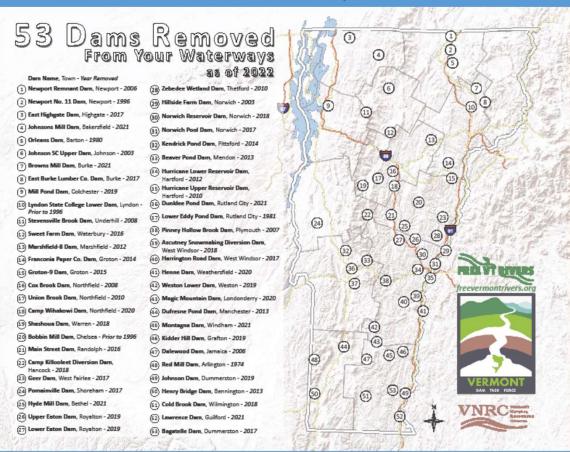
Only
Flood
Control
Dams are
Designed
to
Operate
Empty

All Other
Dams
Operate
Full <u>and</u>
Increase
Flooding

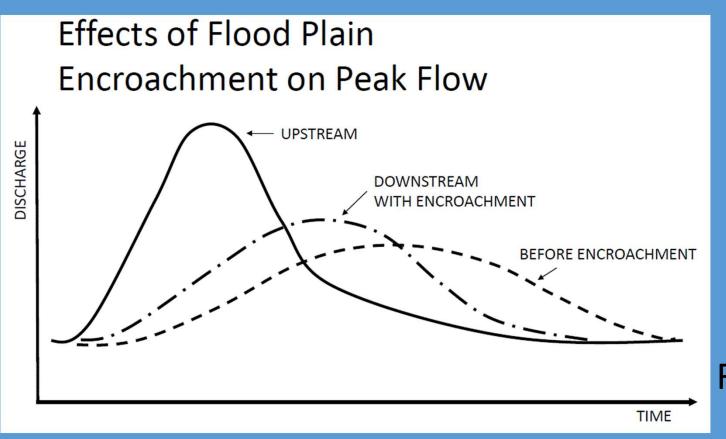
On Stream Dams Make Flooding Worse

Dams
Gone
Reduce
Flooding

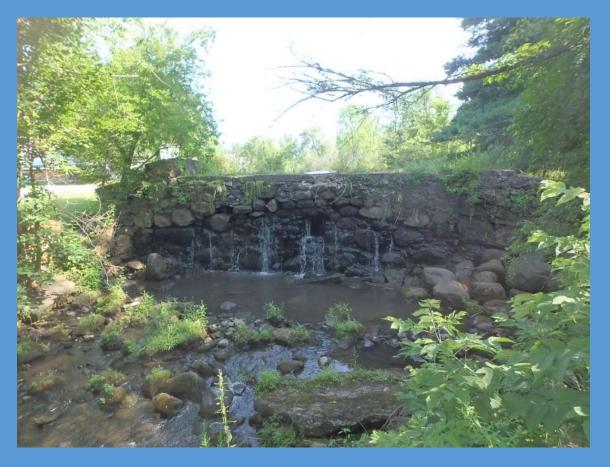
Dunklee Pond Dam Before Removal

Crumbling
Stone Dam
A <u>Known</u>
Public
Safety
Threat

Ca 1792
Dam in
Poor
Condition

Looking Upstream at Old Stone Dam 2017

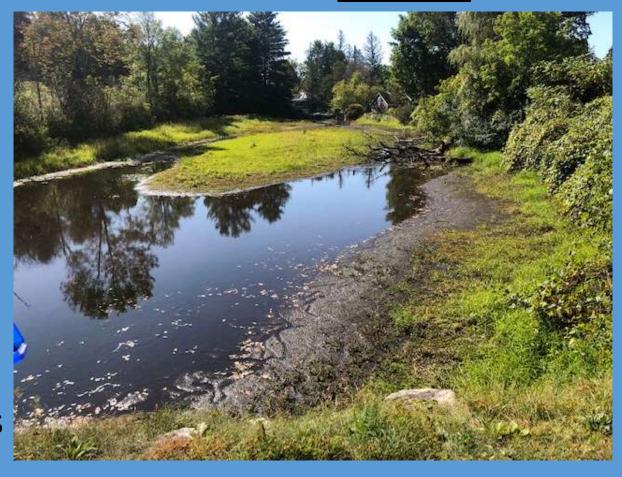
Dunklee Pond Dam Before Removal

T.S. Irene
Sediment
Deposits
Filled in
the Pond

~ 400 lbs Of Phosphorous Removed

Poor WQ

Murky Water

Smelly and Fish Kill Low D.O.

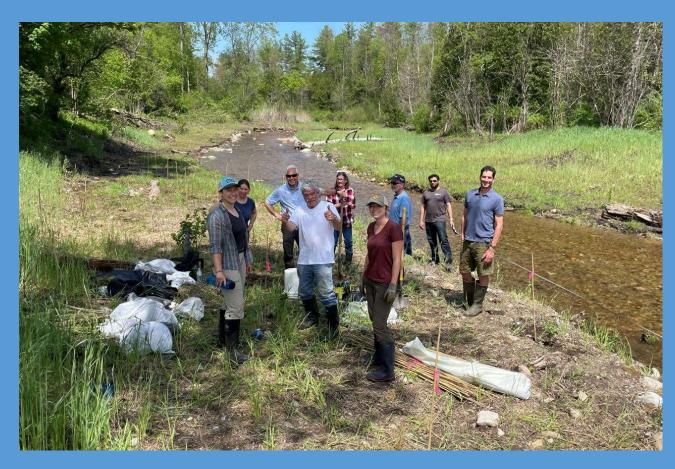
Dunklee Buffer Planting 5/20/22

It takes a
Village
to Plant
a
Riparian
Buffer!

Green It Up!

On 5/26/22 Done!

Another Planting Day and Everyone Walks Away Smiling!

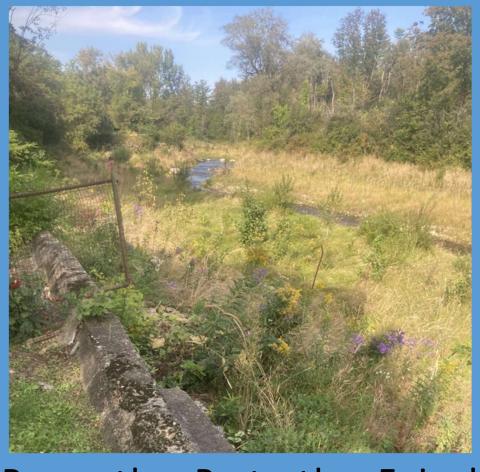
Dunklee

Pond Dam

Removal

Restored

Floodplain on

9/26/23

3 Years
Later
This Dam
Gone
Has
Proven
to
Reduce
Flooding

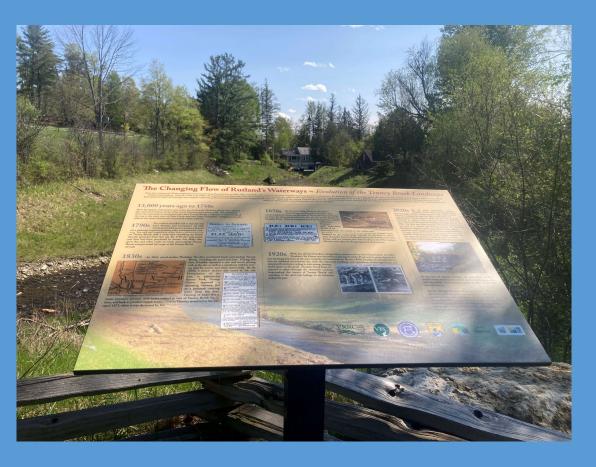
Dunklee **Pond Dam** Removal Historic Preservation Sign About the Dam Removal **Project**

Former
Dam Site
Mid-Top in
Photo. Sign
Information
includes

Indigenous Peoples Use 13,000 Years Ago

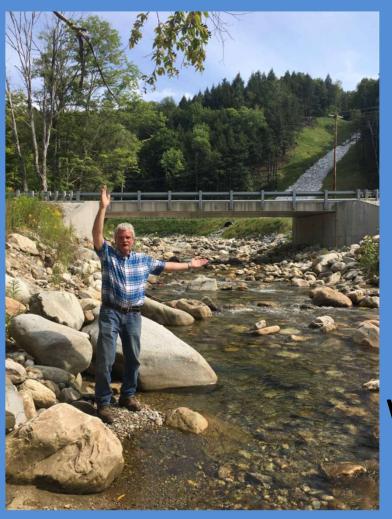
Mendon Built Back Better After 2011 Flood

Medway Road

New Bridge

Wider + higher

after Irene

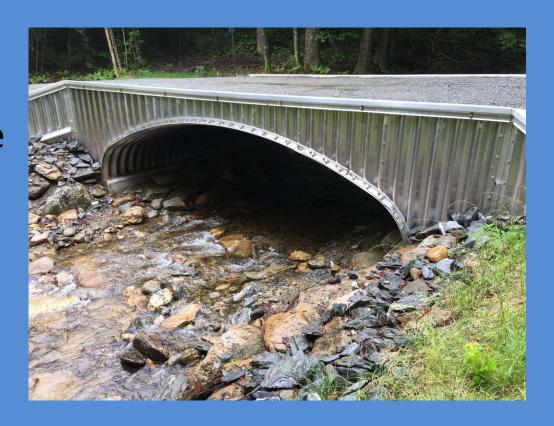
GMNF Culvert Stream Channel Outlet

Larger Culvert replaced before Irene on Green Mountain National Forest in Pittsfield

Culvert was
NOT
Damaged in
the 2011
Irene Flood

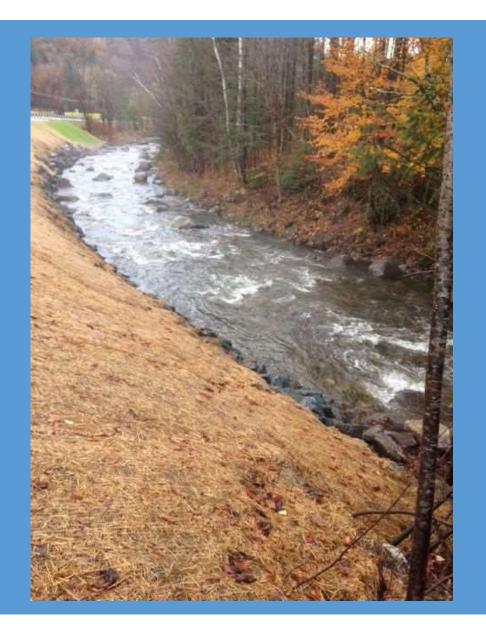
VTRANS ROUTE 12 BED ARMOR DDIR REPAIR

Channel was over-excavated in the initial emergency repair

Channel width was too narrow and subject to more erosion.

Stabilize Downcutting Excavated Channel from further scour 2015

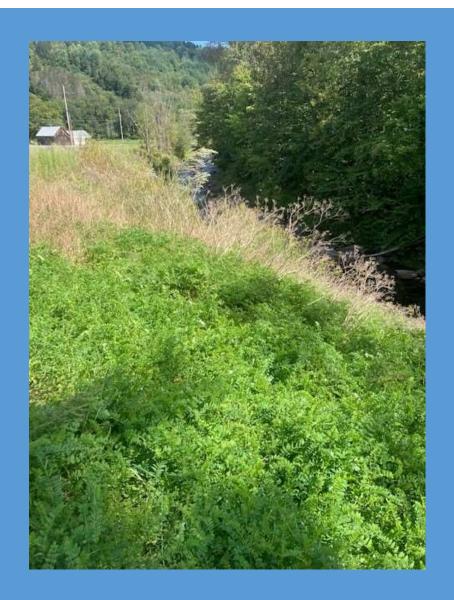
VTRANS ROUTE 12 BED ARMOR DDIR REPAIR

Historically Gulf Stream Brook was Narrowed for Route 12.

Proper Stream Width was Restored to Protect Route 12 in Future Floods in 2014.

Rip-Rap is Now Green in 2021.

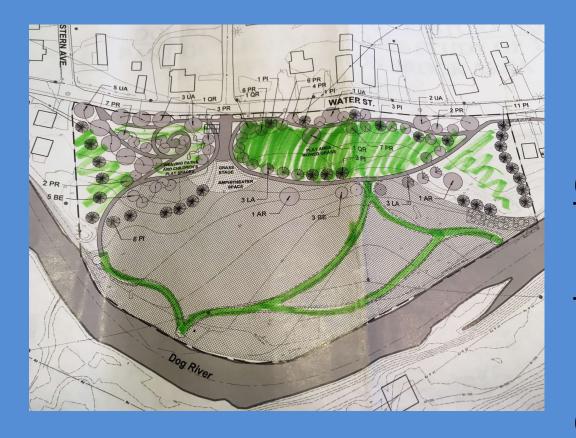
Northfield Dog River Park After 2011 Flood

Paths, Gazebos, Pavilion, Picnics, Benches, Birding, Fishing, Wading, **Flowers**

Flood Ruin to a
Community Asset,
Many Volunteers
Enjoyed Fun Work,
Rewarding for the
Northfield
Community

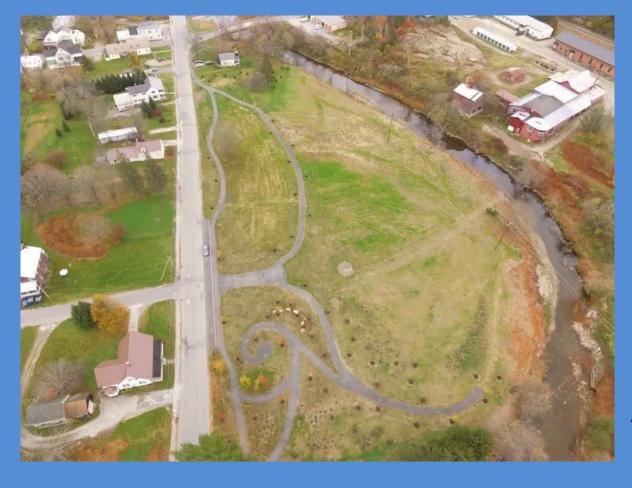
Dog River Park after Removal of Buyout Buildings, Regrading and Rough Layout

Dog River Park
Successful
Floodplain
Restoration
Reduced Flood
Water 6" Drop in
2023 Flooding

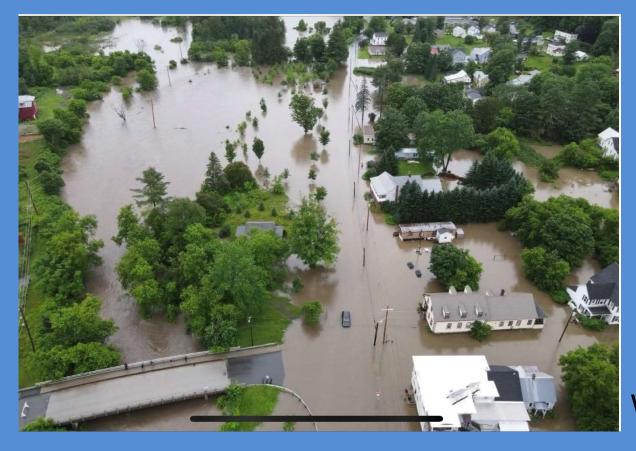
Dog River Park after Removal of Buyout Buildings, Regrading and Rough Layout

Dog River Park
Successful
Floodplain
Restoration
Reduced Flood
Water 6" Drop in
2023 Flooding
