Transportation Resilience Planning Tool (TRPT)

MUNICIPAL DAY, 2023

OCTOBER 20, 2023

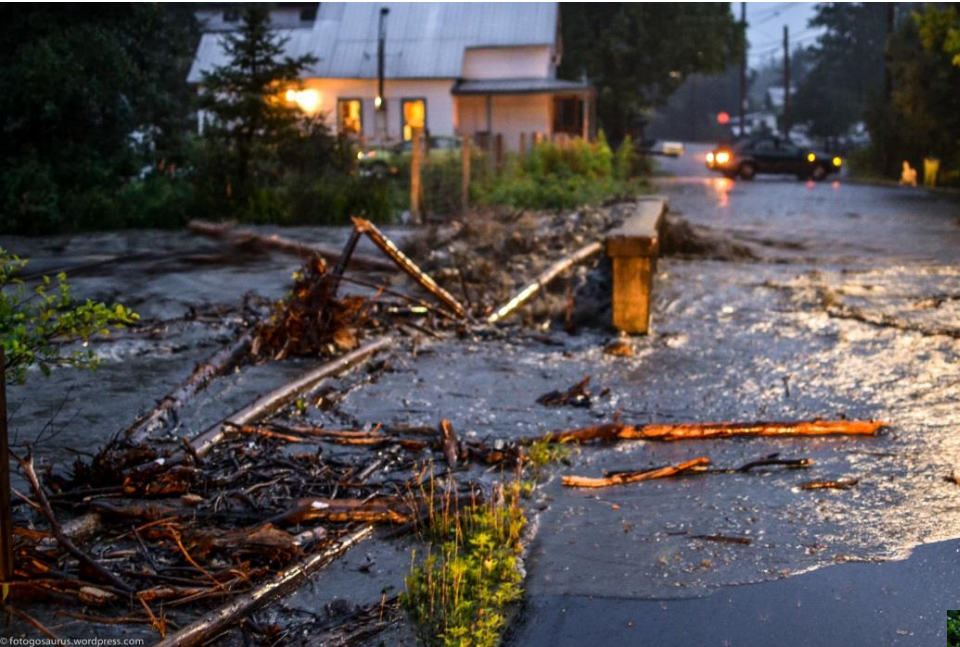
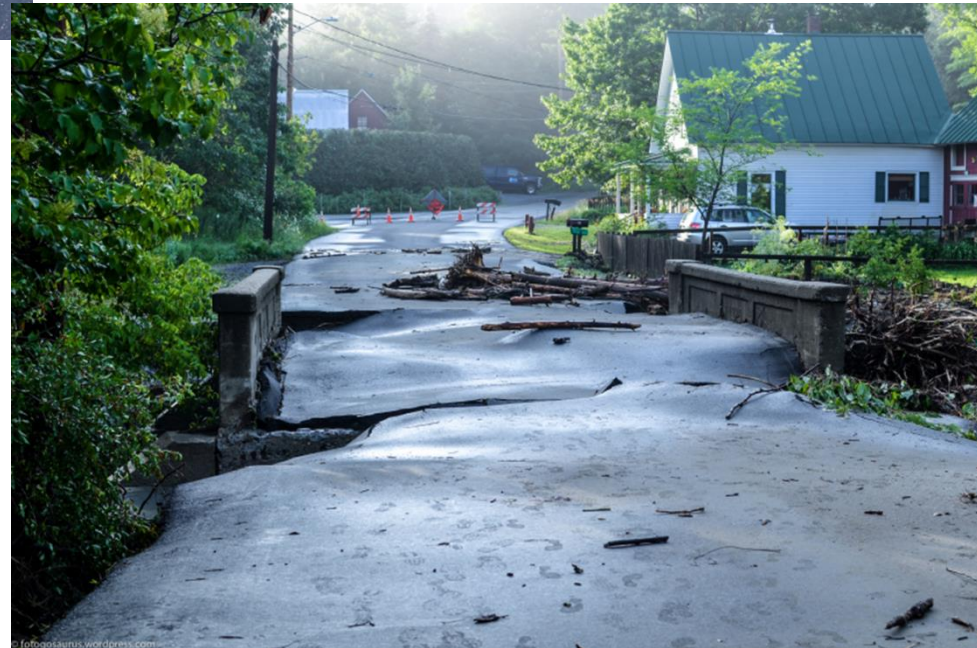
Great Brook
Brook Road Damage, 10-Year Flood
Plainfield, VT
7/19/2015
Photo taken by B. Towbin

Great Brook
Brook Road Damage, 10-Year Flood
Plainfield, VT
7/20/2015
Photo taken by B. Towbin

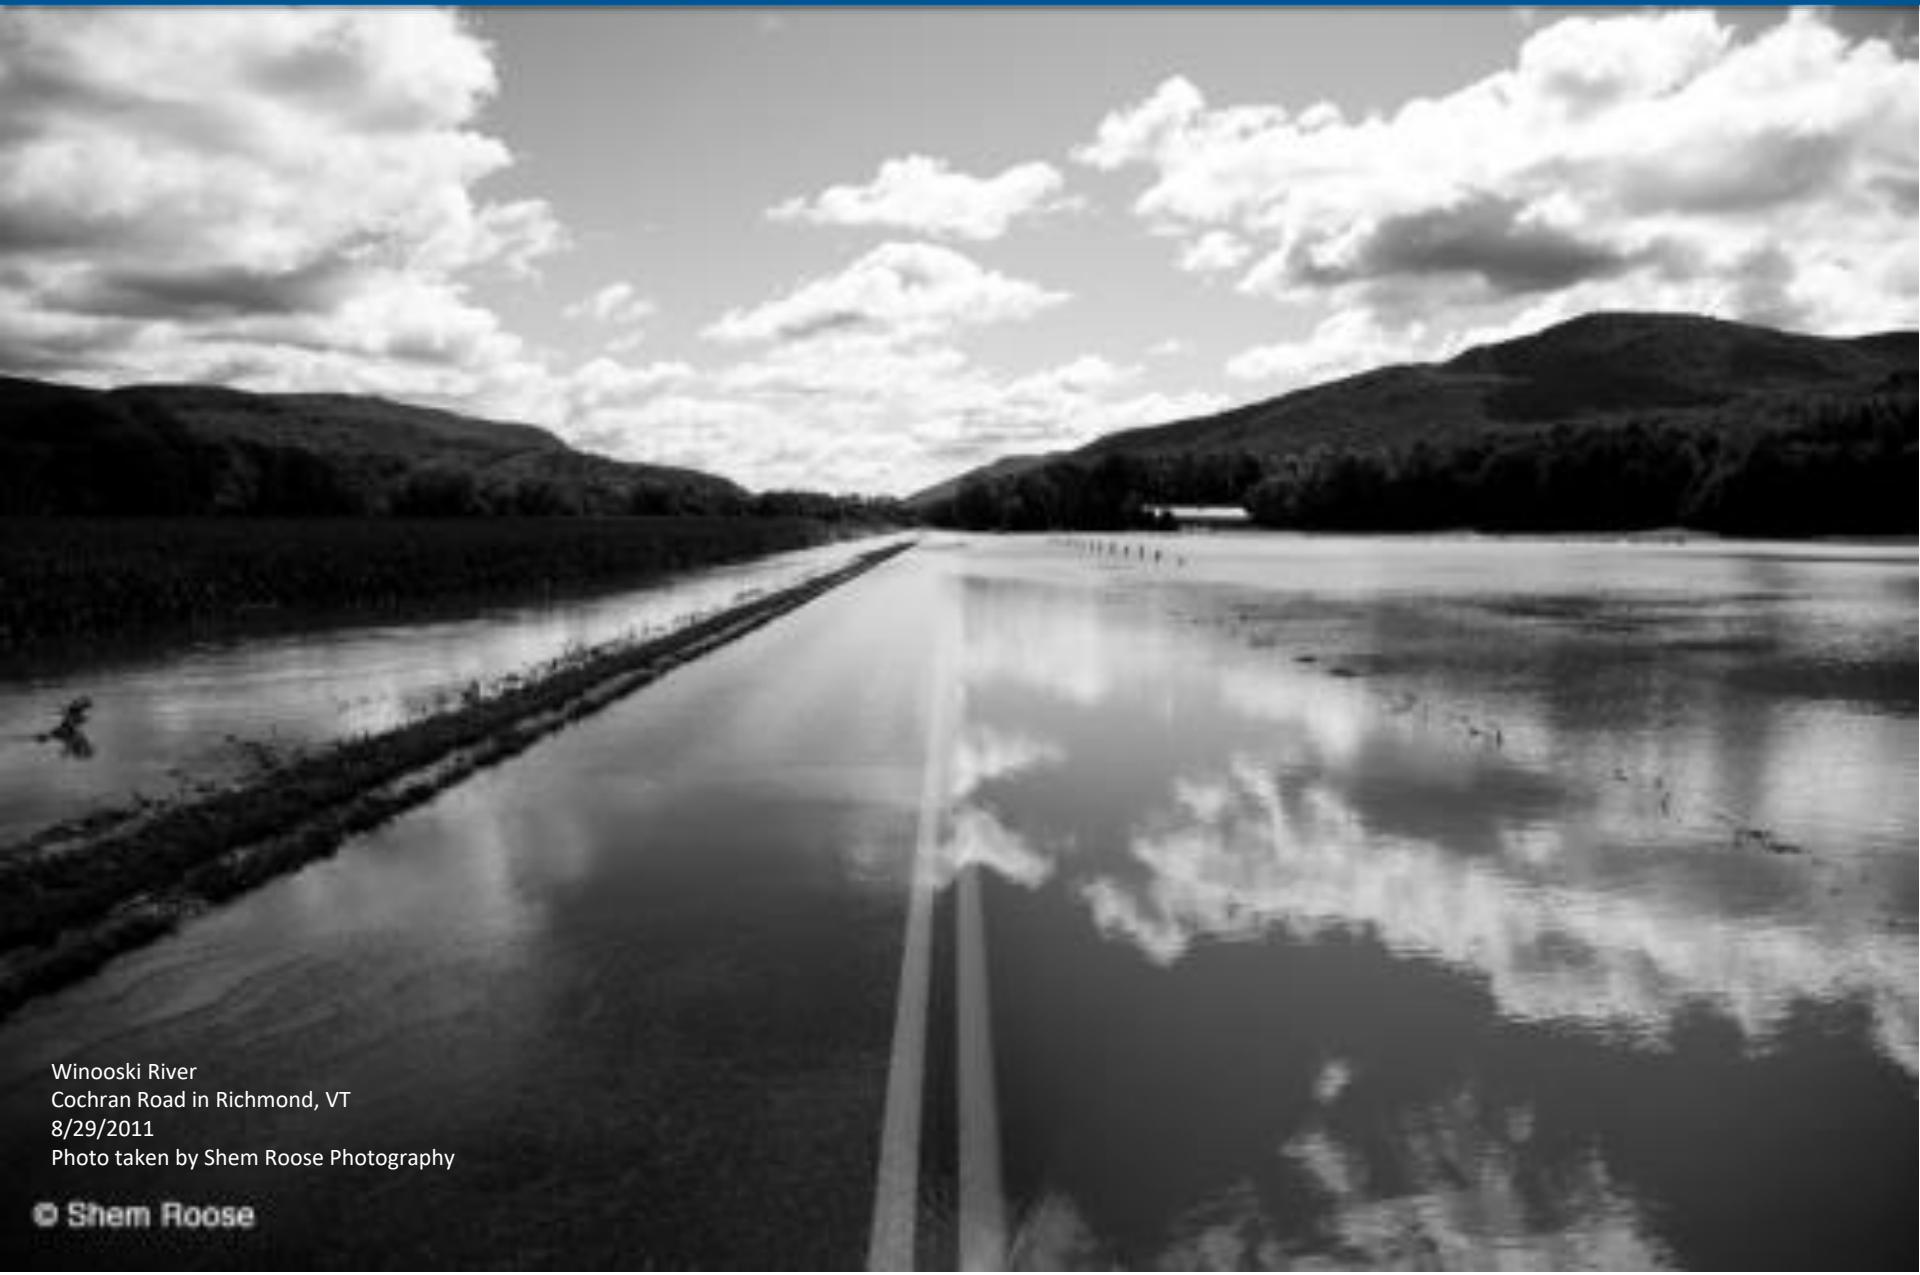
Inundation

Winooski River
Cochran Road in Richmond, VT
8/29/2011
Photo taken by Shem Roose Photography

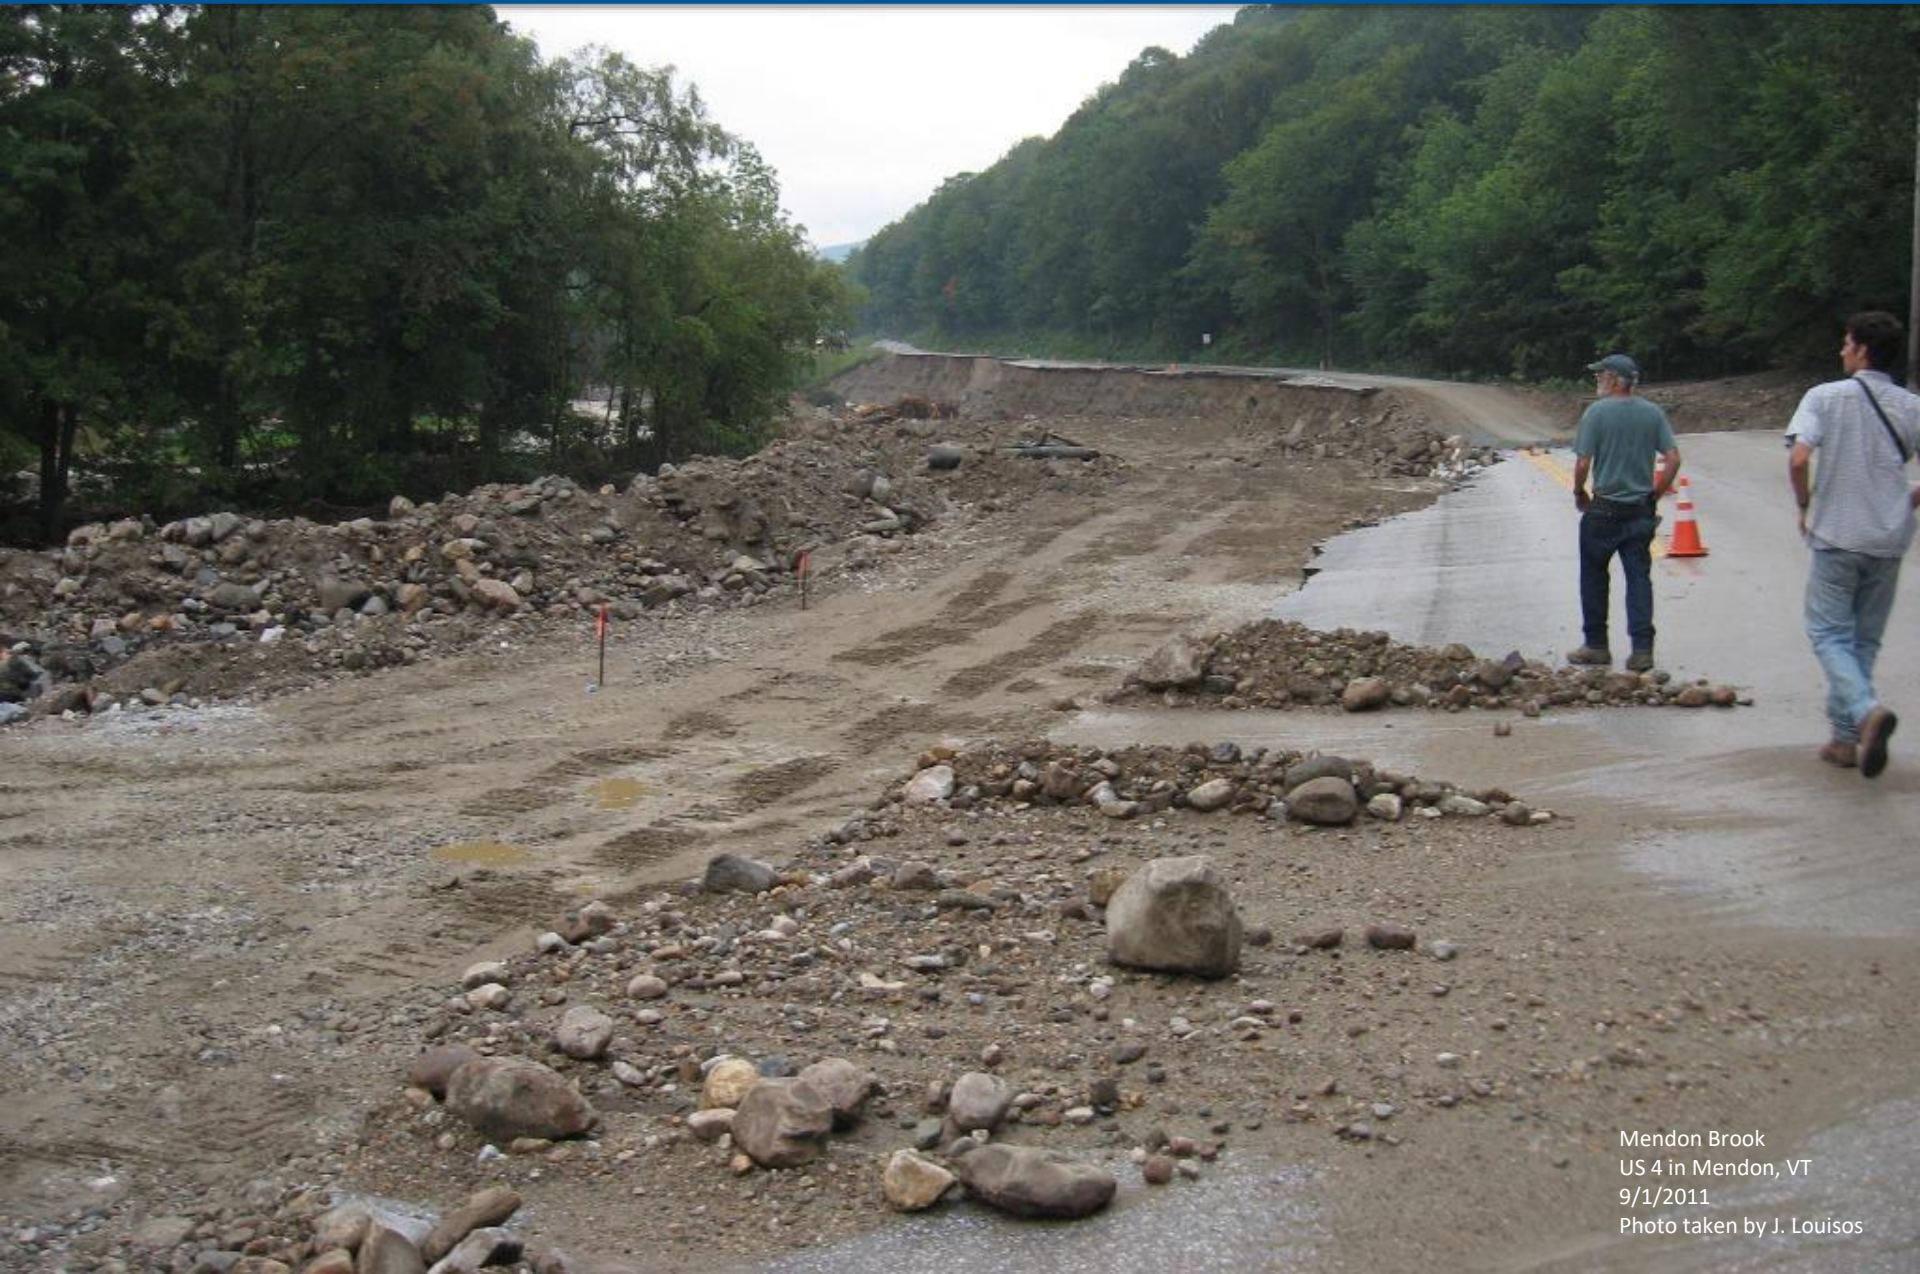
Erosion

Mendon Brook
US 4 in Mendon, VT
9/1/2011
Photo taken by J. Louisos

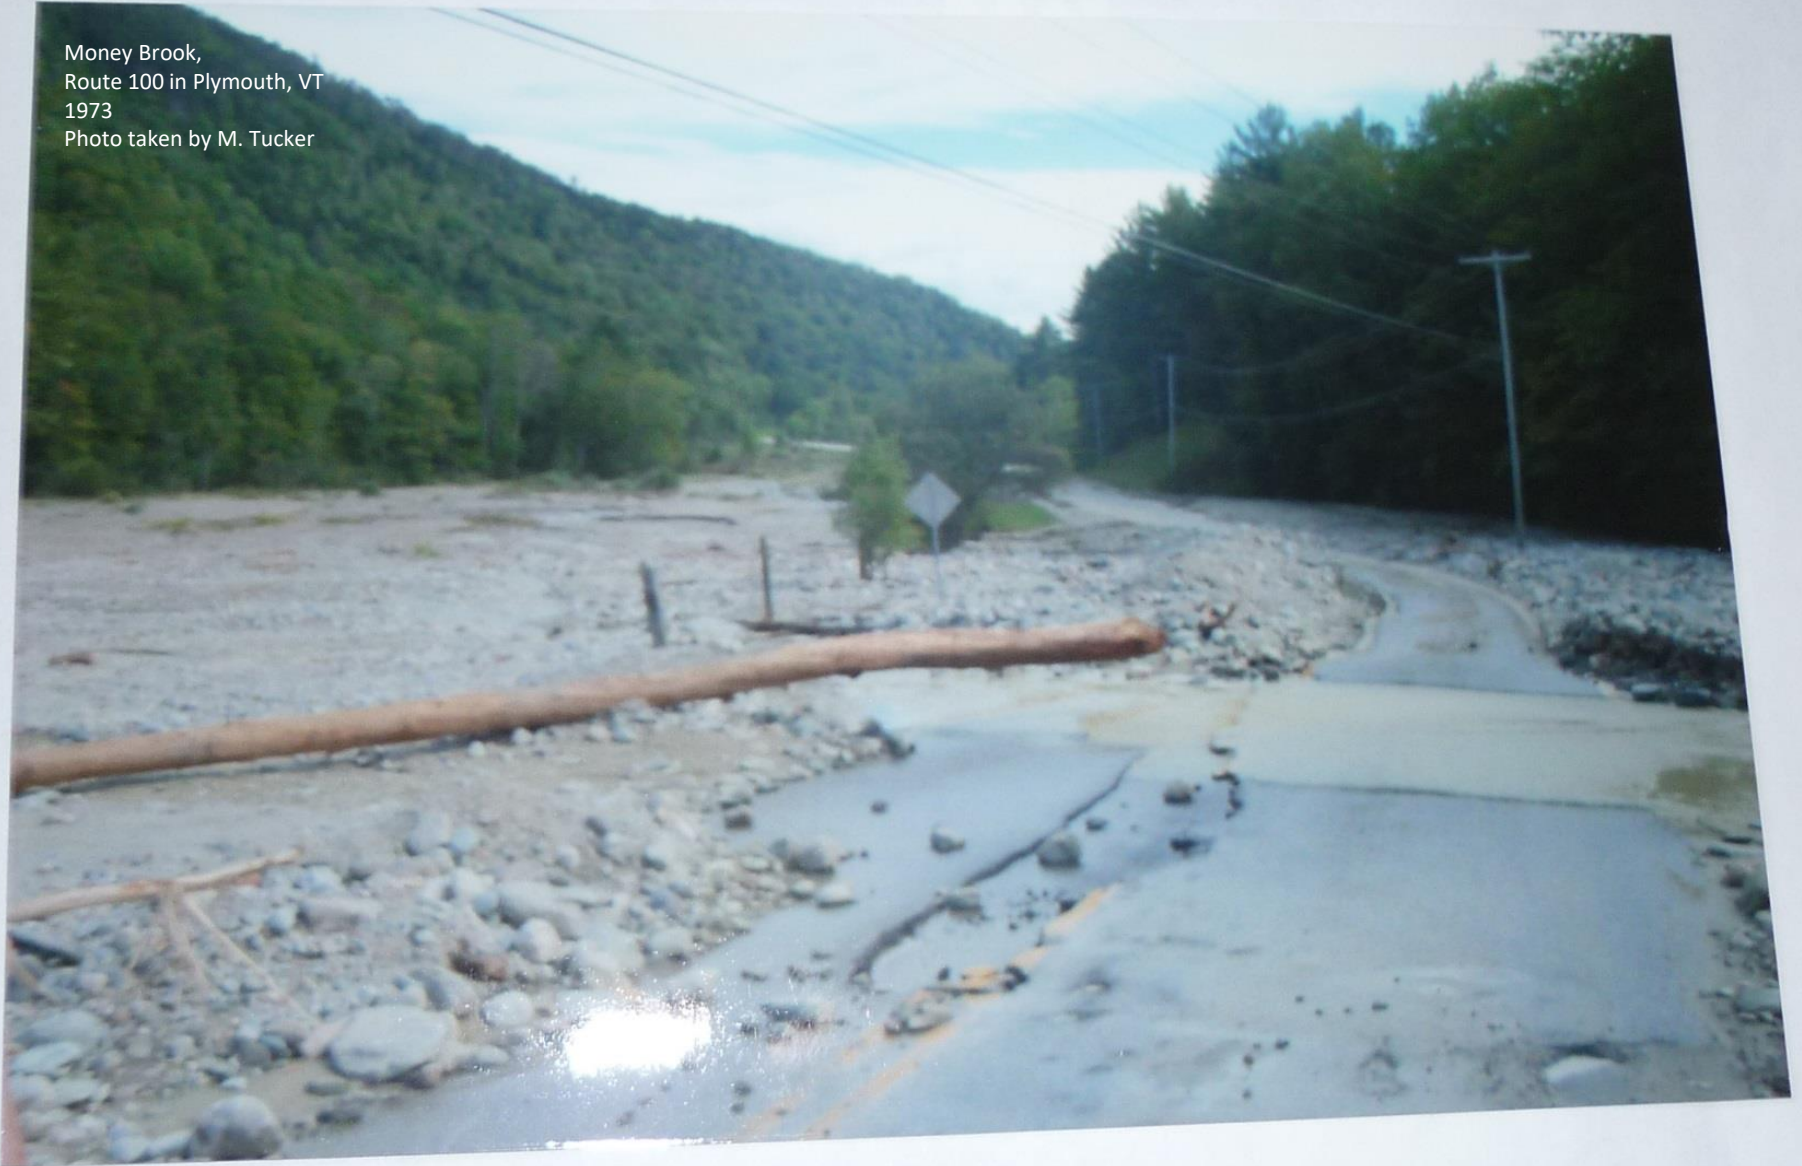
Deposition

Money Brook,
Route 100 in Plymouth, VT
1973
Photo taken by M. Tucker

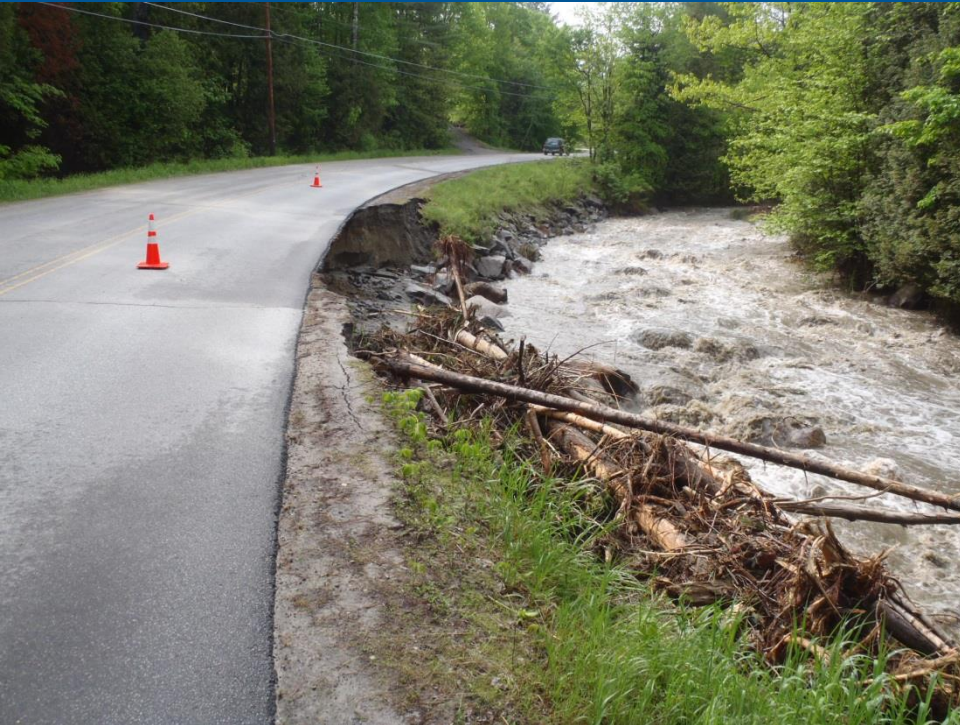
Failure Mode - Partial Closure

Great Brook
Creamery Street in Plainfield, VT
5/27/2011
Photo taken by G. Springston

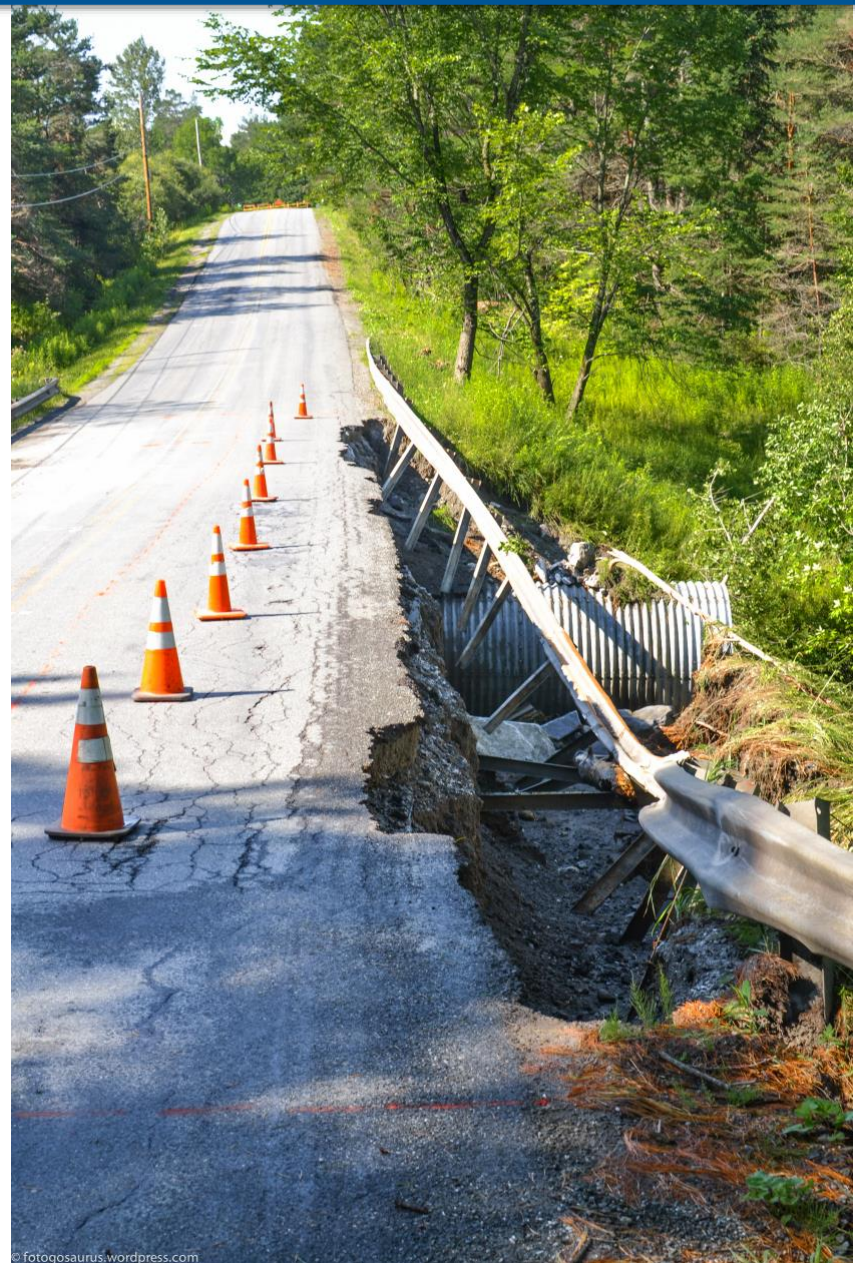
Great Brook
Brook Road in Plainfield, VT
7/20/2015
Photo taken by B. Towbin

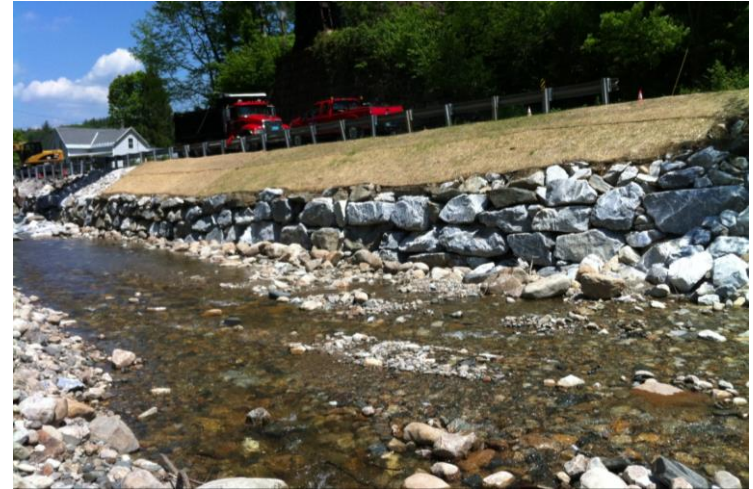
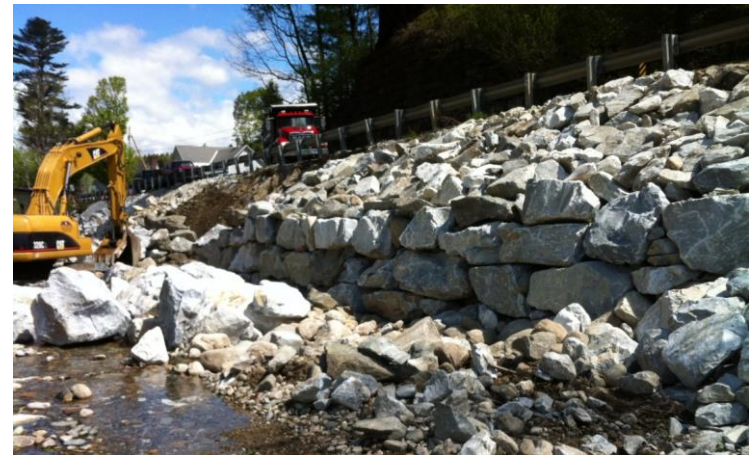
VT Route 155, Mt. Holly, VT

Placed riprap wall

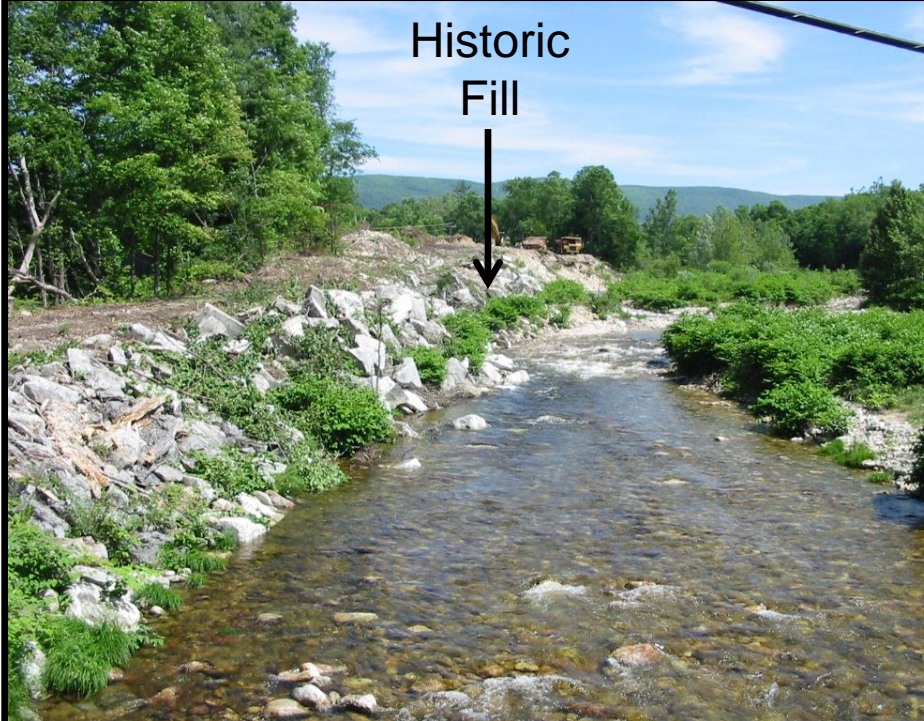
Historic
Fill

Floodplain Restoration Example

Roaring Branch
Bennington, VT
2008

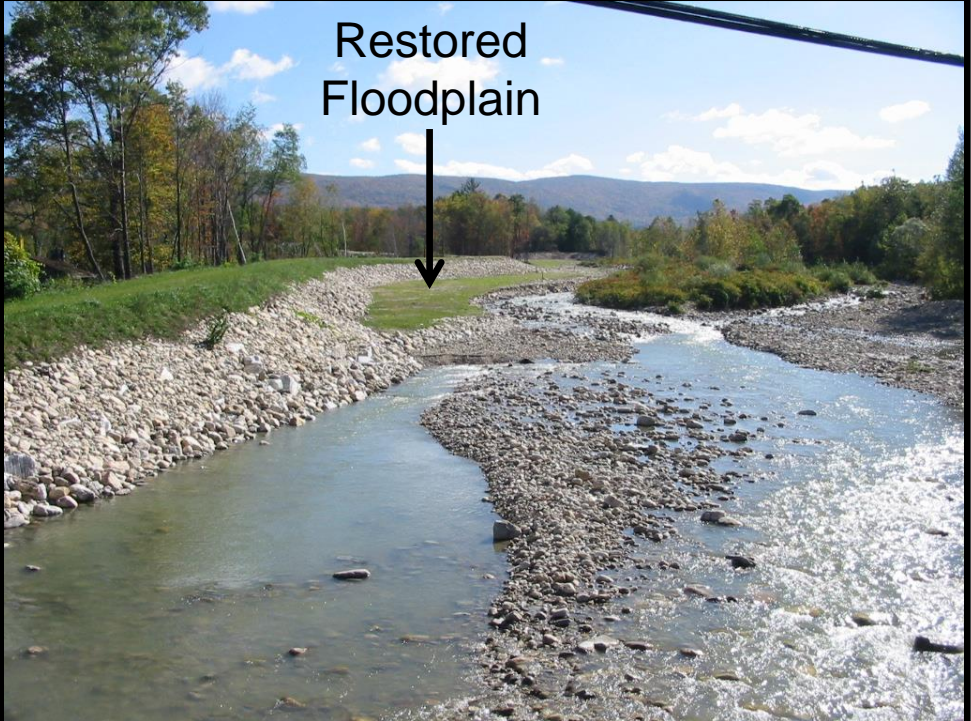
Restored
Floodplain

Roaring Branch
Bennington, VT
2010
