WHY REMOVE OBSOLETE DAMS?

Todd Menees, River Restoration Engineer
DEC WSMD Rivers Program Science Team

Connolly Pond Example: Start with the End in Mind

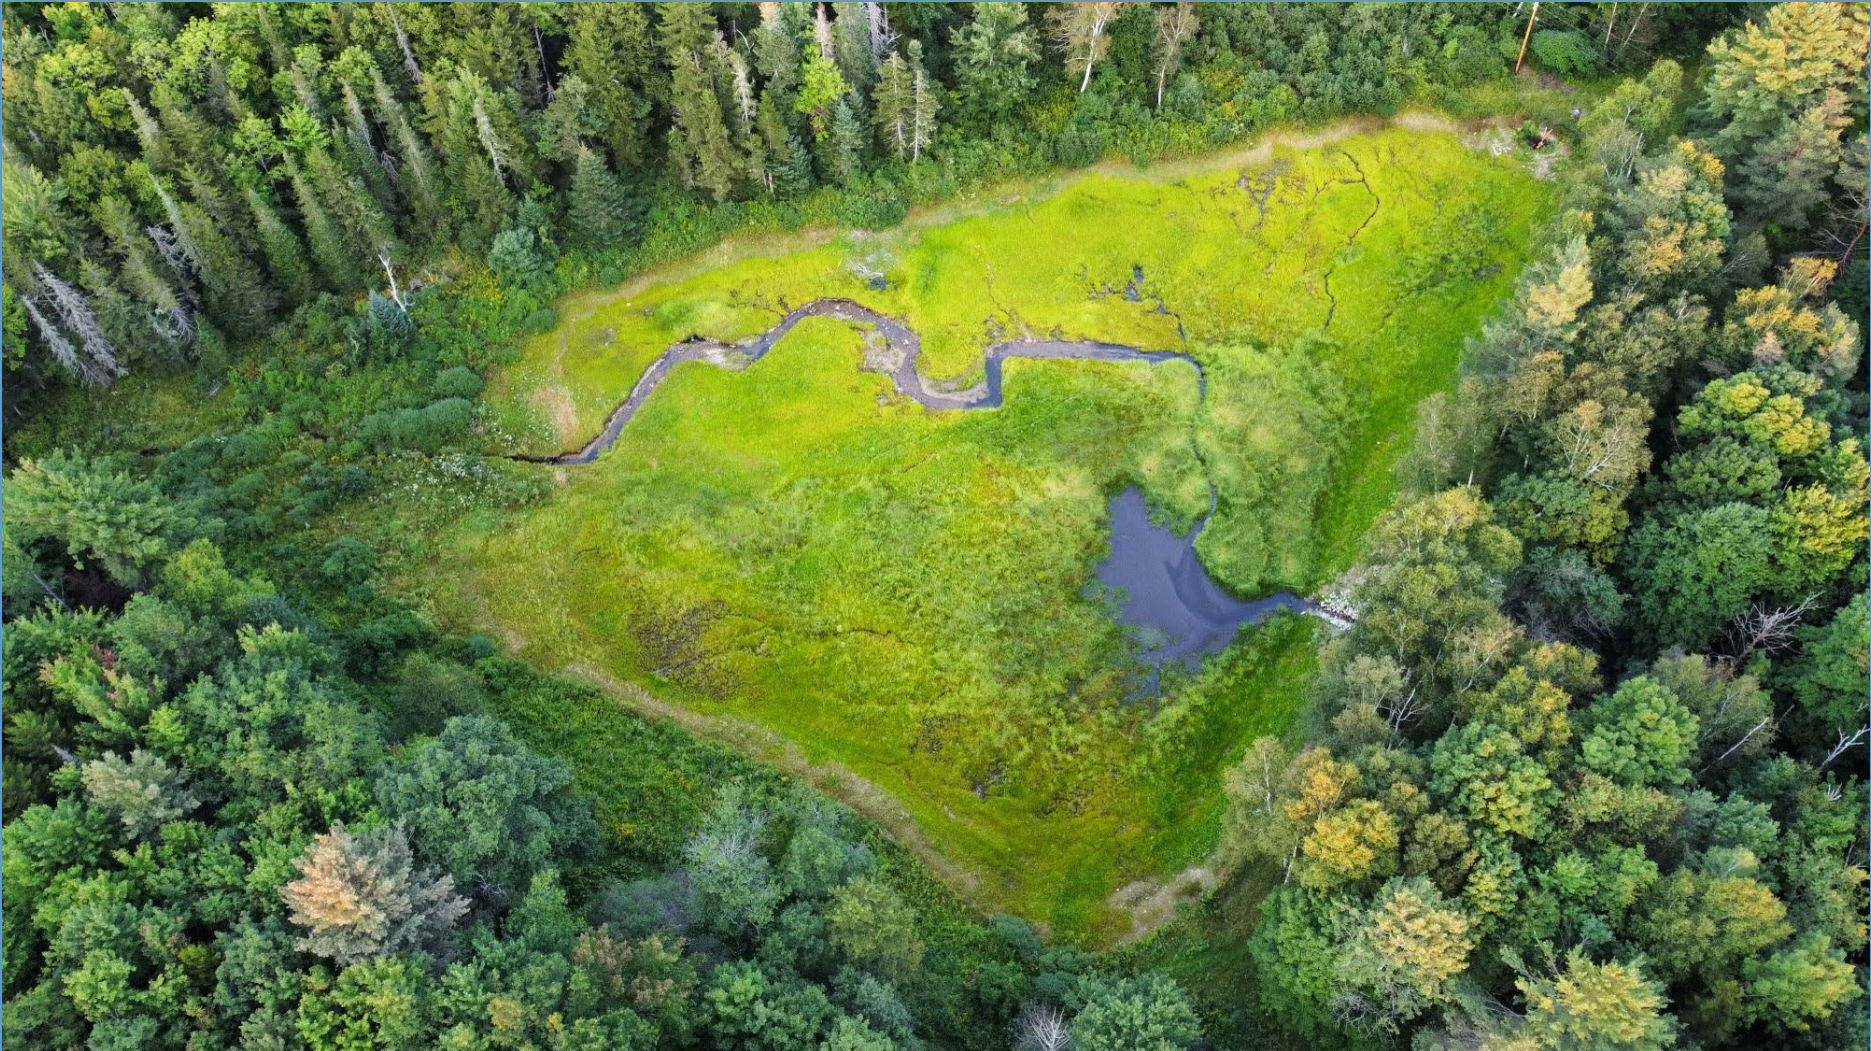
Connolly Pond Wetland 10 Months Later

320' L
15' H
10' W
7 – 10
ac/ft
volume

Fire
Pond

Crop
Water
Source

1950
Earth
Dam
Poor

Hazard

Condition

Significant

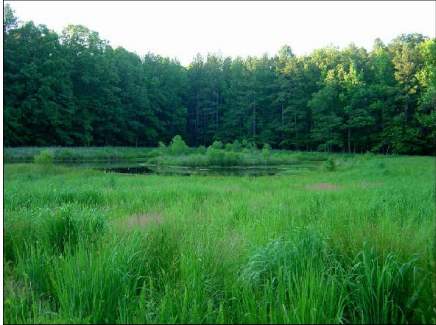
RESTORED WETLAND VEGETATION

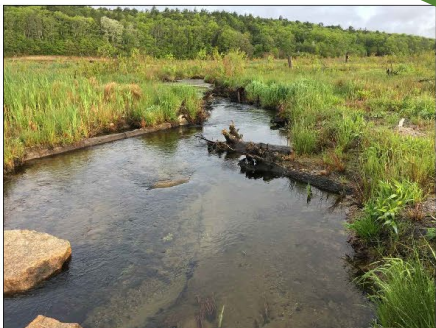
RESTORED PILOT STREAM CHANNEL

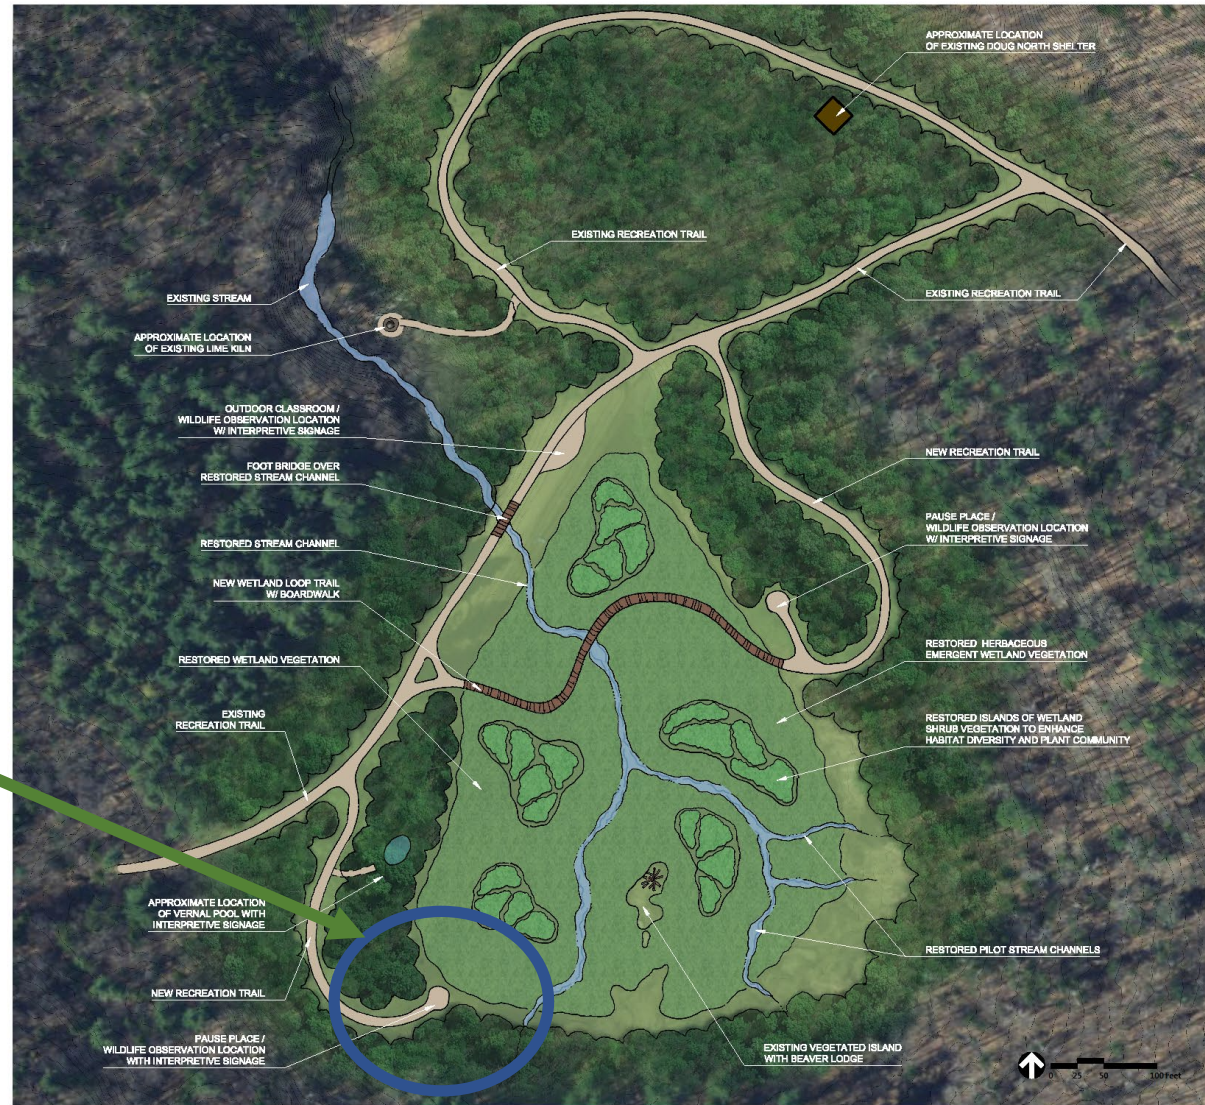
Peggy's Pond Dam Planting Plan After Removal

Water Drawn Down 2020

After Dam Removal

Seed and Mulch Only

30% Design Stage

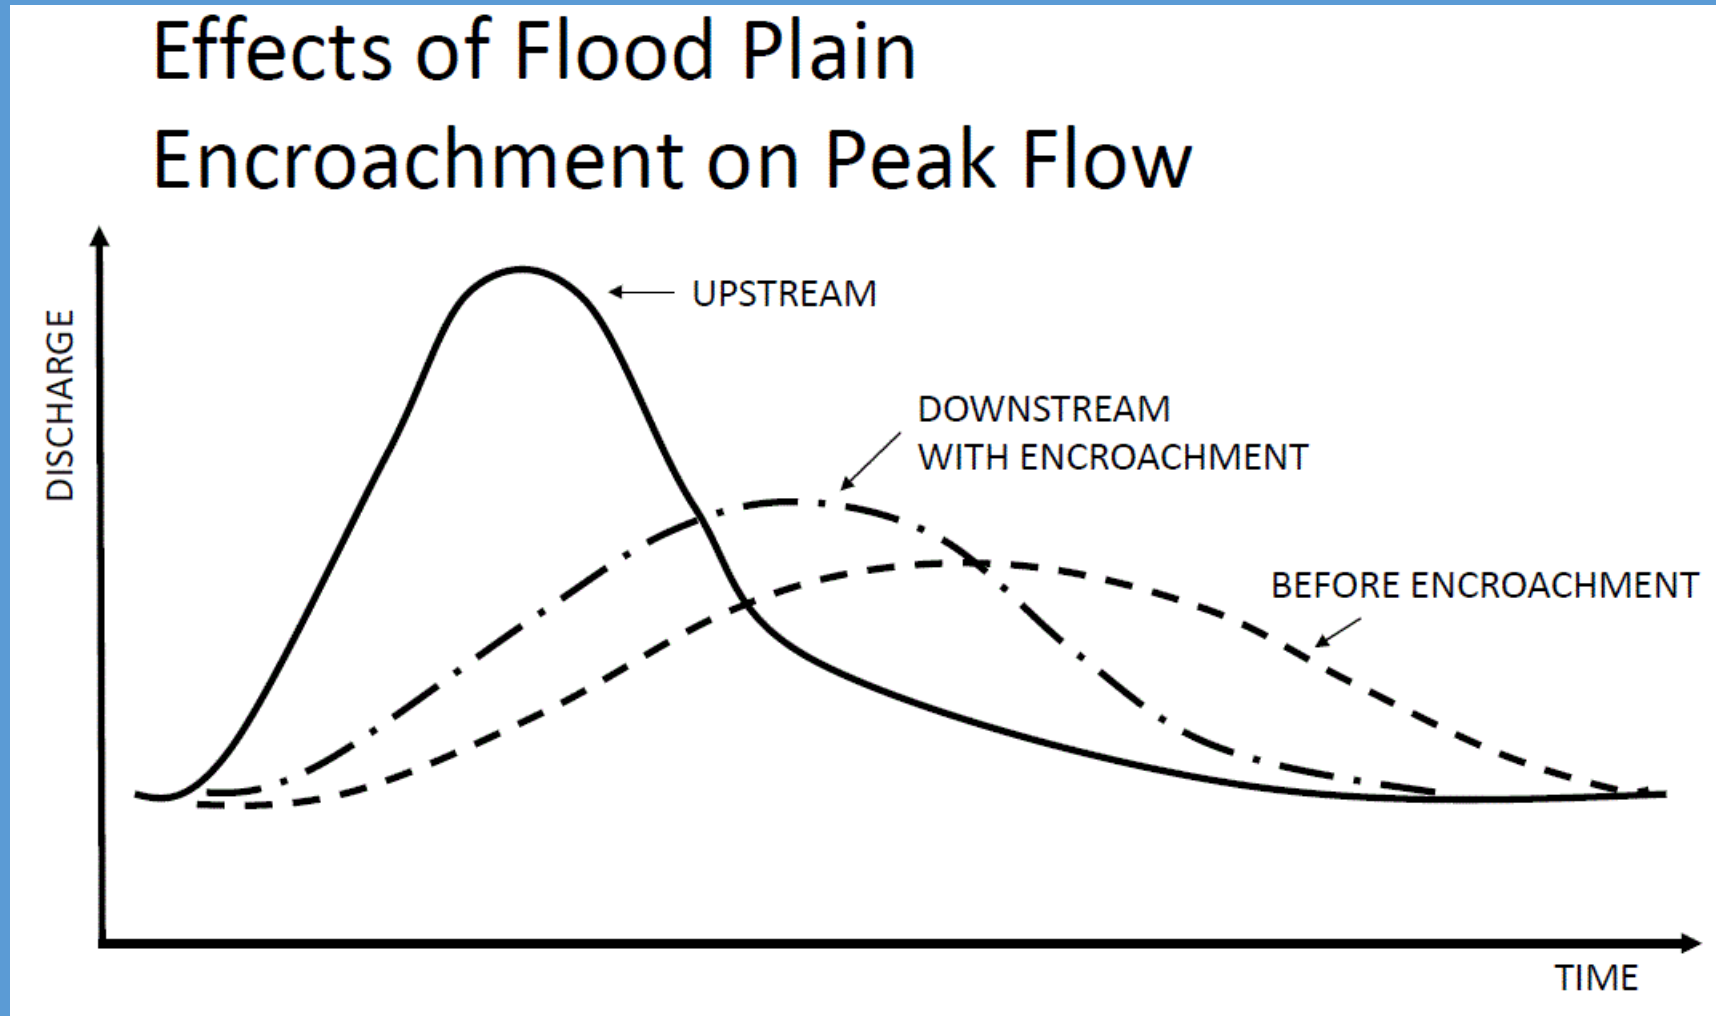
Science: OnStream Dams Encroach on Floodplain

OnStream
Dams
Make
Flooding
Worse

Dams
Gone
Reduce
Flooding

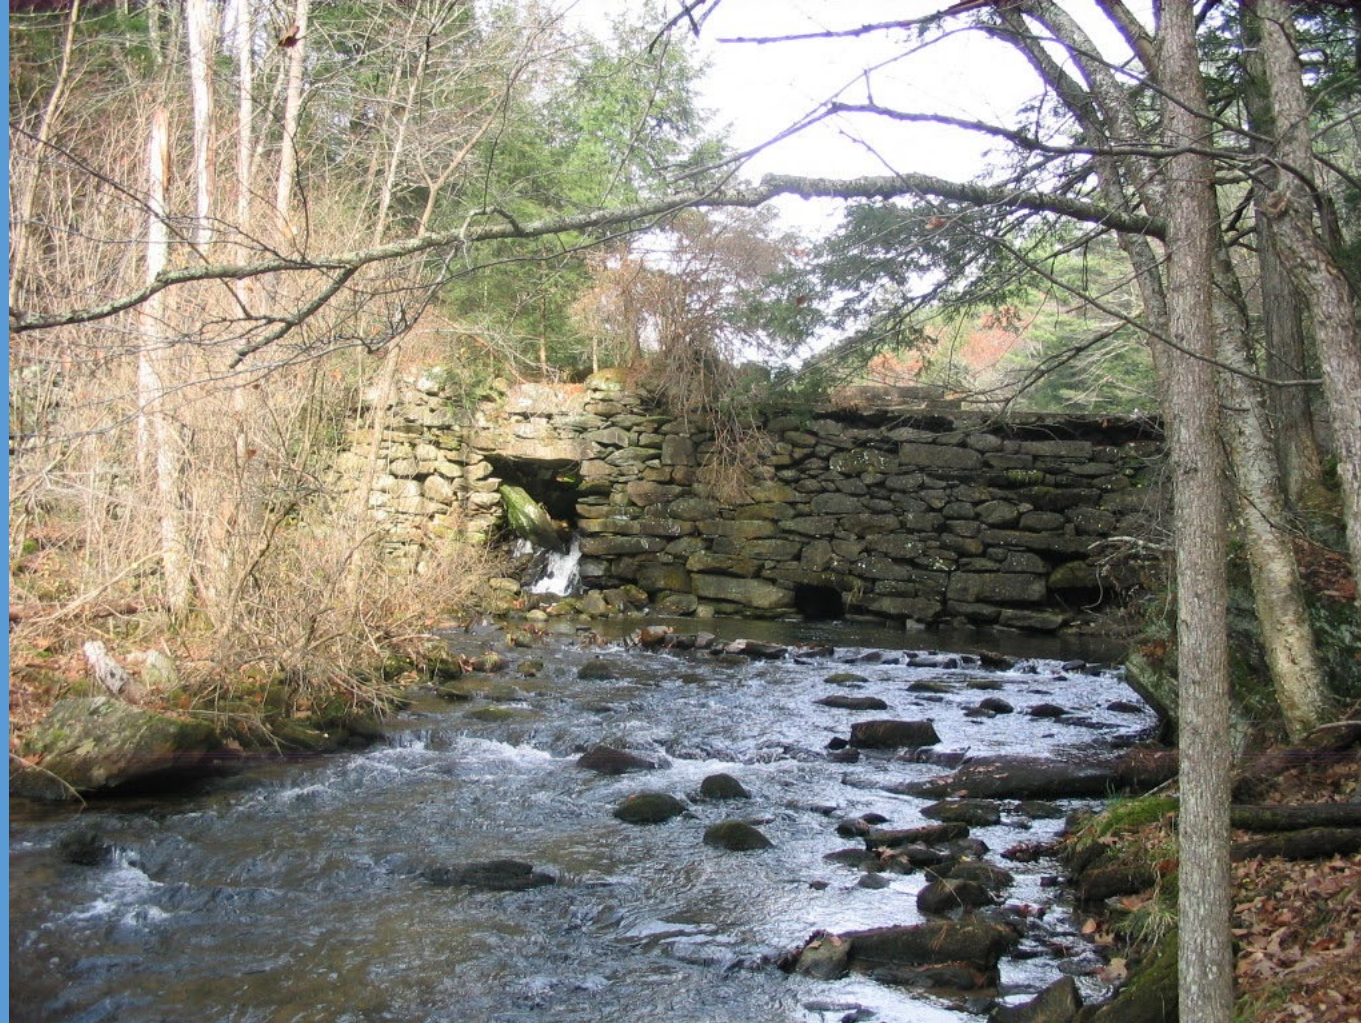
Kendrick Dam 2013

Old
1870
Mill,
Town
Owned

Before
Removal
2014!

10 sq mi
Upstream
Of Rock
Dam,
Good
Brook
Trout
Stream

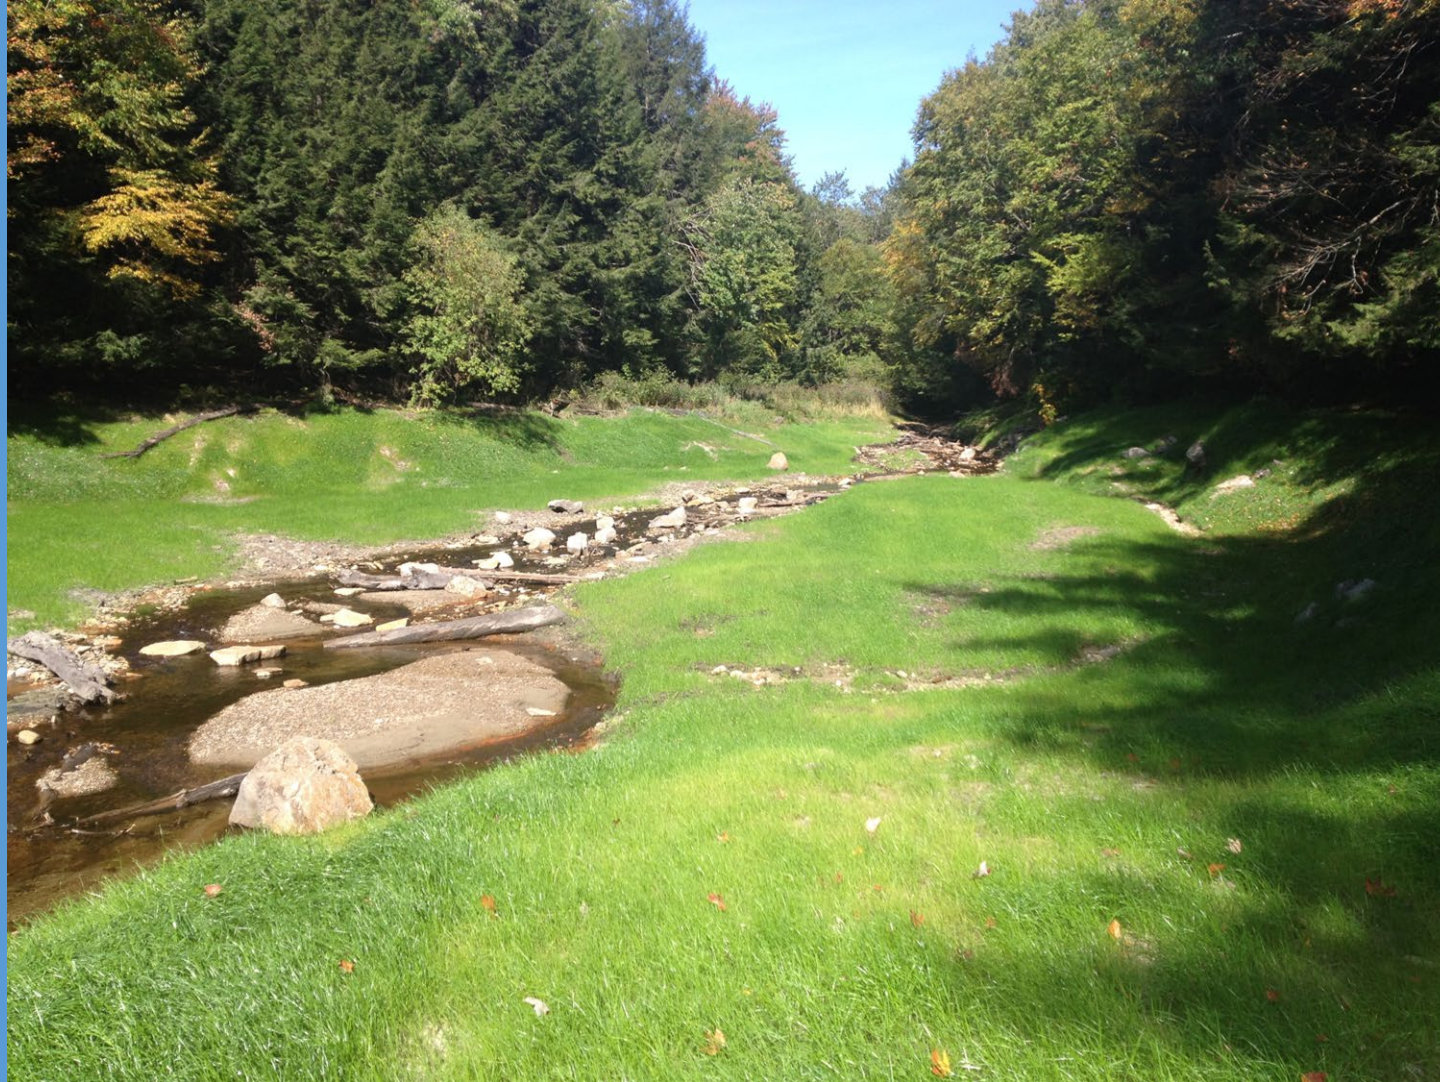
Kendrick Dam Gone 2015

Stream
and
Floodplain
Restored

After
Removal
2014!

Aquatic
and
Terrestrial
Habit
Restored
Upstream
Of Rock
Dam

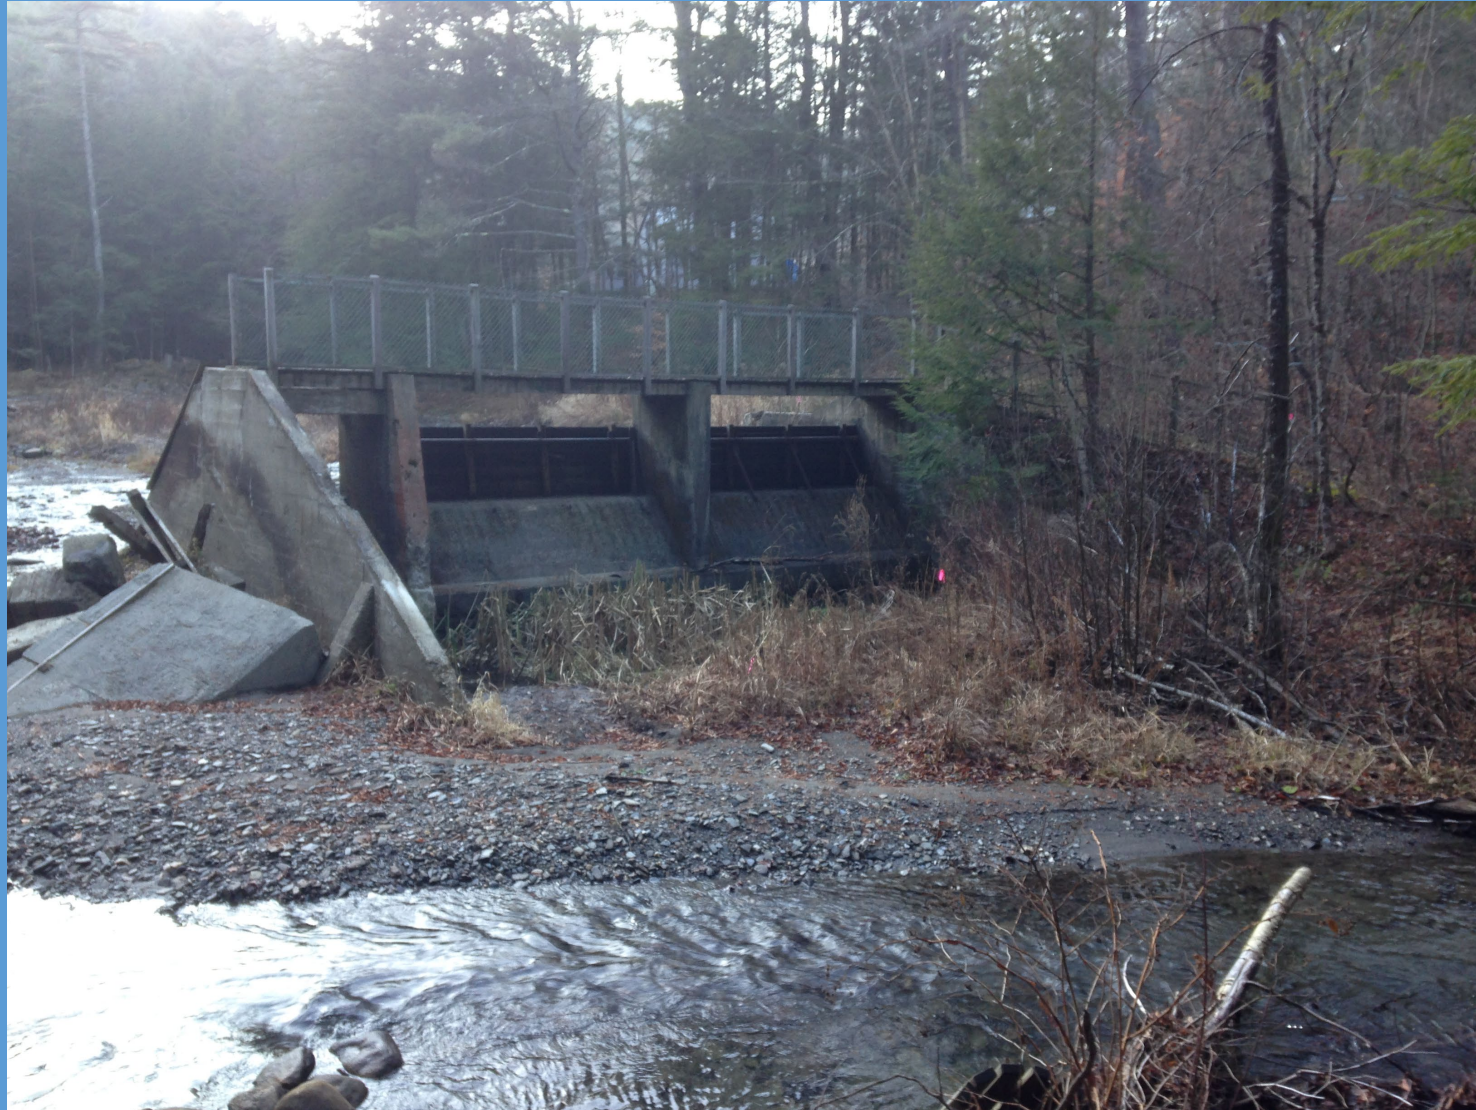
Norwich Pool Dam 2015

Old
Town
Rec
Pool

After T.S.
Irene
Breached!

Concrete
Dam
Built by
Town
WWII
Veterans

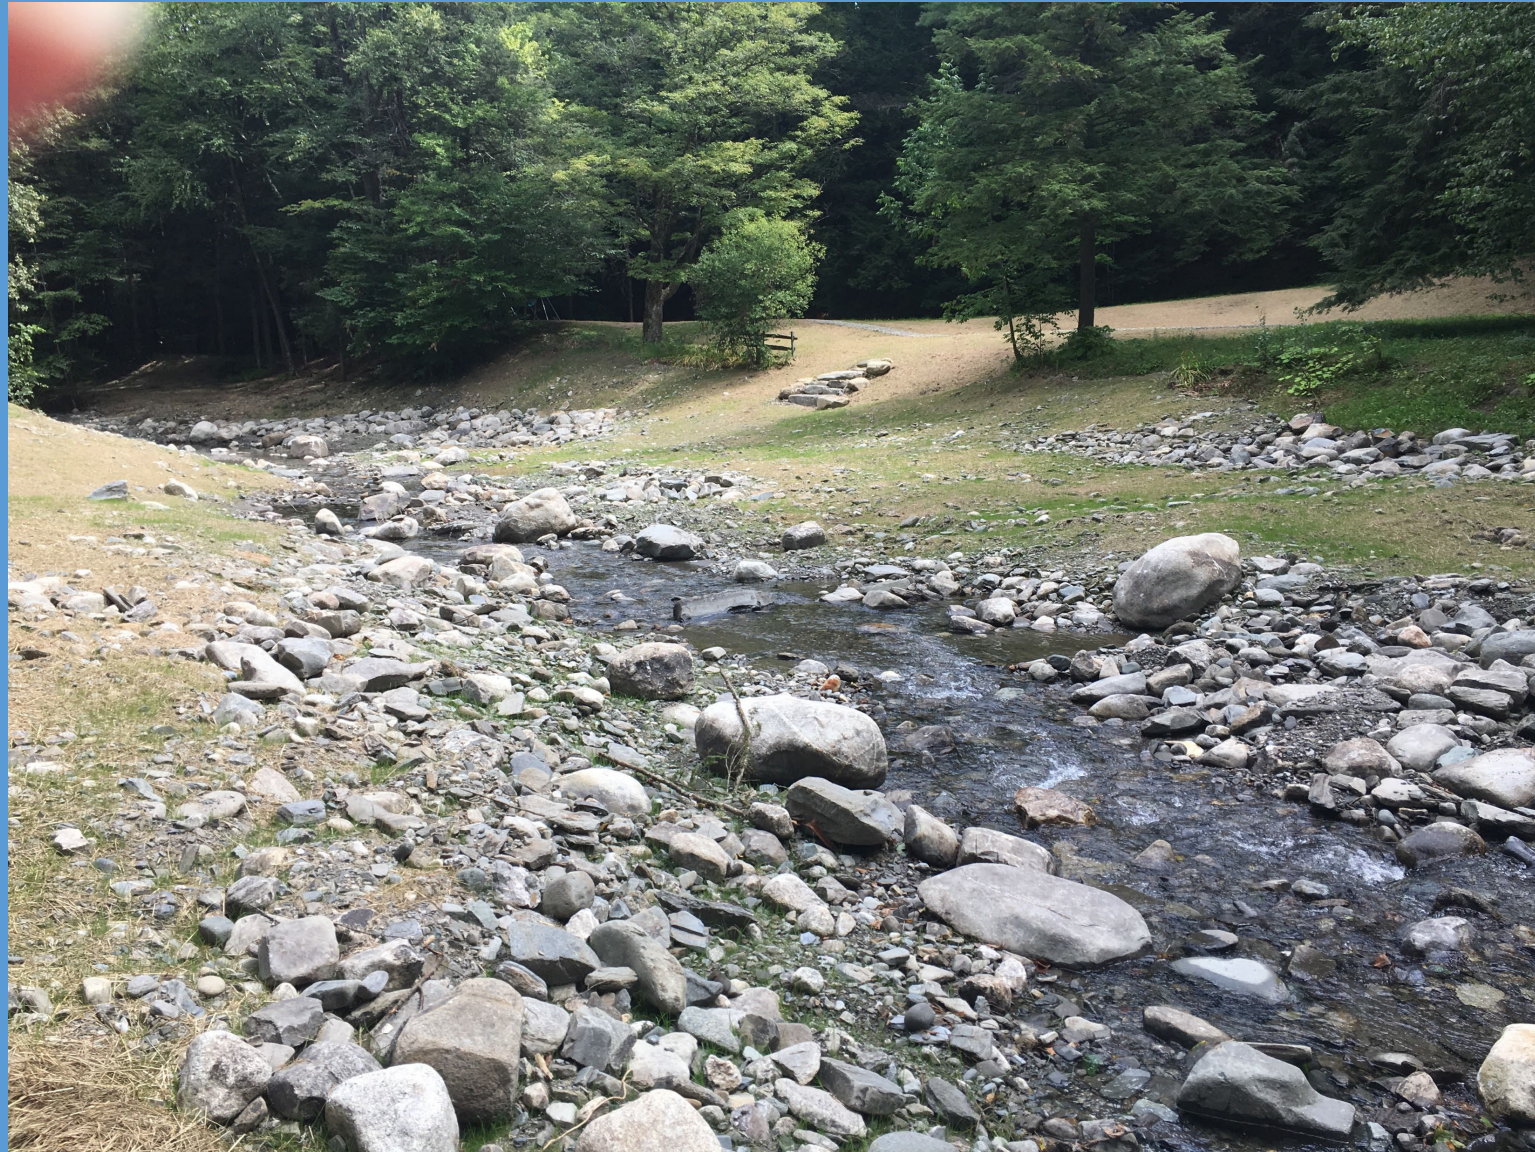
Norwich Pool Dam Gone 2017

Removed
2016 Full
Breach!

Dam
Gone

Rock
Steps
For
Public
Access

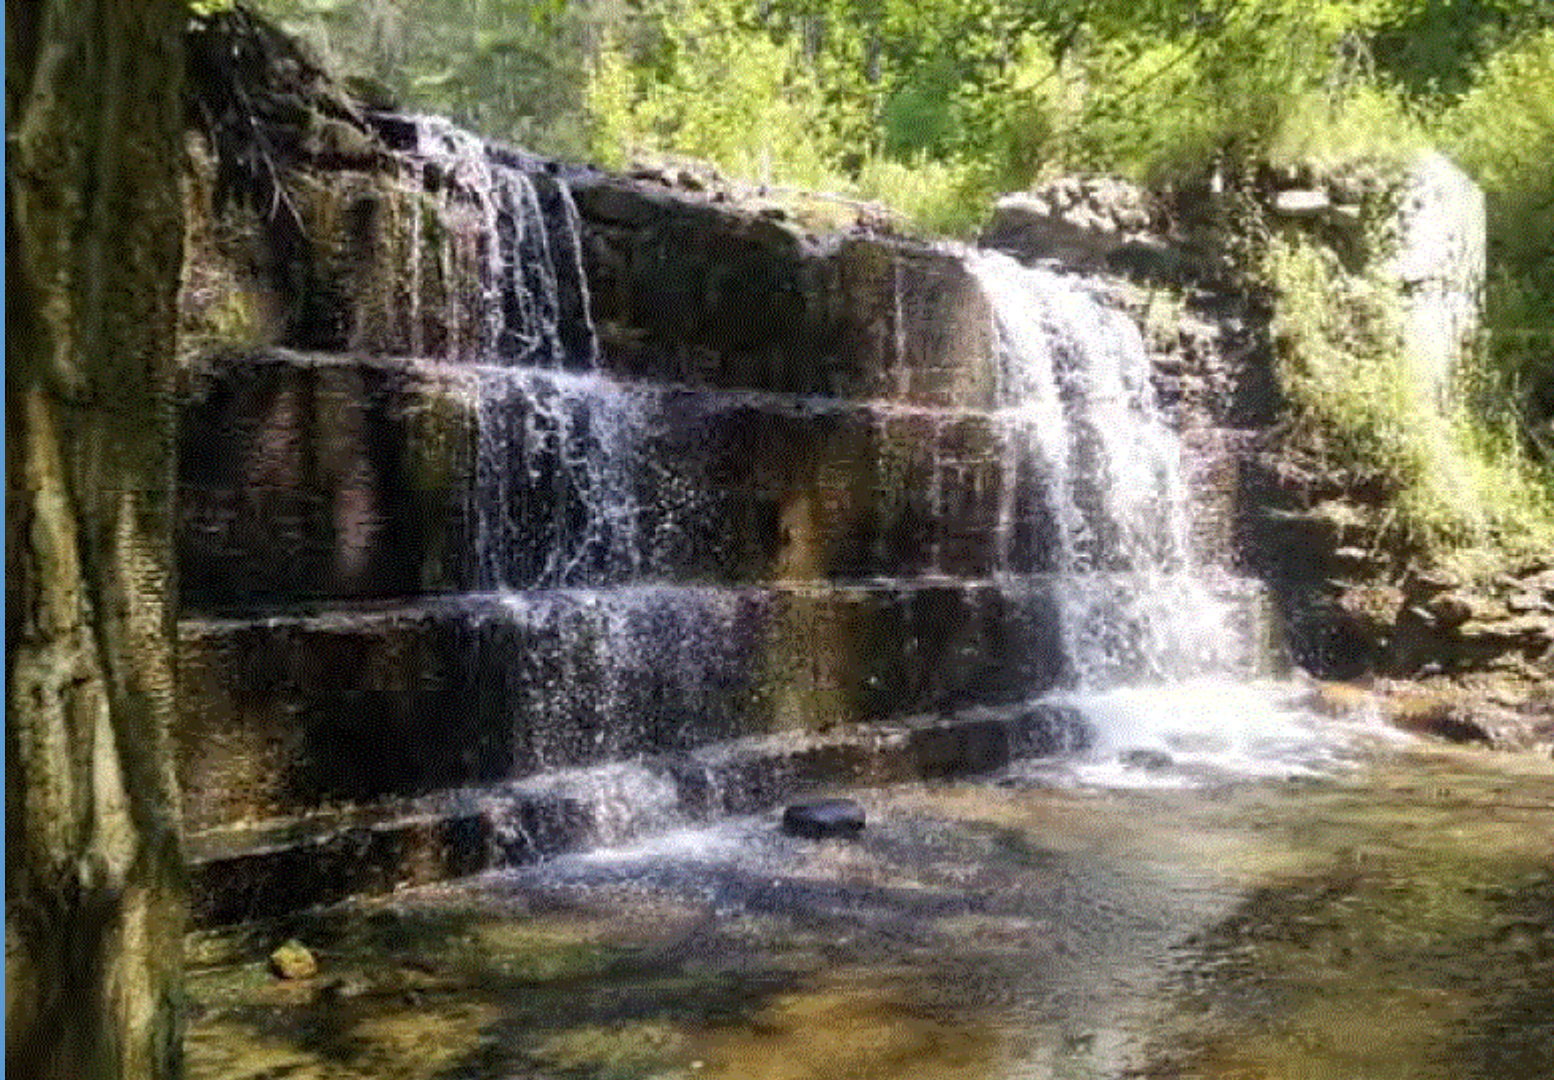
Norwich Reservoir Dam 2017

Old
Town
Water
Supply

Before
Removal
2018!

12.5'
High
By
40' long
Concrete
Dam

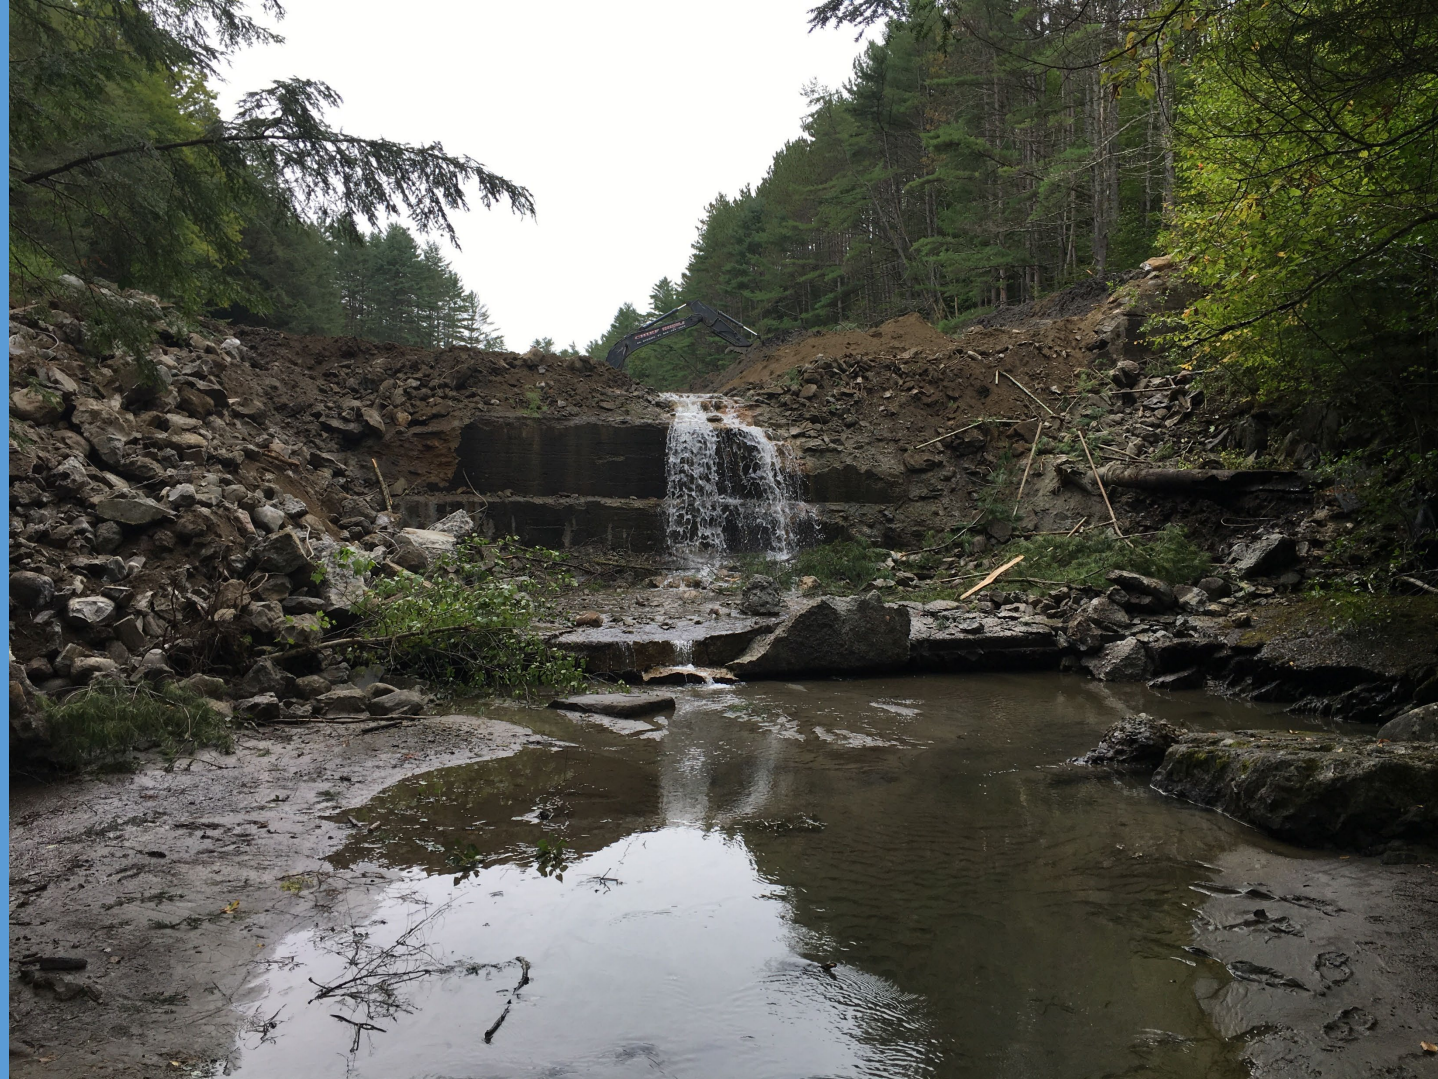
Norwich Reservoir Dam 2018

During
Removal
2018!

12.5'
High
By
40' long
Concrete
Dam

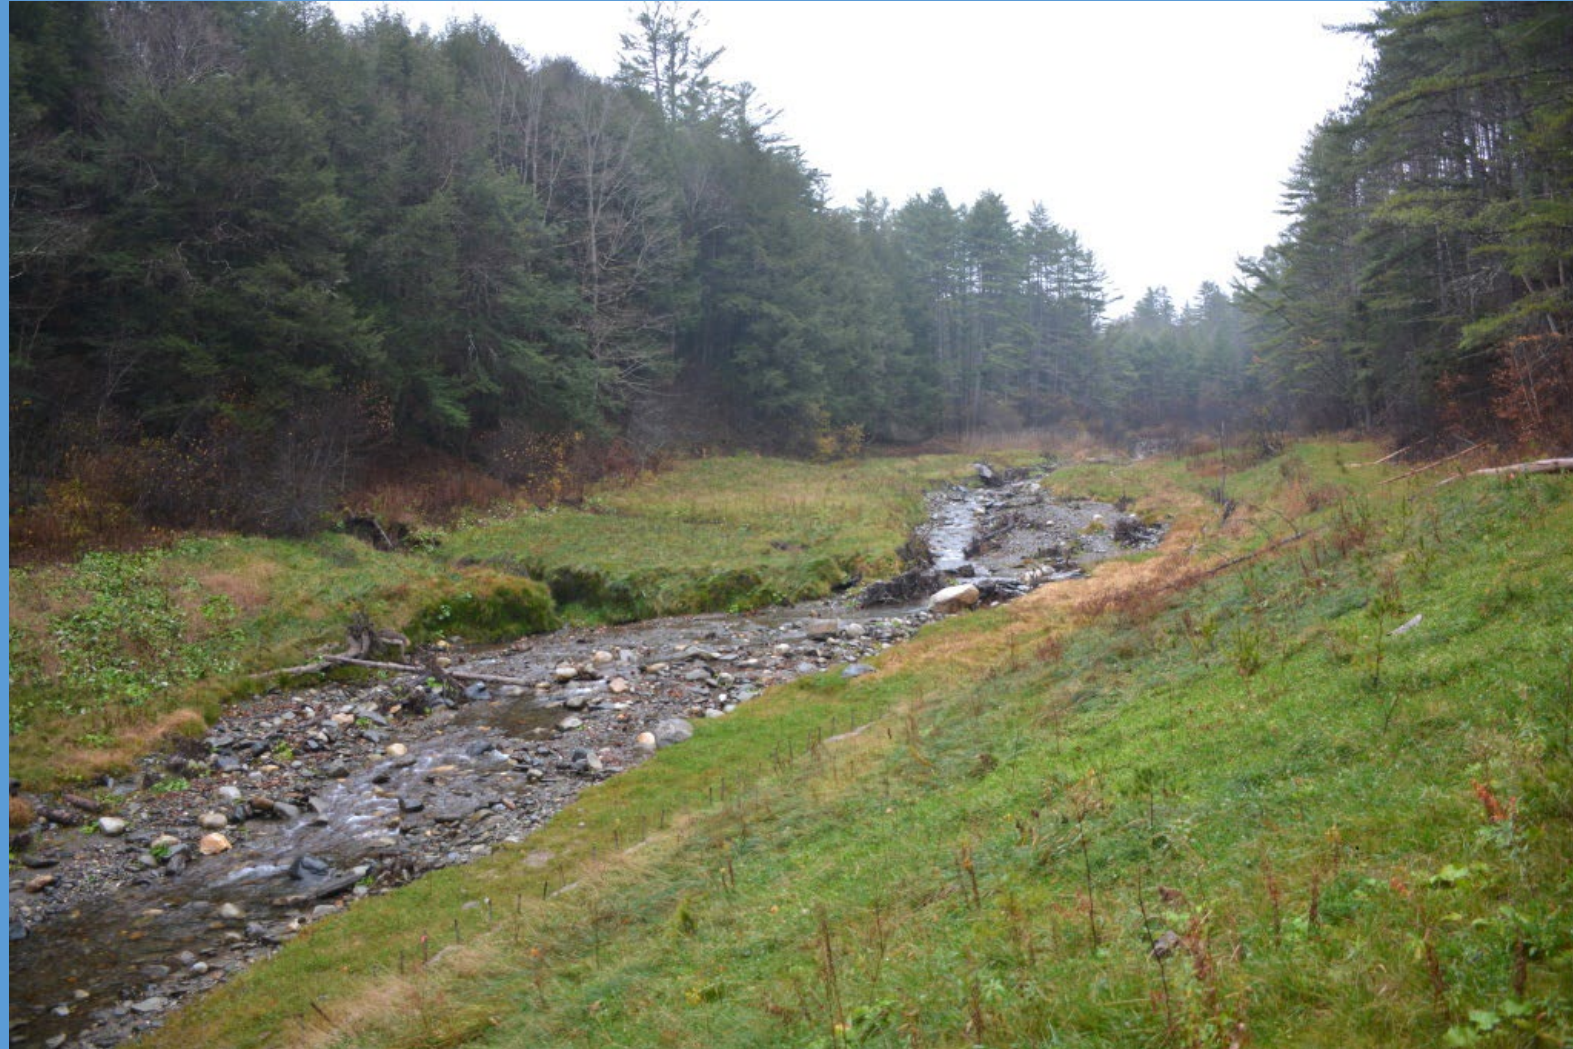
Norwich Reservoir Dam Gone 2020

After
Removal
2020!

Naturally
Vegetated
And
Planted
By
Volunteers

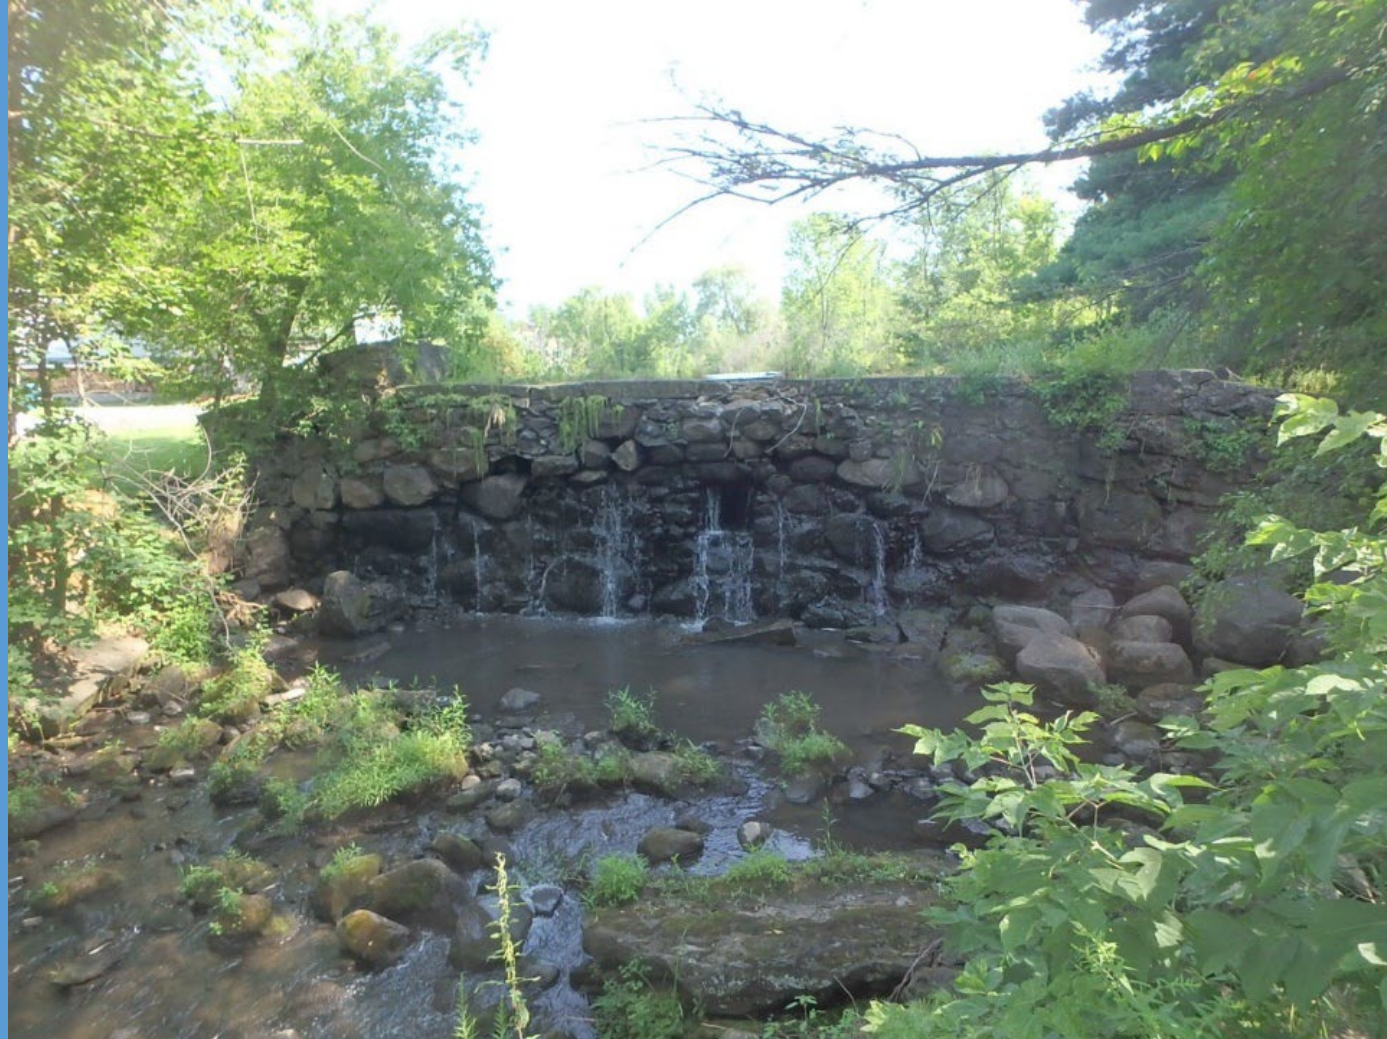
Dunklee Pond Dam Before Removal

Crumbling
Stone Dam
Known
Public
Safety
Threat

Looking Upstream at Old Stone Dam 2017

Ca 1792
Dam
Poor
Condition

Significant
Hazard Dam

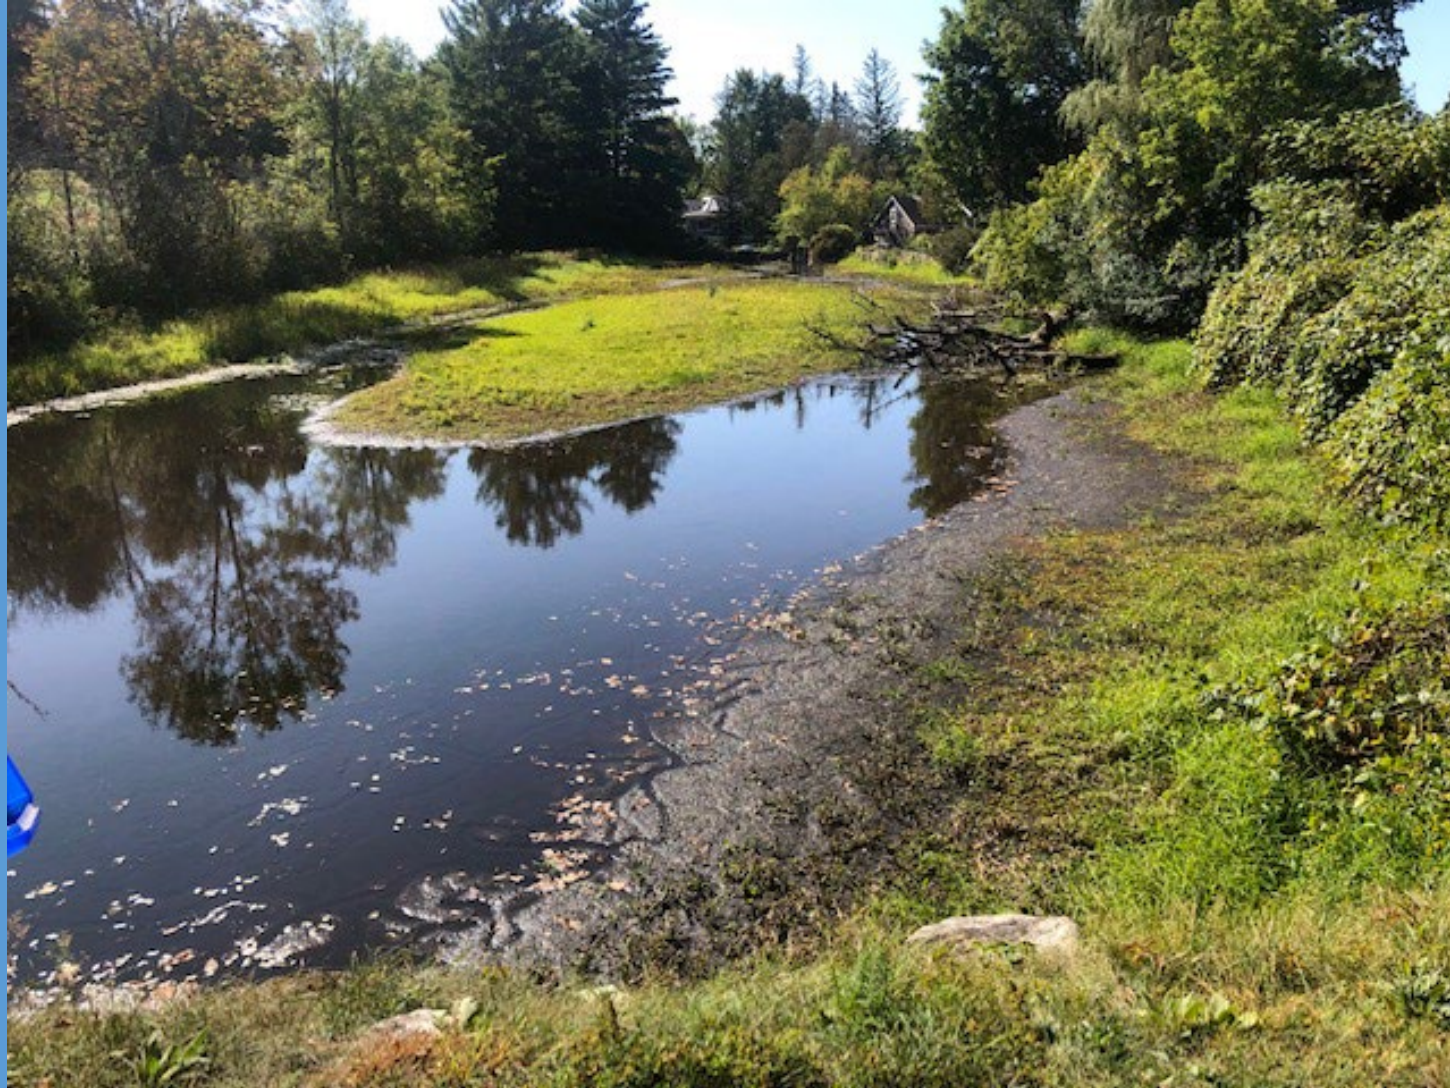
Dunklee Pond Dam Before Removal

T.S. Irene
Sediment
Deposits
Filled in
the Pond

~ 400 lbs

Of
Phosphorous
Removed

Poor WQ

Murky
Water

Smelly and
Fish Kill
Low D.O.

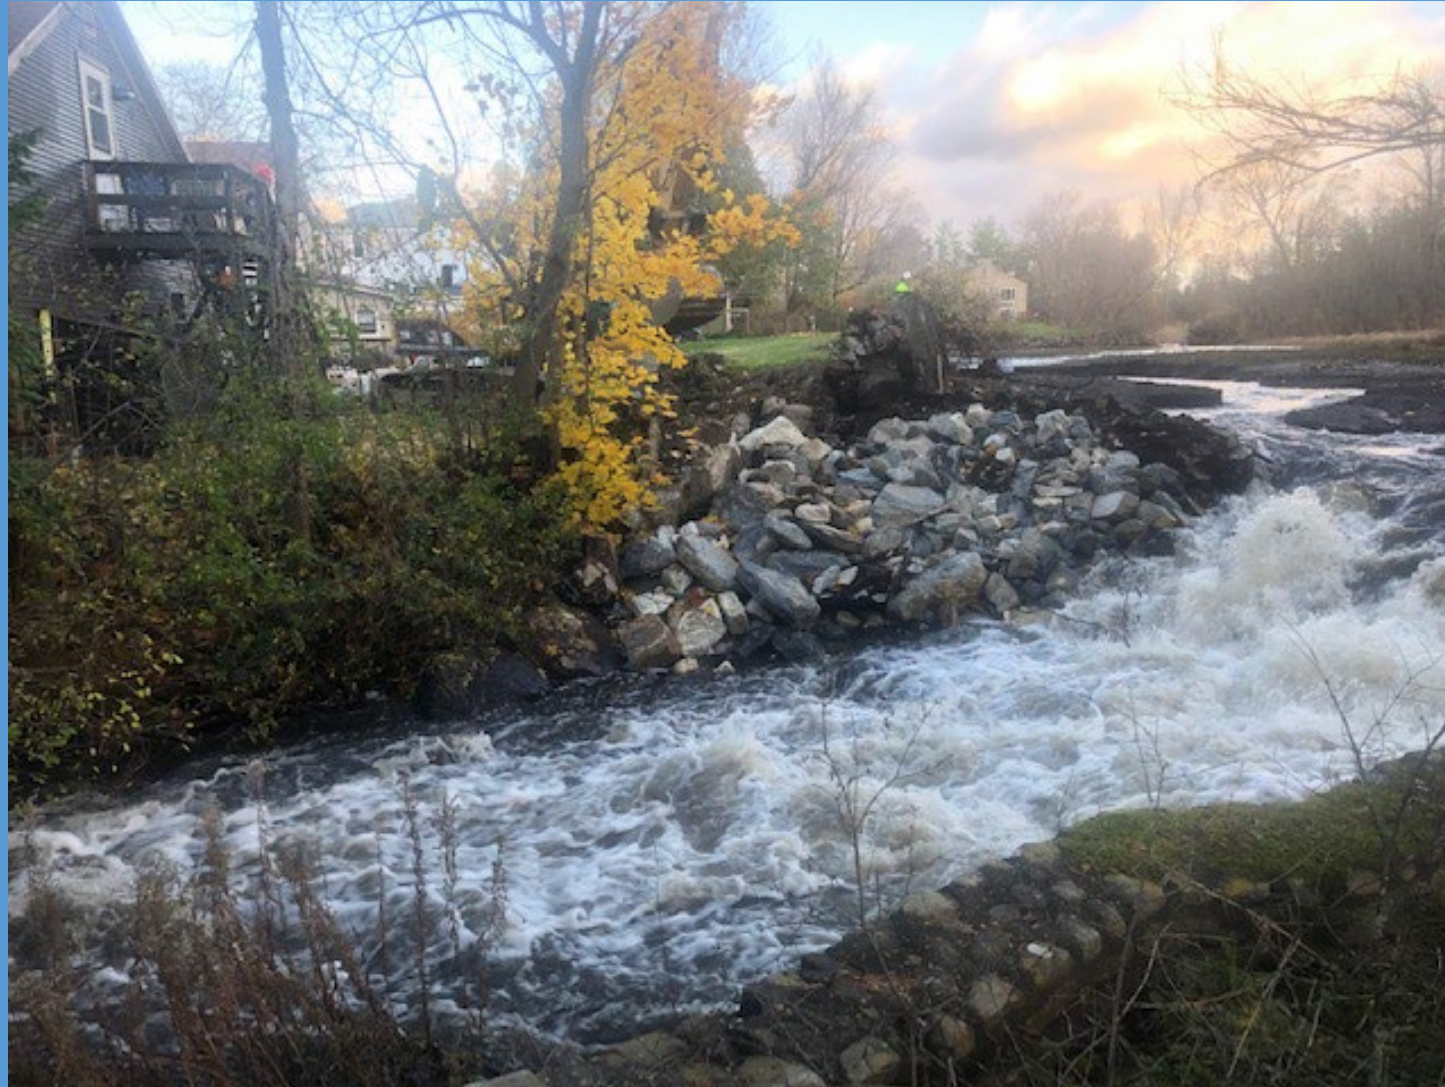
Dunklee Pond Dam Partial Breach

Next Day
Halloween
Flood for
Public
Safety
Threat

Dam
~160 l.f.
above
Route 7

Looking Upstream at 2019 Partial Breach

Irene
Spilled
Water
on the
Sidewalk

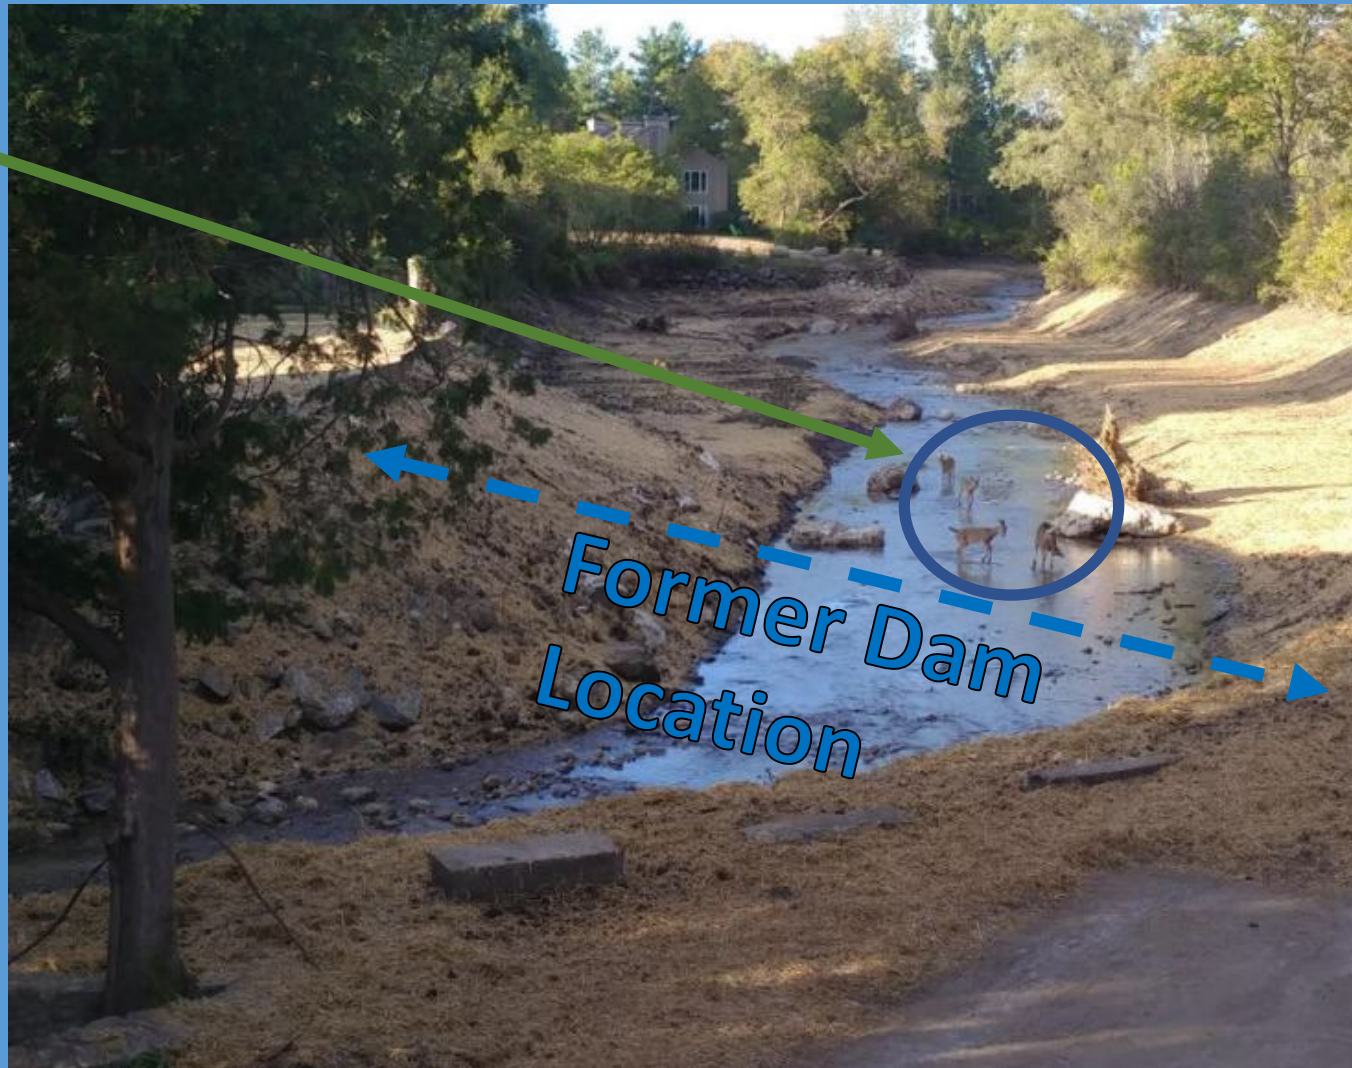
Dunklee Pond Dam After Full Removal

Removal
Completed
10/28/21

~400 lbs. of
Phosphorous
Removed

Floodplain
Storage

Captures

Future

Sediment

Phosphorous
