WHY REMOVE OBSOLETE DAMS?

Todd Menees, River Restoration Engineer
DEC WSMD Rivers Program Science Team

Connolly Pond Example: Start with the End in Mind

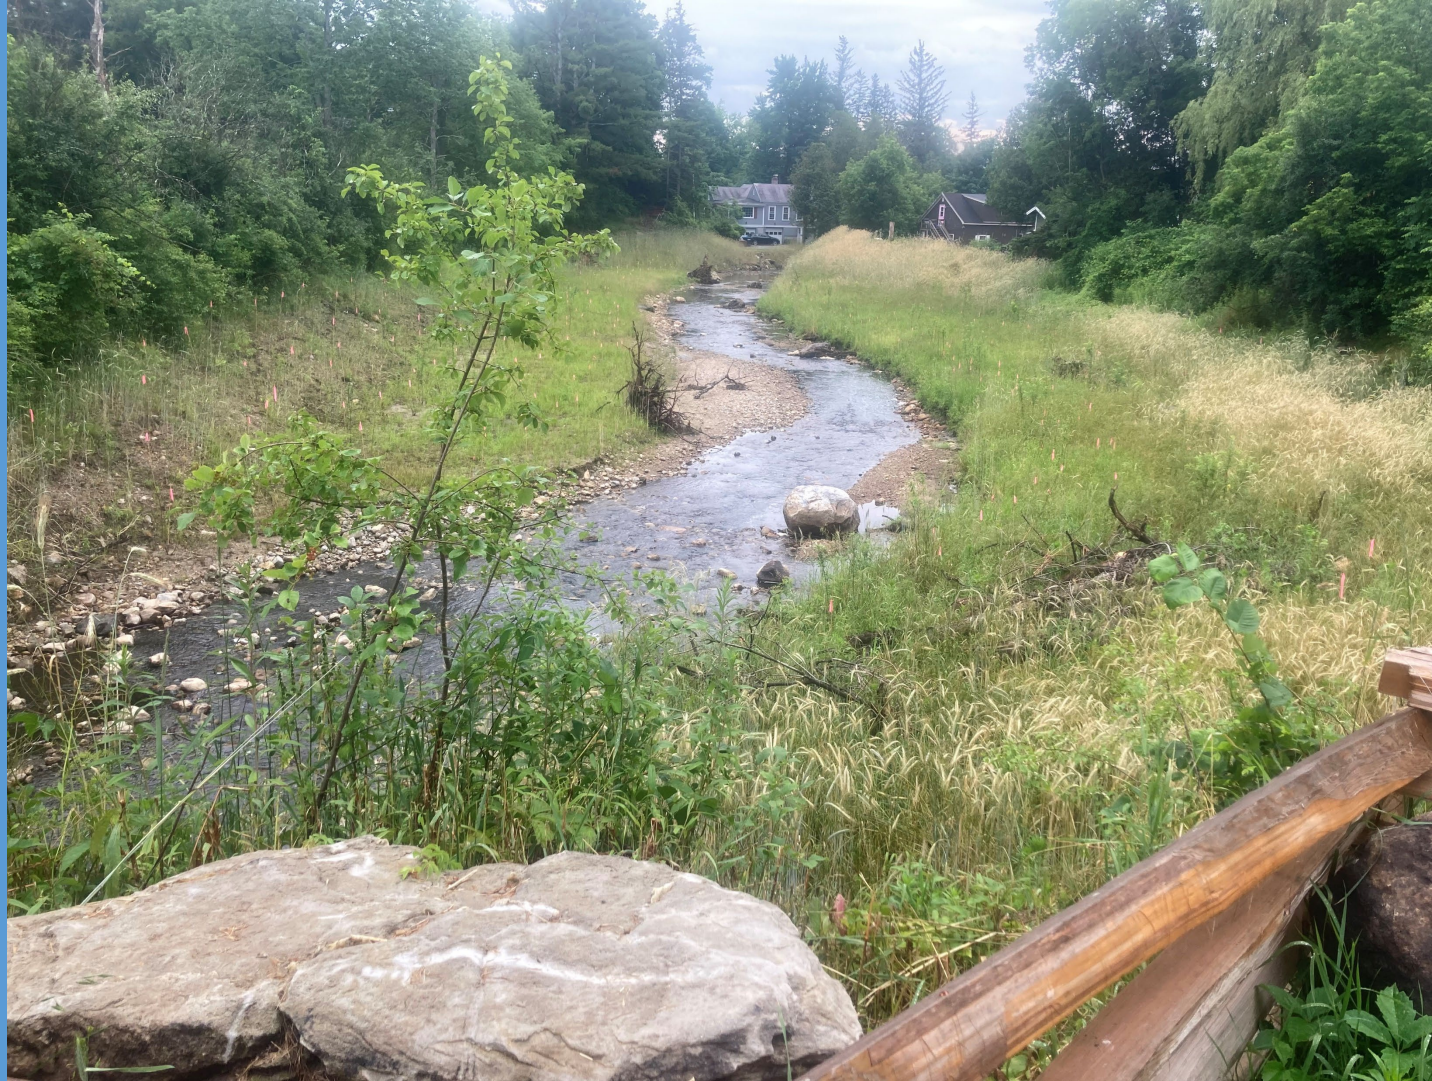
Dunklee Buffer Growth 7/5/22

Looking
Down
Stream
at New
Riparian
Buffer!

After
Done on
5/26/22
Greened
It
Up!

Now We Monitor Survival Rates and Maybe Plant More?

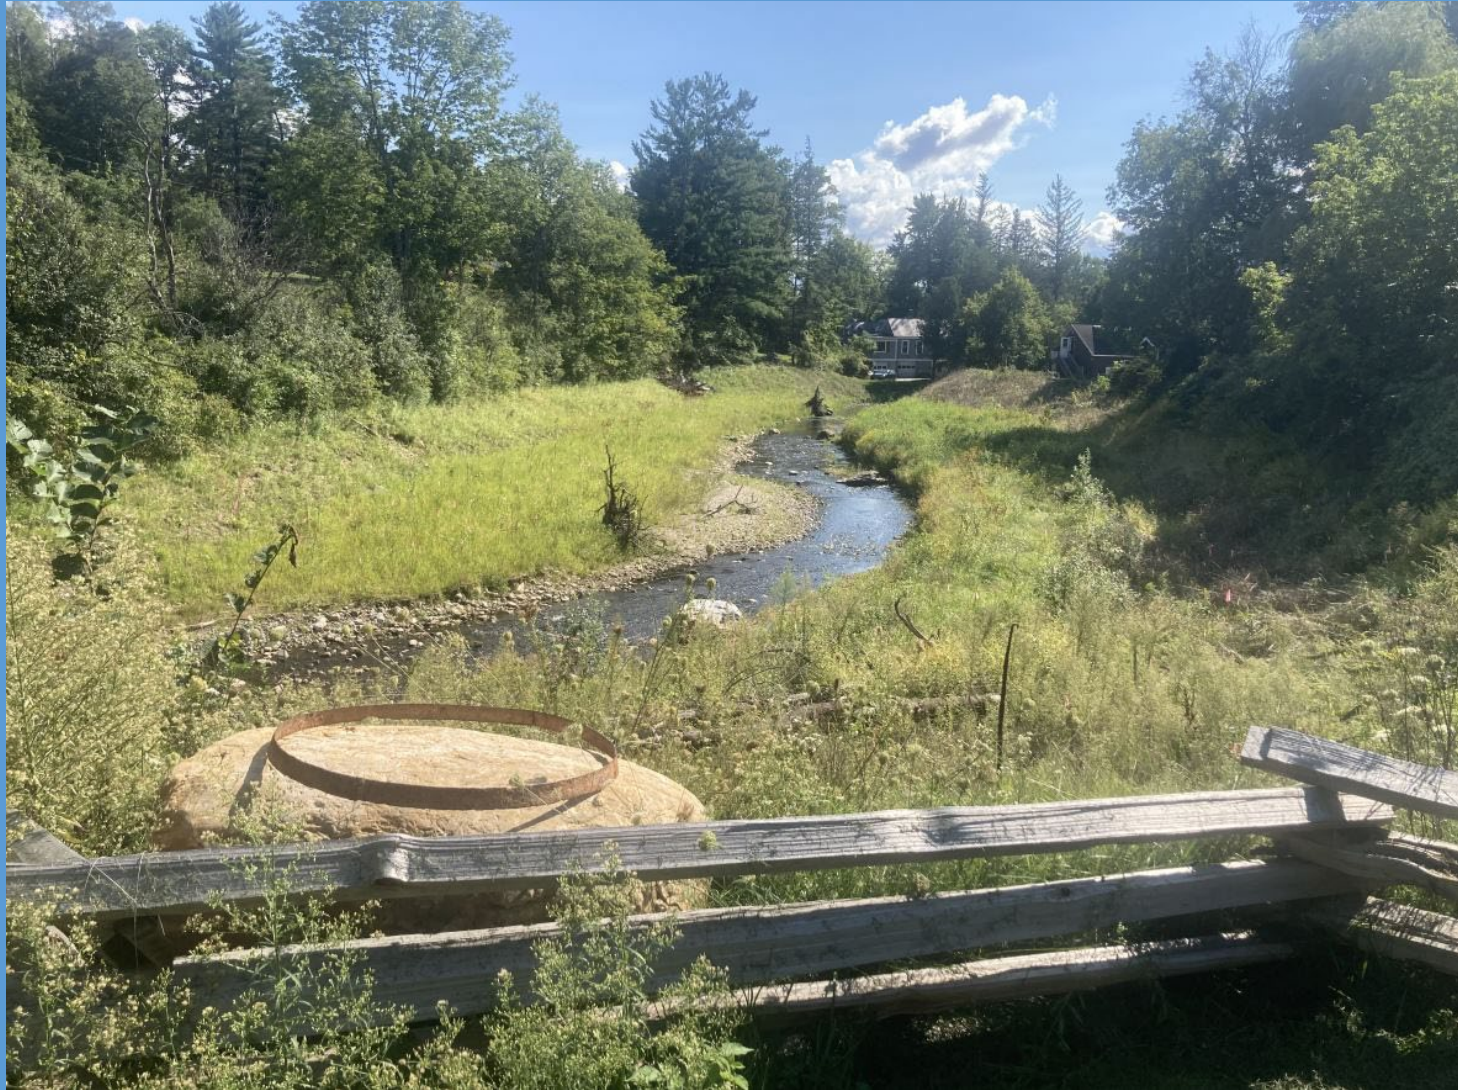
Dunklee Buffer Growth 9/8/22

Looking
Down
Stream
at
Meander
Bars and
New
Stream
Channel!

After
Summer
Growth
2022

Now We Monitor Channel Development!

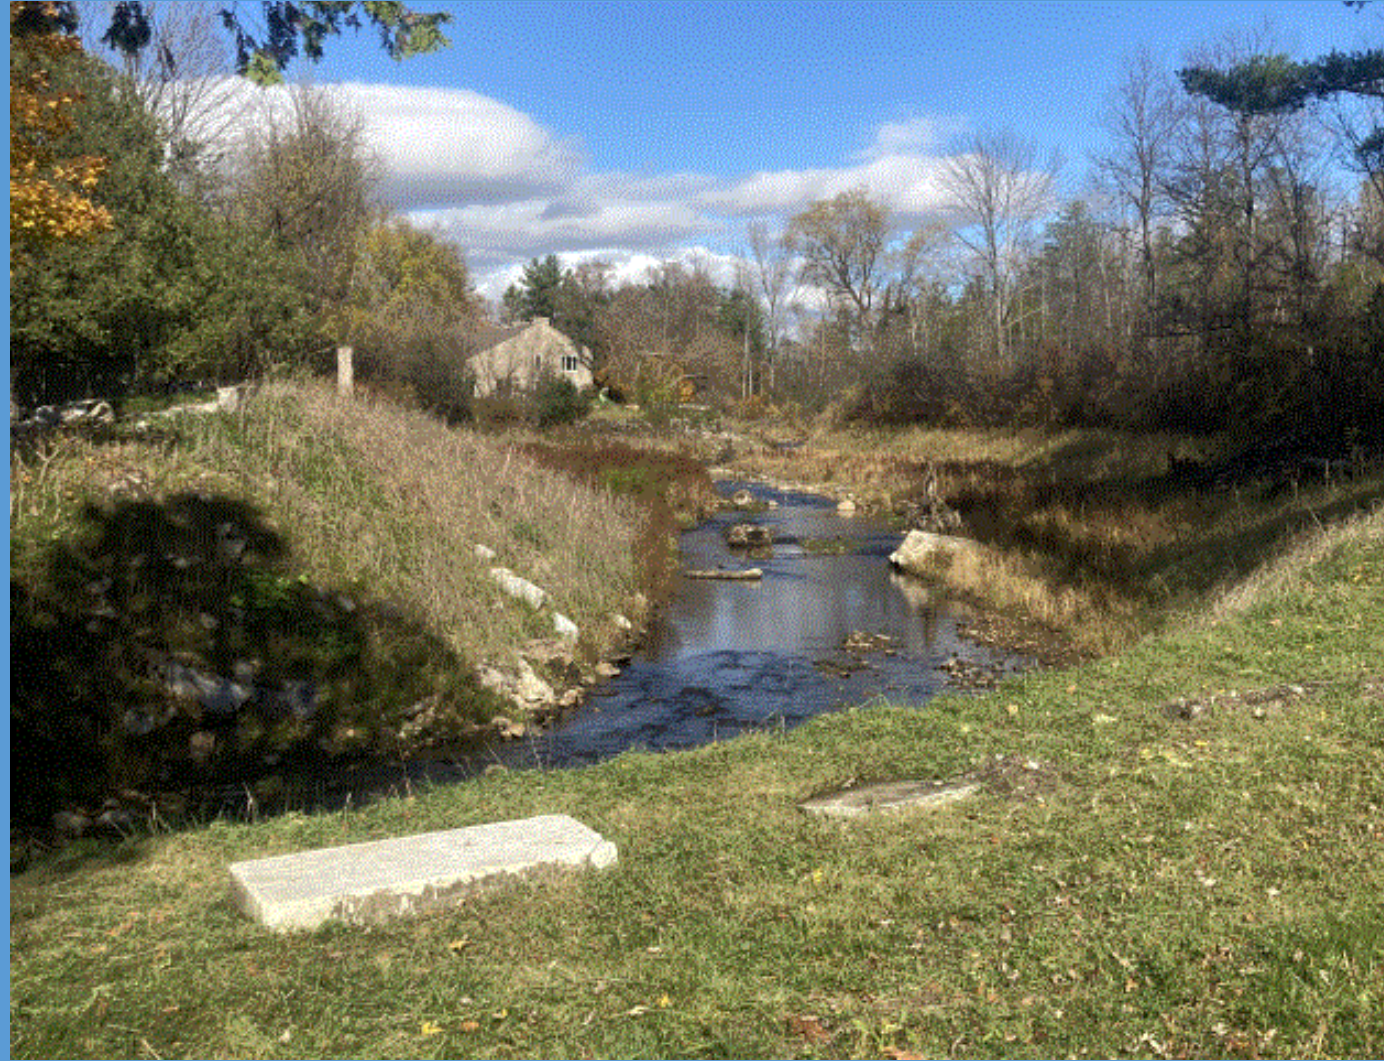
Dunklee Buffer Growth 10/25/22

Looking
Up
Stream
at
Meander
Bars and
New
Stream
Channel!

Summer
to Fall
Growth
2022

Now We Monitor Vegetation Growth!

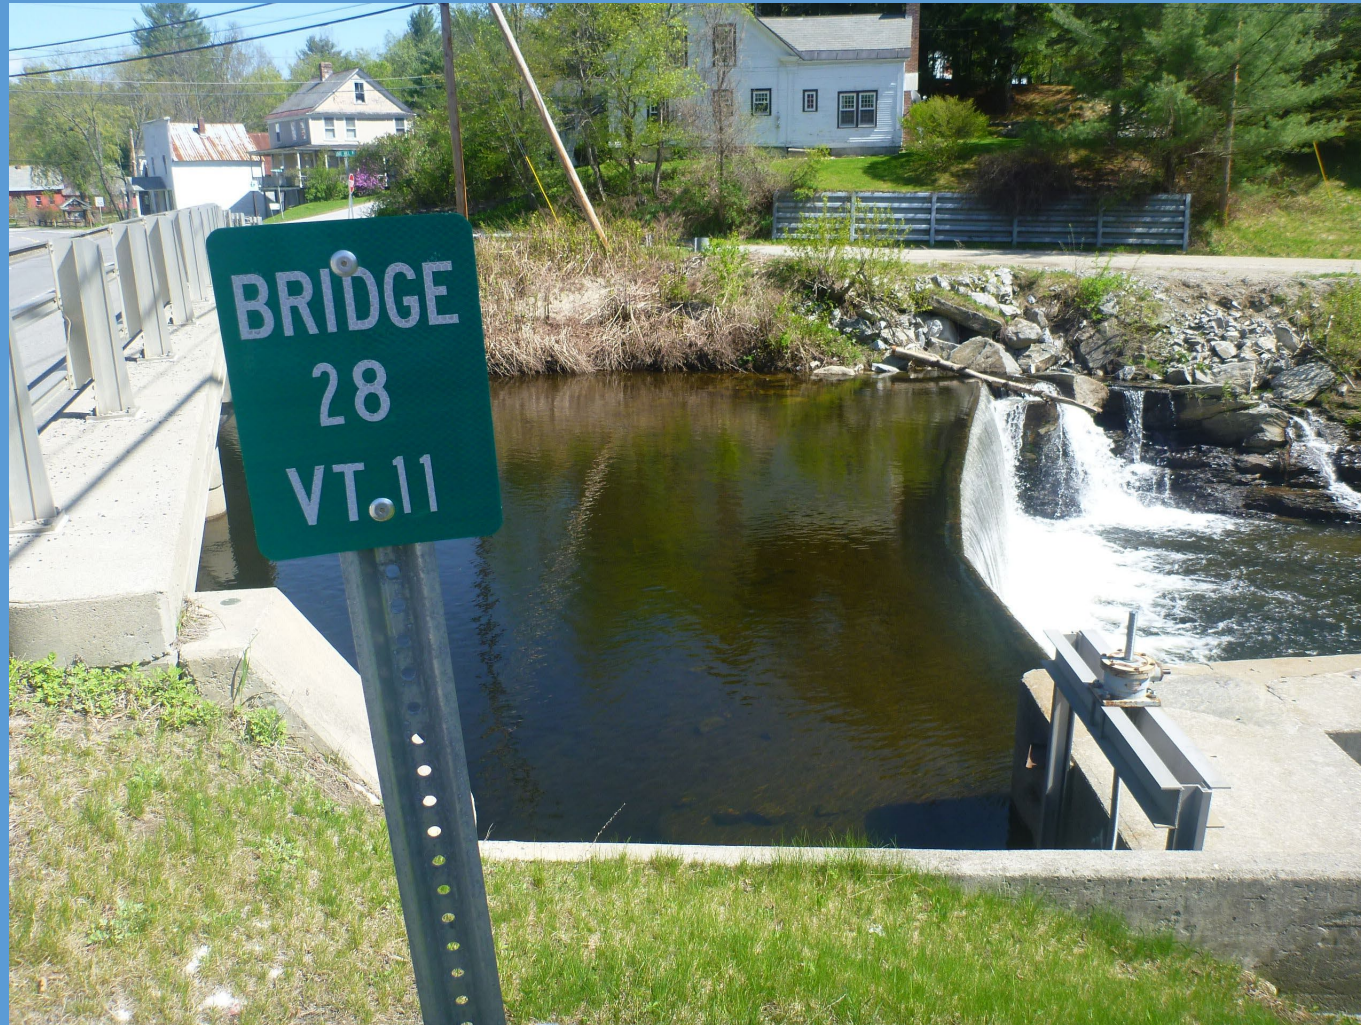
Williams Dam Londonderry 2014

Looking
East

At Route
11 State
Bridge

Poor
Condition
Dam

Irene
Damage
and Over
Topped
Route 11

Increases Flooding in Town!

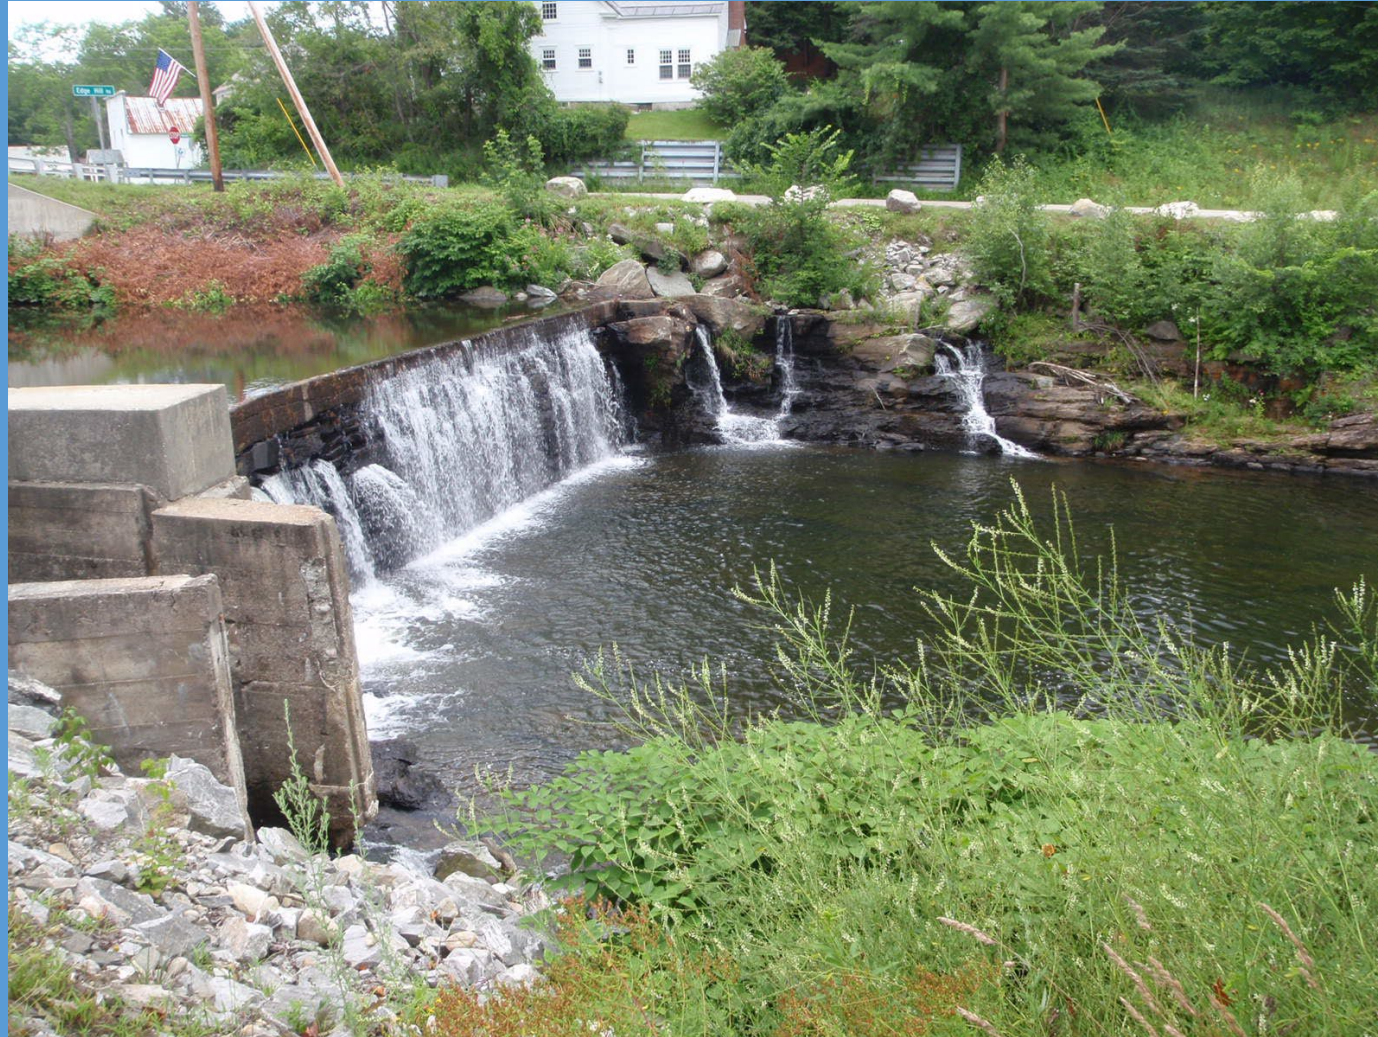
Williams Dam Londonderry 2014

Looking
East
At Edge
Hill Road
and Dam
Face

Rock
Rip-rap on
both sides
of Dam
and Town
Road

Increases Flood Damage!
