*Reducing Wildlife Mortality on Roads in Vermont:
Determining Relationships Between Structure Attributes and Wildlife
Movement Frequency Through Bridges and Culverts to Improve Related
Conservation Investments*

Paul Marangelo, The Nature Conservancy, Vermont Chapter
Laura Farrell, Phd.
May 2019

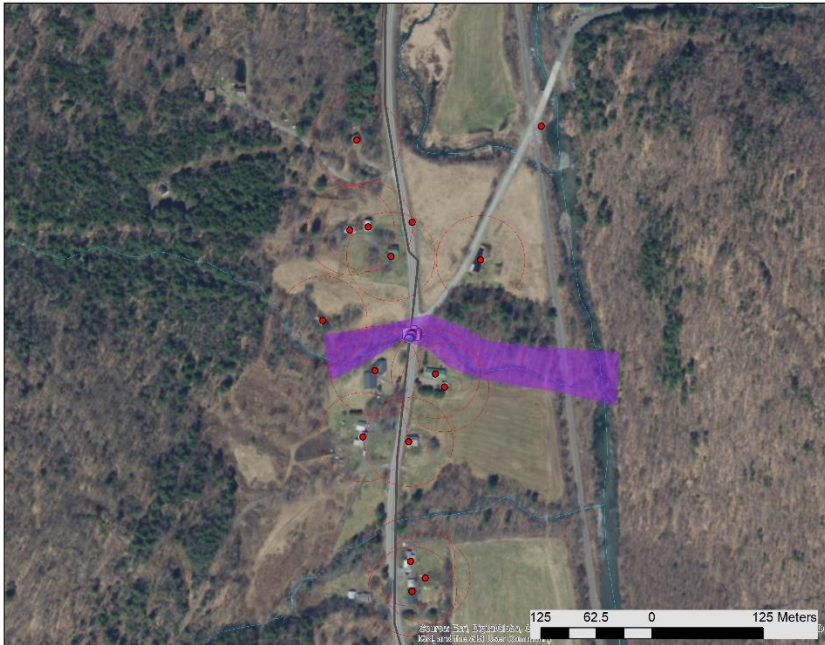
Figure 5. 50m buffers were created around all residences within 300m of a transportation structure and overlaid with the movement pathway polygon (Site 12a-10, Braintree).

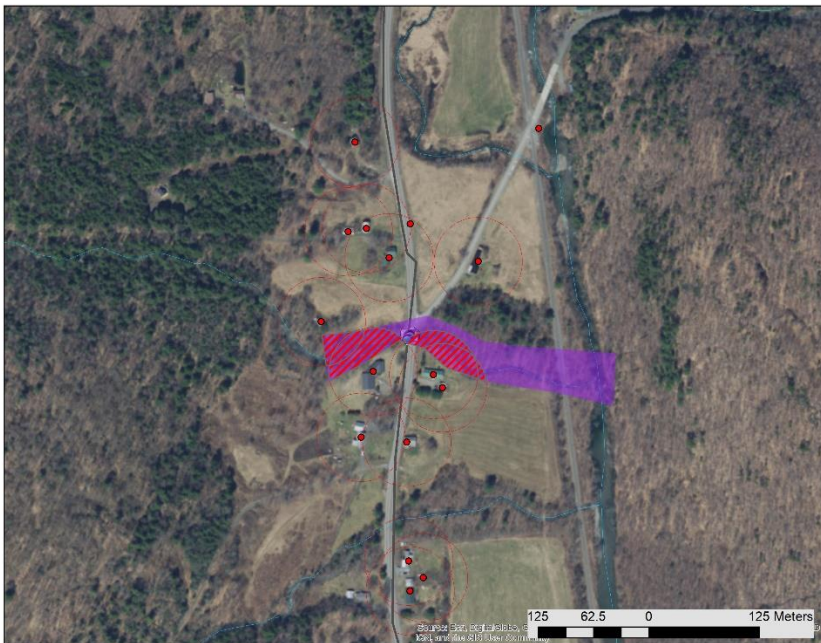
Figure 6. Red hatches represent the intersection of the most likely movement pathway with 50m residence buffers considered “influenced by development”. Development index for this site was the proportion of the “influenced by development” within a “most likely movement pathway” to the total pathway area (Site 12a-10, Braintree).

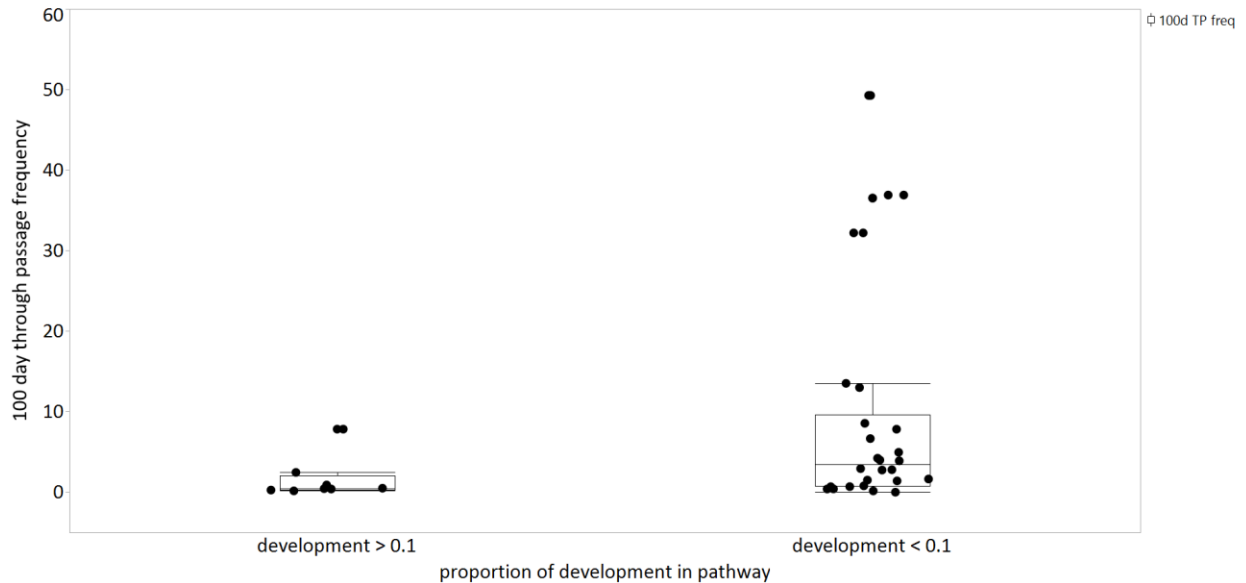
Figure 8: Comparison of 100day through-passage frequencies of sites where the development index <0.1 vs >0.1. Comparison includes sites from project phases 1 and 2, with new Post-Irene structures (6), structures with poor movement surface availability (1), sites with fragmented structural connectivity (4) excluded. Difference between the mean of both groups is statistically significant (Wilcoxon rank-sum test, $p=0.031$).

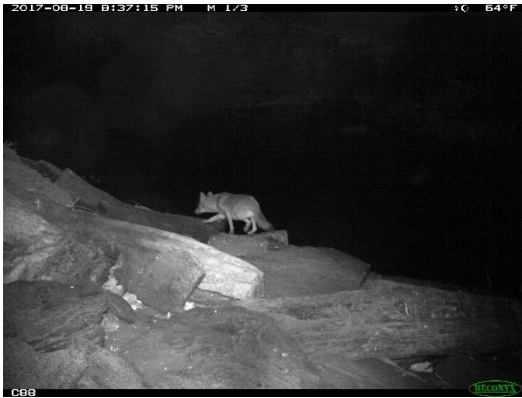
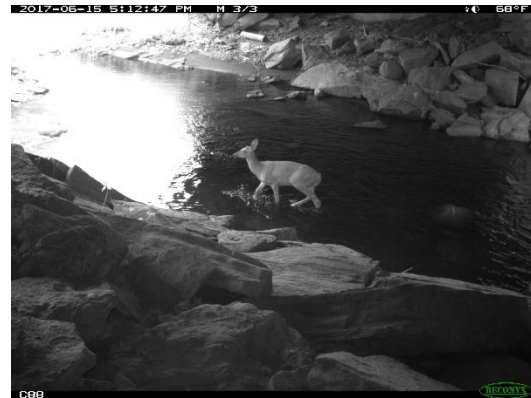
Figure 14. Illustration of secondary movement surface at site 113-19, Vershire. Most species used the riprap bank, while deer used a “wet streambed” secondary movement surface composed mostly of sand/gravel.

Through-passage frequencies were enhanced at a small number of sites by the existence of viable secondary movement surfaces (Figure 14). Most often, secondary movement surfaces were wet stream bottoms with substrate of gravel, cobble, and sand, and were used by deer. For example, Site 113-19 in Vershire hosted, in addition to the movement of other focal species over the rip-rap streambanks (bobcat, fisher, coyote, small weasel), deer moving over the inundated stream-bottom under the bridge span. Through-passage frequency at this site is likely higher than what otherwise would have been recorded over the main “riprap” movement surface, which deer typically avoid.

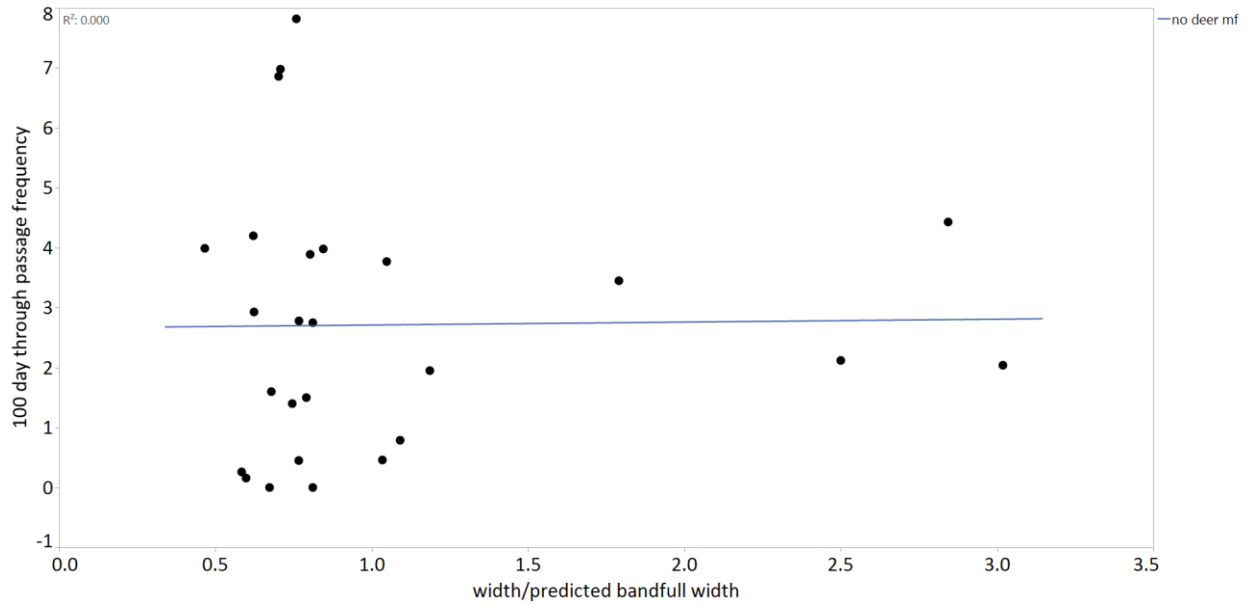
Figure 17. Scatter plot of through-passage frequencies vs. structure width/bankfull width ratio, excluding all deer through-passages.

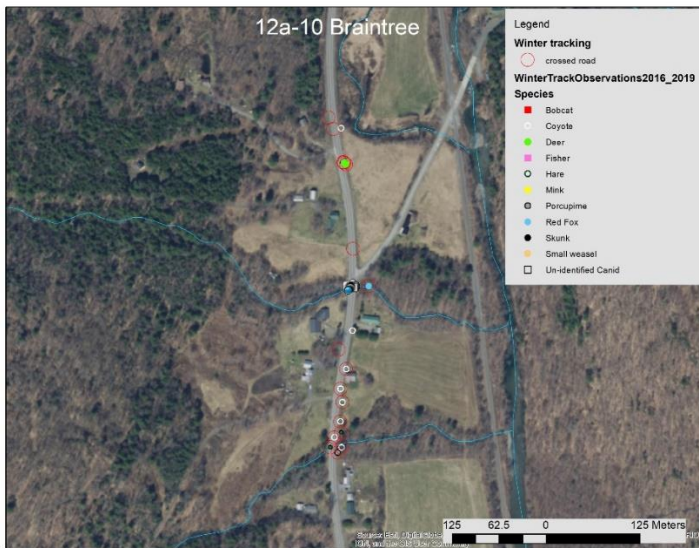
Figure 19. Map of focal species road crossings at Site 12-10, (Braintree). This site had only 1 deer through-passage during the project and had a relatively high development index. Road crossings denoted by red circles. Red circles without a species identifier represent crossings of non-focal species.

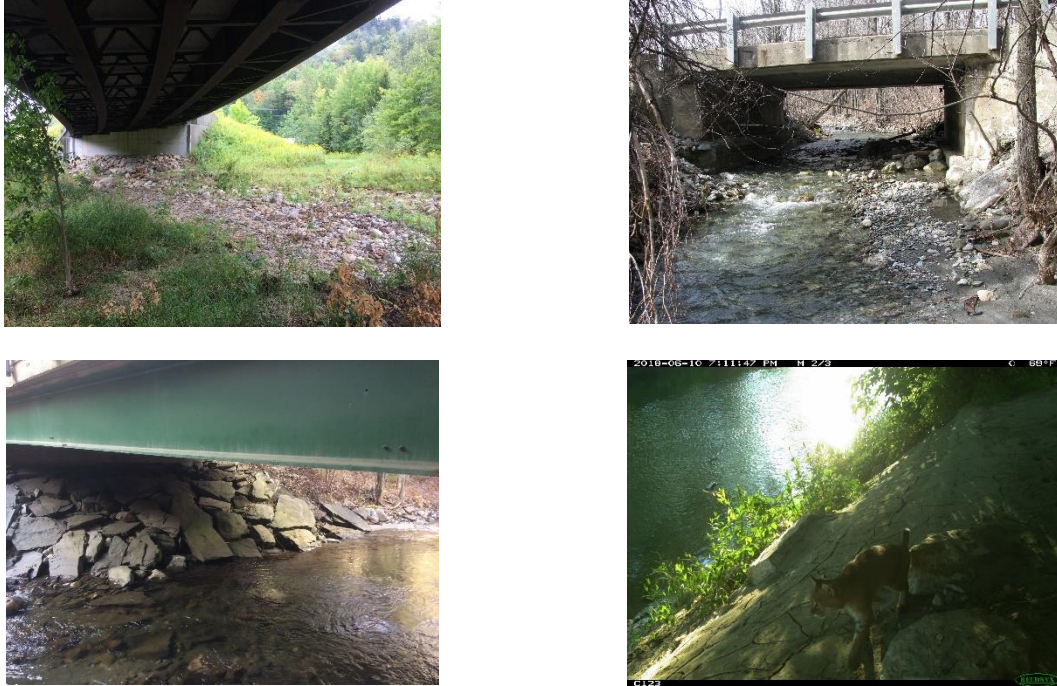
Figure 22. Examples of the variety of movement surface types that *spans* can provide. Upper left: “even floodplain” under valley-spanning bridge (9-25b, Searsburg). Upper right: “dry streambed” in a *span with footing shelf* where nearly all through-passages occurred on the streambed, which was typically entirely dry during summer months. Lower left: “riprap” streambank movement surface commonly found under many *spans* (not a project site). Lower right: “even streambank” of fine sediments under a *span* that does not cross an entire river valley (Union Street, Brandon, VT).

These designs appear best suited for maximizing wildlife through-passage. Their large size is amenable to the broadest set of wildlife species for through-passage (Figure 22), and they sometimes host more than one movement surface type. Standard practices such as rip-rapping streambanks² hinder wildlife usability however, unless the hydrological conditions under a bridge allow for the deposition of finer sediments that fill up lower elevation riprap crevices, or entirely preclude the need for extensive bank armoring under the span. Some *spans* serve roadway needs that span entire valleys. Such *spans* are the largest of all, have very large structure width/bankfull width ratios (all >2.5 in this study), usually do not constrict floodplains with abutments, and thus can offer the width of an entire floodplain for under-road wildlife movement. Moreover, it is possible that our through-passage frequency data under-represents wildlife use of the larger structures in particular, as cameras need to detect animals over longer movement detection fields than at smaller structures, making them less sensitive to detecting smaller species.

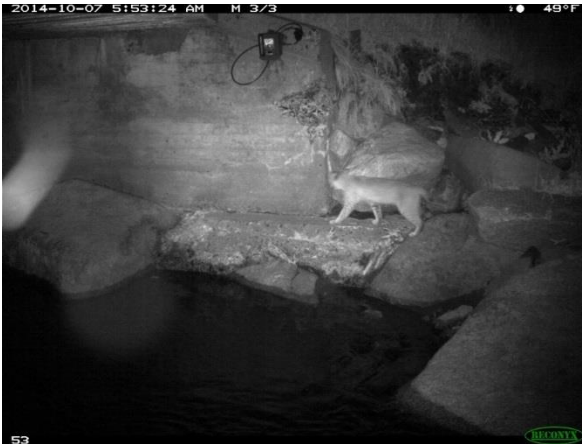
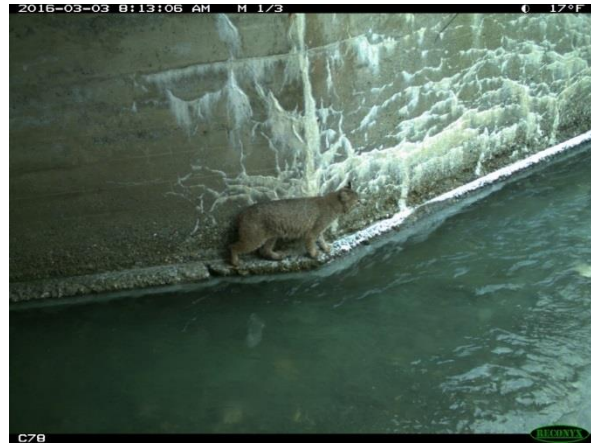
Figure 23. Bobcat through passages at span with footing shelves structure design types (Site 114-20 (left) and 4a-13 (right)).

Spans constructed on shallow ledge often feature exposed concrete footings, which create level dry “shelves” that wildlife use for movement. Older structures that are dramatically undersized for their stream can still support wildlife movement via footing shelves (as was observed at sites 4a-13 and 114-20 from Marangelo and Farrell (2016); Figure 23), even when the structure otherwise offers no other movement surface due to perpetual inundation. These structure types are relatively scarce, but illustrate how the offering of a dry, level, movement surface can create opportunity for wildlife through-passage in a structure that would otherwise be unusable. Footing shelves as narrow as 6” were used by species such as bobcat (Figure 23). Results from these structures suggest that shelves constructed specifically to provide a usable movement surface in any type of structure can offer benefits of increased through-passage, given suitable site characteristics.

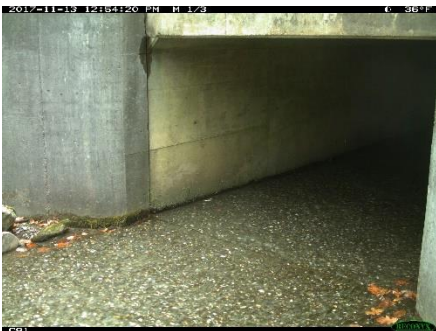
Figure 24. Examples of old box culverts with “sheetflow concrete” movement surface. Site 30-22 (West Townshend) and 15-76 (Cambridge, Marangelo and Farrelll 2016).

These structures typically receive use by only species that tolerate wet movement surfaces. Their bottoms are flat and unless they host an intermittent stream, feature a movement surface characterized by the sheetflow of water over flat concrete under nearly all flow conditions “sheetflow concrete” (Figure 24). These structures are especially abundant throughout Vermont.

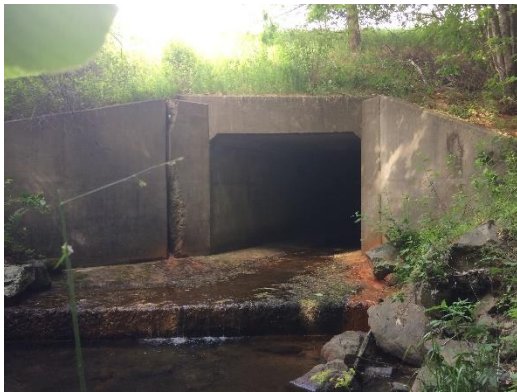
Figure 26. Example of a *V bottom box culvert*, with “dry concrete” movement surfaces along culvert walls. Site I91-17-2, Putney.

These structures are very rare – we found only 2 suitable for game cameras. By channeling water into the center of the culvert, they offer superior dry movement surface availability compared to the wet flat bottoms of typical of *old box culverts* (Figure 26). Project data probably does not reflect the potential of this design type for encouraging wildlife through-passage, as both structures studied were much longer than most wildlife prefer (both were over 235 feet long). Since newly constructed box culverts are likely to feature embedded designs, and are thus more likely to have more favorable movement surfaces than dry concrete (Figure 11), the relevance of “V bottomed box culverts” to the management of road corridors for increased permeability for wildlife appears questionable.
