Bolton Waterbury STP 2709(1)
Wildlife Connectivity Study
Final Report

McFarland Johnson

July 2016

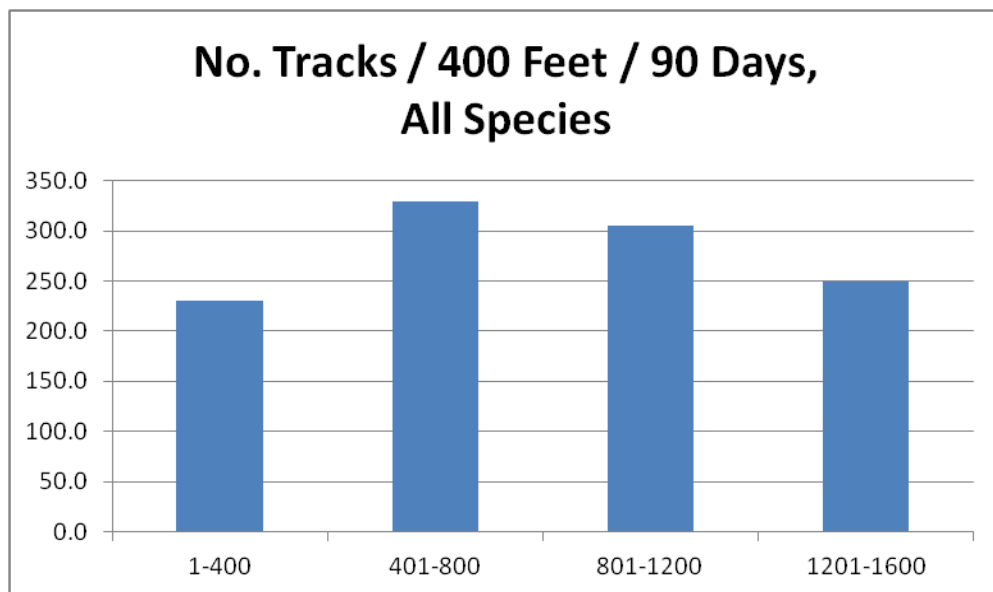
Figure 26. Number of track sets/400 feet/90 days - all species

The following figures show the numbers of tracks found within each of the four distance-from-road categories. Overall, the least number of species was found within the segment closest to the road edge, and the greatest numbers were found in the next segment. Deer were most abundant at the furthest segment (1201-1600), while coyote and fisher were most abundant within the second segment (401-800). There were also large numbers of deer further out, in two of the 1601-2000 foot segments, which were not included in the analysis. It is not clear how these spatial patterns relate to the roads. It is possible the road is a repellent while the forest edge is an attractant.

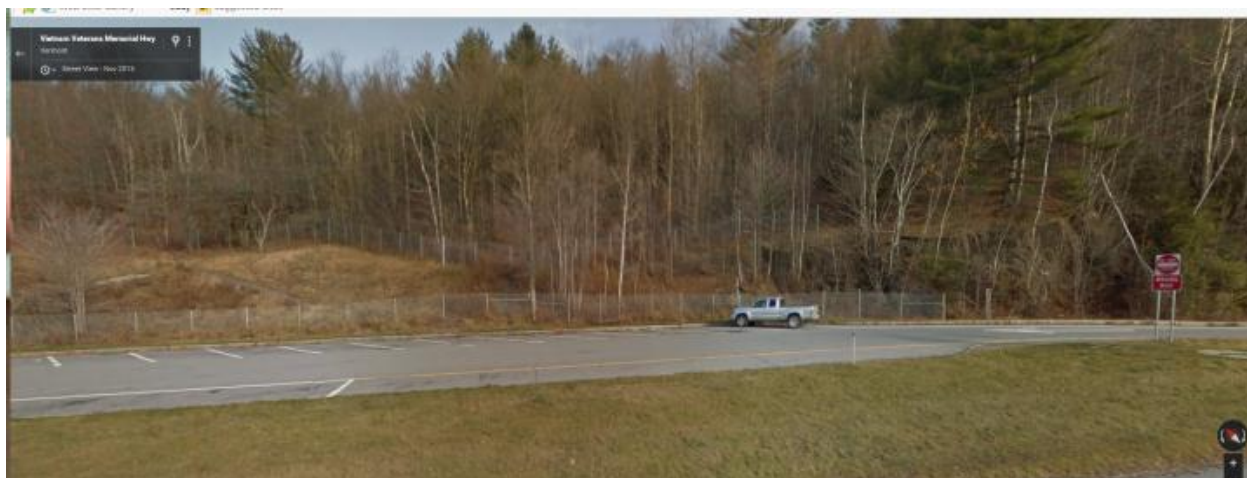
Photo 6. Rest area with parallel chain link fences and smaller rock cut

East of Orchard Springs Estates, continuing to Little River, was an area of scattered wildlife travel. In this segment, 66 animals crossed over the road surface, 18 via culvert, and 4 under the bridge over US Route 2 by Farr's Landing Road. The road crossings were mostly coyotes and foxes, plus 6 deer, 3 mink, 3 raccoon, 2 fisher, and 1 weasel. The culvert crossings included 7 mink, 2 each of fisher, fox, raccoon, and weasel, with 1 squirrel and several unidentifiable. Passing under the bridge were 2 skunks, 1 raccoon, and 1 squirrel. One segment has a rest area with two parallel chain link fences (Photo 6).

(West of Little River – Google Maps image)

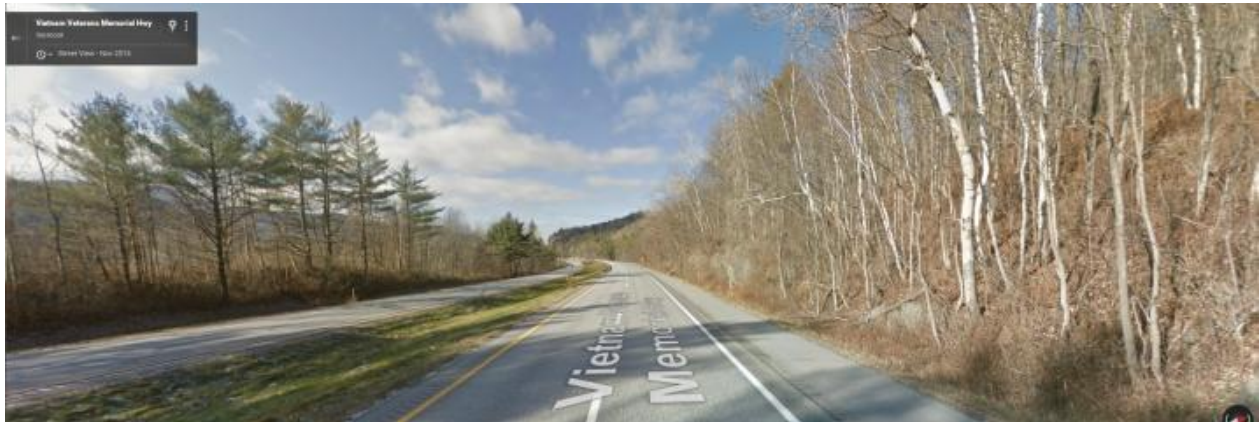
Photo 7. I-89 forested both sides to pavement edge with no obvious barriers

East of the Little River bridge to the Exit 10 ramps (Photo 7), animal tracks were spotty. Of 40 sets of tracks, 32 crossed over the road surface and 8 passed through culverts. Crossing over the road were 7 coyotes and lesser numbers of fox, weasel, hare, mink, deer, fisher, raccoon, and cottontail. Using culverts were 6 foxes and 2 raccoons.

(East of Little River – Google Maps image)

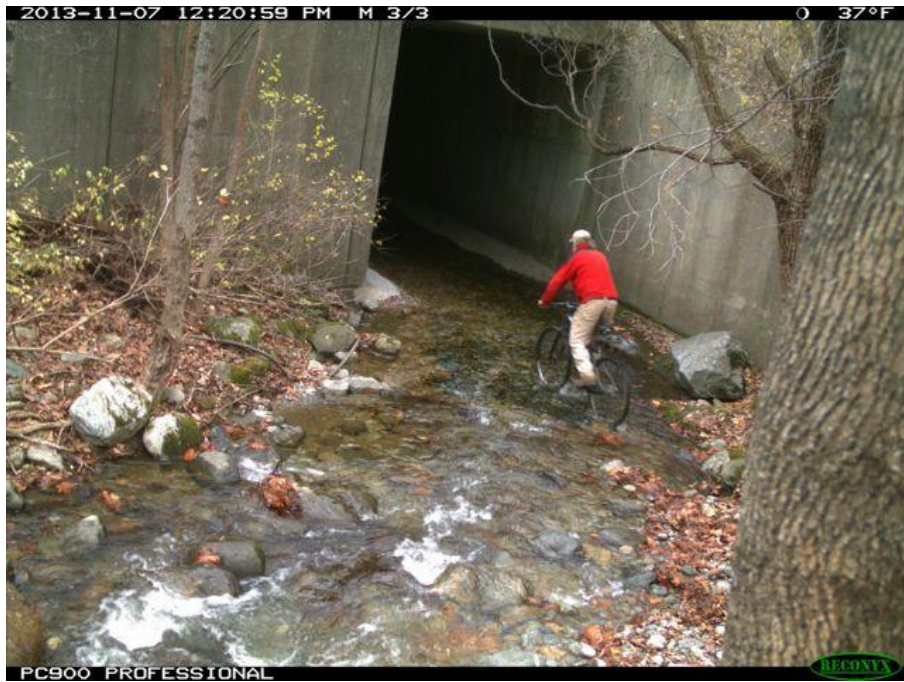
Pineo Brook inlet, north side of US Route 2, facing south

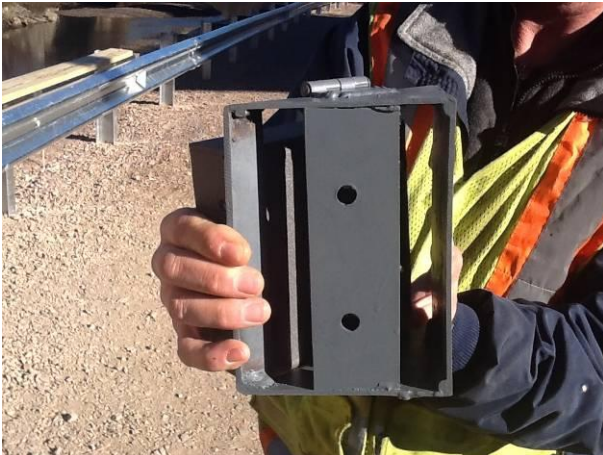
Back side of fabricated housing for angling to the side
