# Reducing Wildlife Mortality on Roads in Vermont: Documenting Wildlife Movement near Bridges and Culverts to Improve Related Conservation Investments

September 30, 2016

Paul Marangelo, The Nature Conservancy, Vermont Chapter  
Laura Farrell, Phd.

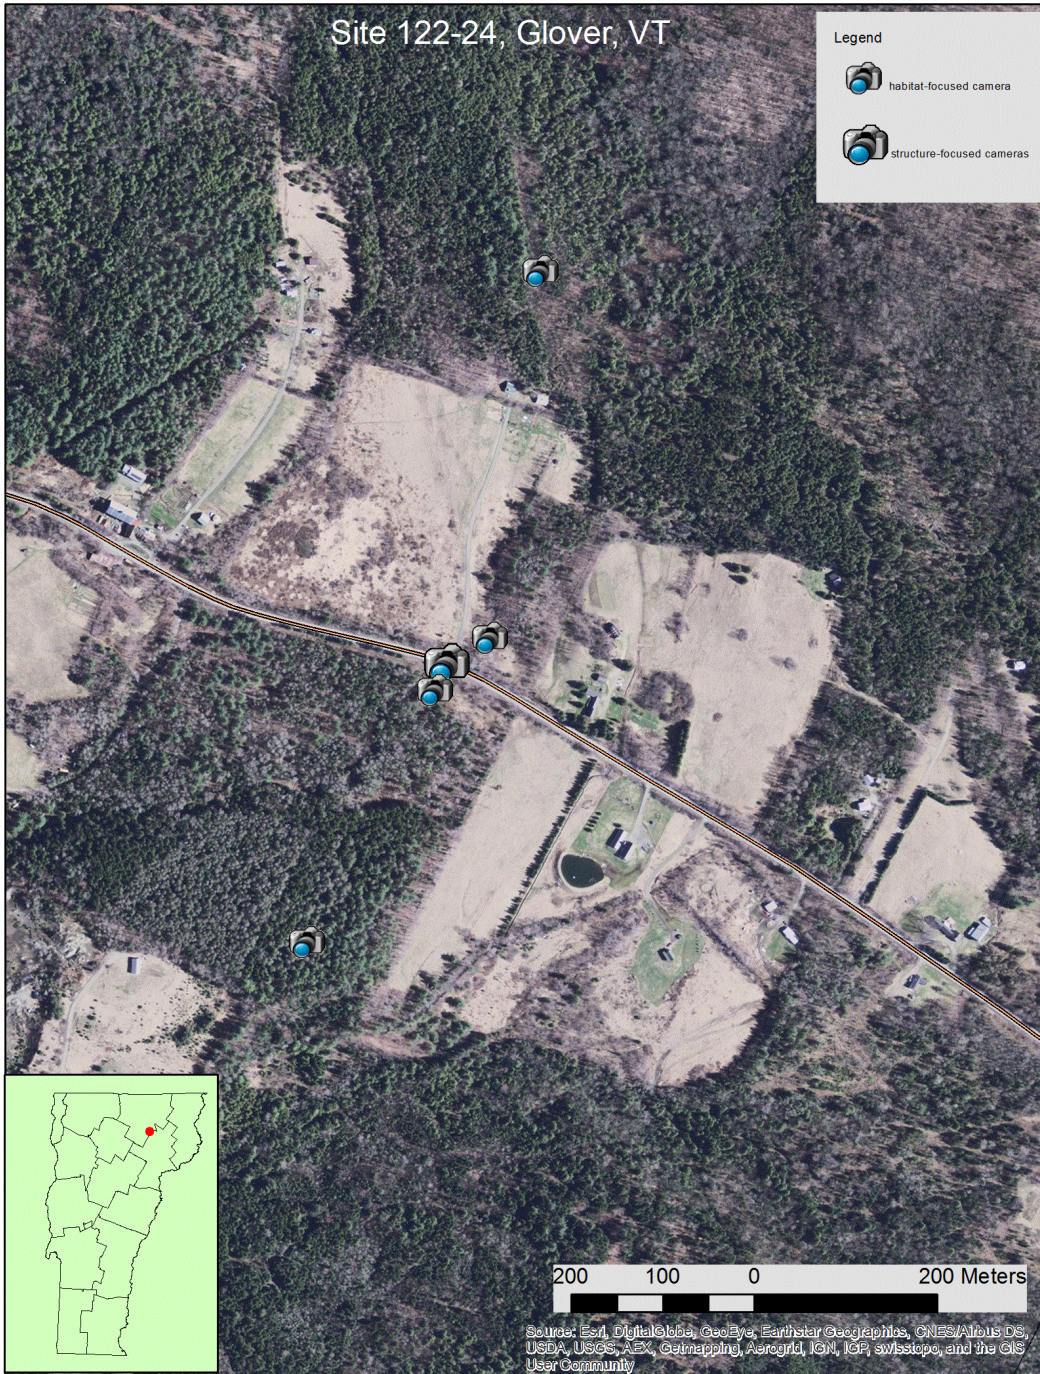
Figure 2: Placement design of game cameras at sites with both habitat and structure-focused cameras. Habitat-focused cameras were set approximately 200' and 1600' from the road.

To characterize wildlife presence in habitat adjacent to structures, we established 24 habitat-focused cameras across 6 sites (Table 1, Figure 1a-d). At each of these sites, in addition to the structure-focused cameras, habitat-focused cameras were installed on both sides of roadway in the best available habitat at distances of approximately 200ft and 1600 feet away from the structure (Figure 2). Some placement modifications needed to be made at some sites due to inability to get landowner permission on some parcels, and in one case, rescindment of camera siting permission in mid-project by a landowner. Cameras were focused in locations that appeared to favor wildlife movement (game trails, near wetlands, on seldom-used logging roads, etc).

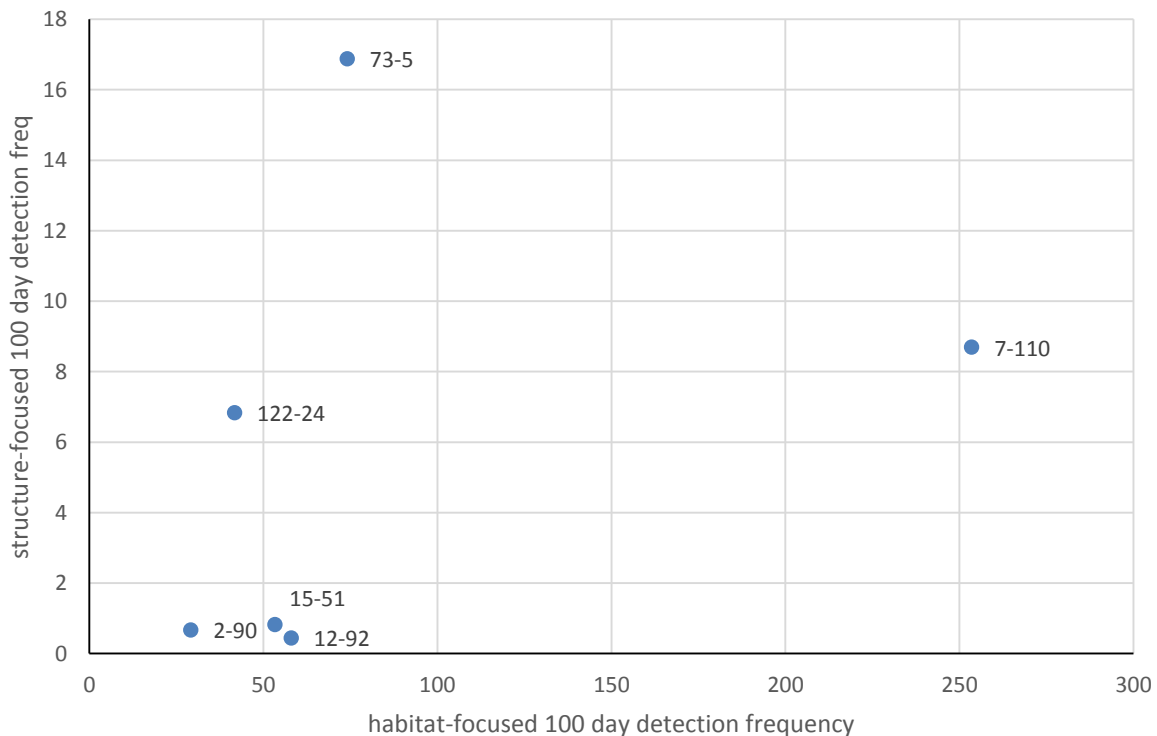
Figure 5. Plot of detection frequencies from structure-focused cameras vs. habitat focused cameras at 6 sites with habitat cameras. Data points labeled by their respective sites.

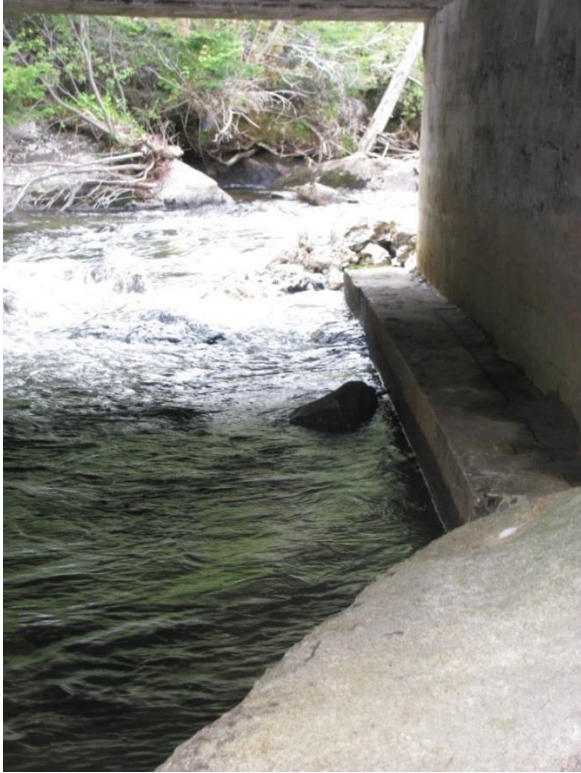
Figure 7. Concrete “abutment shelf” at Site 114-20 in Newark

When we attempted to classify the transportation structures at our study sites into size class categories as defined in Shilling et al (2012), three of our study sites did not fit neatly into the structure size class criteria. Site 114-20 in Newark, VT is wide enough (19.5') to be placed in the "large" size class category. However, the river channel itself under the bridge is always completely inundated with swift-moving water at least 1' deep, and is unsuitable for wildlife movement. The structure has two 1.2' wide concrete ledges on the sides of the bridge abutments that are almost always dry (Figure 7), which are the only movement surfaces under the structure available for terrestrial wildlife. Because there is only 5' of clearance above these ledges, the structure was instead placed in the "small" size class, despite the structure's width. Site 73-5 in Sudbury crosses over Otter Creek on Rt 73 and is by far the longest bridge (220 ft) in our set of study sites, and spans the wide mainstem of Otter Creek and a broad dry floodplain. While far surpassing the width criteria for a the "large" size class, this structure did not quite meet the height criteria needed to be included in the "medium" or "large" size class categories (there was only between 5 -7' of clearance between the likely movement surface (the dry floodplain) and the structure). We nevertheless decided to assign this structure in the "large" size class because of its width and relatively large openness ratio. At its greatest clearance, (7'), it is just less than the minimum height clearance needed to be categorized as "large" or "medium". Finally, Site I91 101-2s was a pipe 7' in diameter, but was classified as "small" because it did not meet height criteria for medium/large.

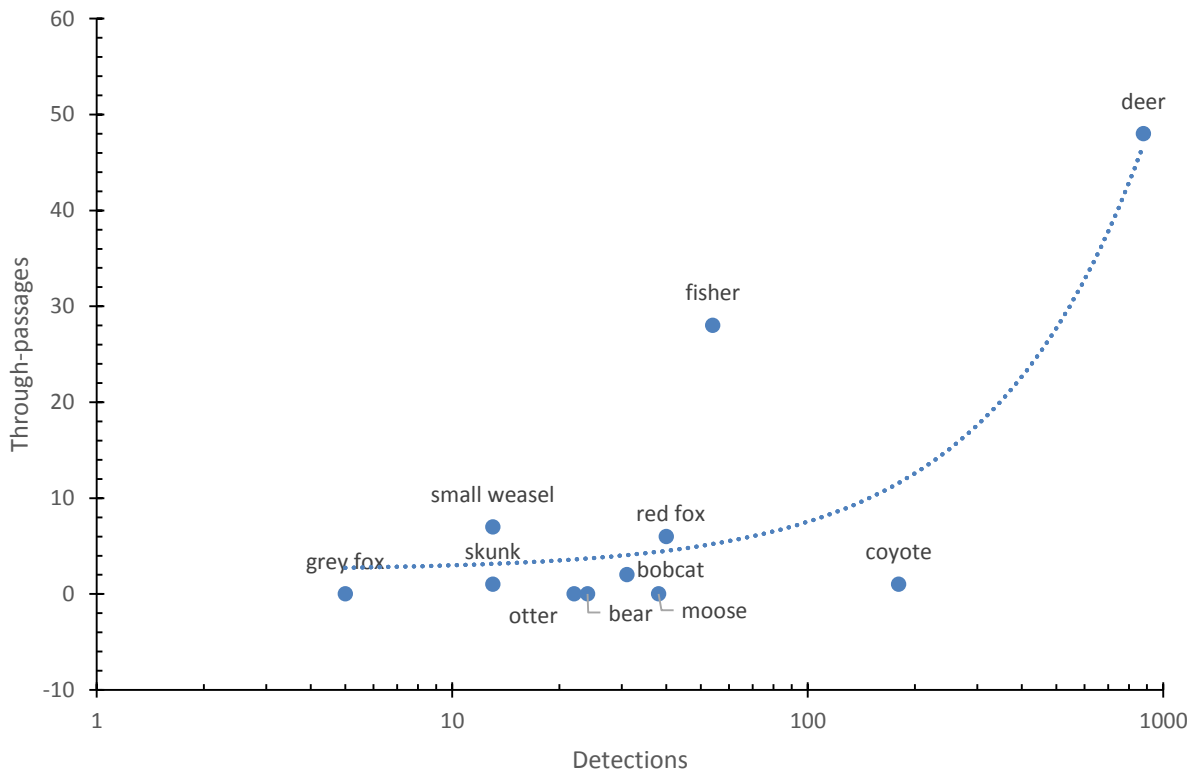
Figure 8: Plot of the number of through-passages vs. number of detections from all cameras at the 6 sites with habitat-focused cameras. Coyotes were detected with the fewest through-passages relative to the number of detections. Fisher were detected with the greatest number of through-passages relative to the number of detections, probably because of fisher's preference for moving through cover caused it to avoid the more open areas where habitat-focused cameras were sited.

than the AHMF guild, where it is placed in Shilling et al (2012). Because coyote through-passages were remarkably rare relative to the number of coyote detections from habitat-focused cameras, Figure 8 suggests that coyotes were not inclined to use transportation structures for road crossings compared to other species (using the best fit least-squares line Figure 8 as a reference). Also, the only coyote through-passage data we have are from large size-class structures. Given that Monzon et al (2014) documented a high degree of genetic introgression of eastern timber wolf genes into the genome of the eastern coyote, it appears that coyote behavior with respect to use of transportation structures may be similar to wolf behavior in key ways. We therefore moved coyotes from the AHMF to the HOHMC movement guild (Table 8).

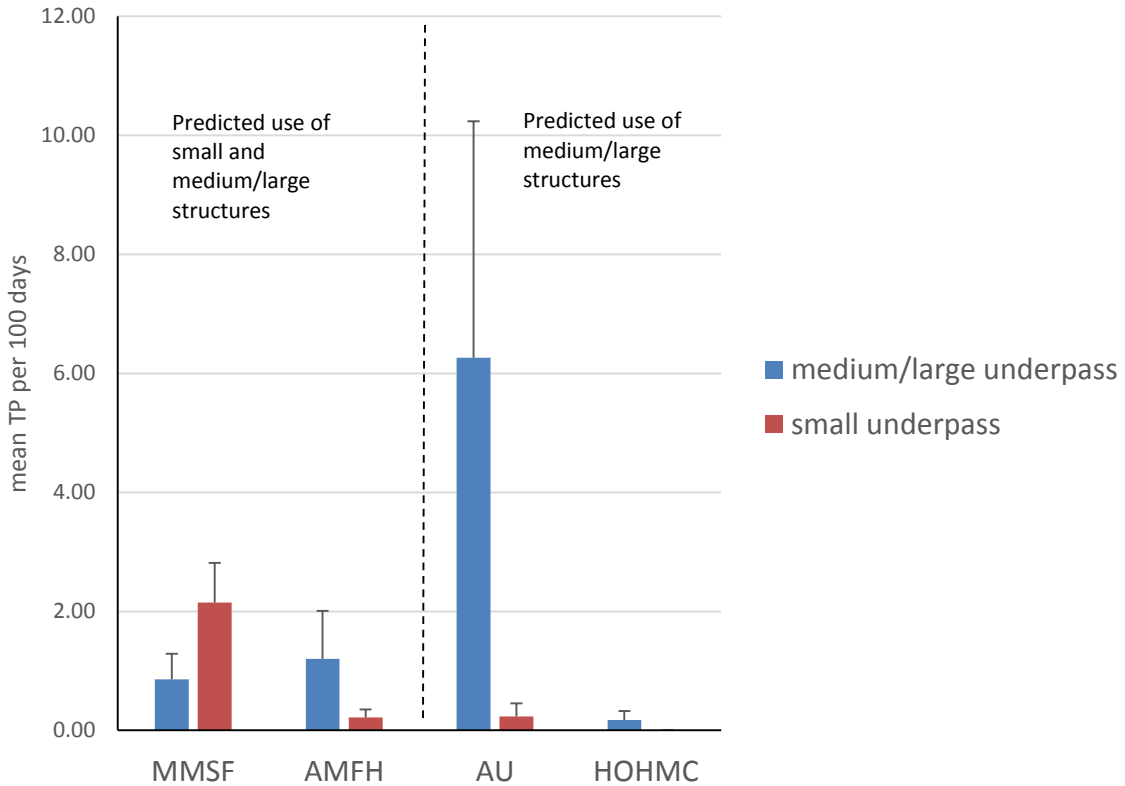
Figure 9: Mean (SE) movement guild through-passage frequencies sites by structure size class. Results are consistent with what we would expect to observe according to the revised movement guild/size class framework in Table 8. Tabulated through-passage frequencies by size class categories were not statistically independent (Pearson Chi-Square = 181.8;  $p < 0.0005$ ).

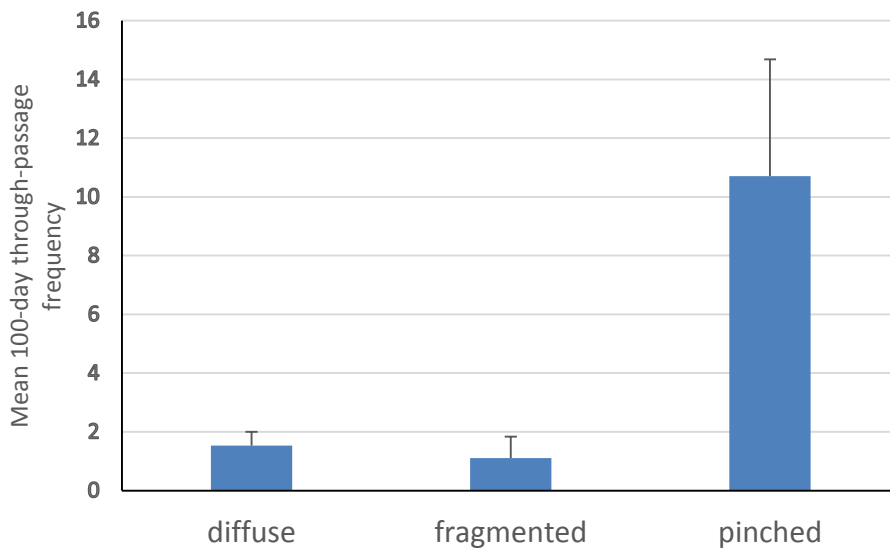
Figure 12. Mean (SE) focal species through-passage frequency for all sites by local-scale structural forest connectivity categories.

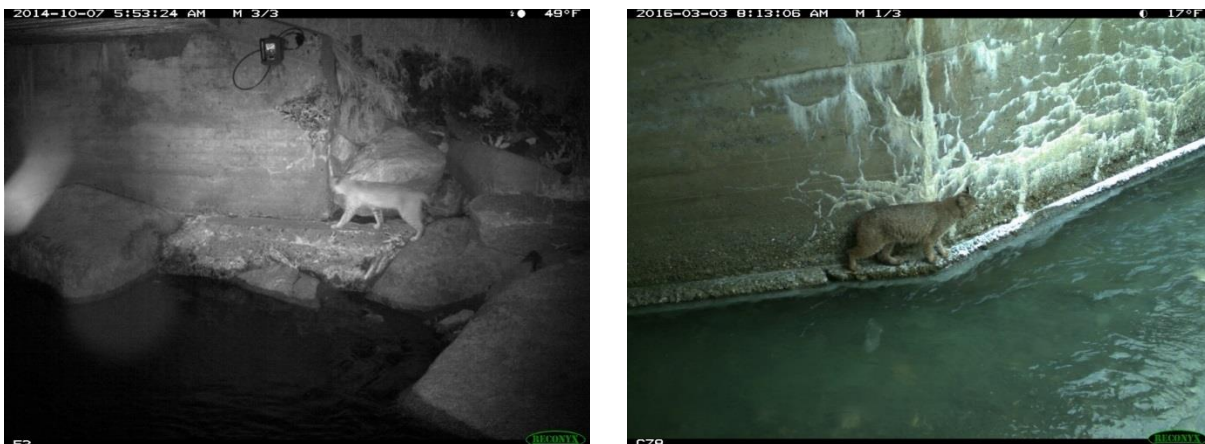
Figure 14. Bobcat using concrete abutment shelves for through-passage at Site 114-20 (left) and 4a-13 (right).

Bobcat especially appeared to favor the use of concrete abutment shelves for moving through structures (Figure 14). Bobcats used these shelves exclusively at 2 sites where there was no other consistent dry movement surface under the structure. One of these shelves was quite narrow (6” wide), with bobcats precariously clinging to the edge of these shelves as they moved under the roadway. Few other obvious relationships between site or structure attributes and through-passage frequencies were evident. While many of site attributes have either been reported as important by other studies or intuitively would seem to be influential, (e.g Average Annual Daily Traffic), project data offered little in the way of broad support for any individual attribute.

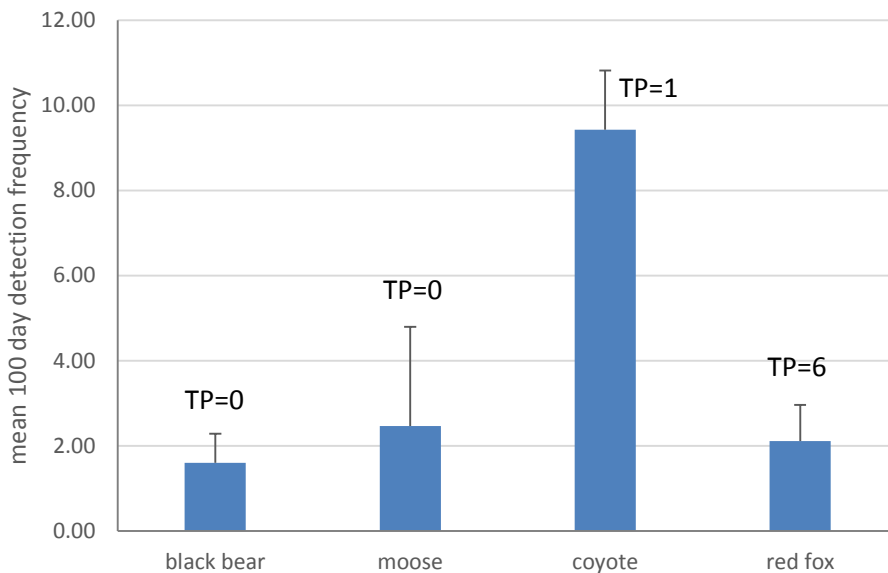
Figure 15. Mean (SE) 100-day detection frequency for habitat-focused cameras for bear, moose, coyote, and red fox. Data labels represent the number of through-passages recorded at these sites for each species. Note that detection frequencies for fox, moose, and bear are similar, yet a substantially higher number of through passages were recorded for red fox.

A lack of our ability to characterize moose and bear movement preferences are probably the most important limitations of our dataset. At sites with habitat-based cameras, moose and bear were detected at frequencies similar to red fox, which had a comparatively greater number of through-passages (Figure 15). While not definitive, the comparison with red fox data points toward the possibility that the structures at these sites were not well-suited for use by bear or moose. According to the Table 8 framework, bear, as part of the AHMF guild, is theoretically capable of using both small and medium/large size class structures, and moose (AU guild) is capable of using medium/large structures (which comprise 3 of the 6 structures at sites with habitat-focused cameras). Our habitat-focused cameras indicate that both bear and moose were present in habitat near monitored structures

in sufficient enough numbers that we might have expected to document at least a few through-passages, yet no through-passages were recorded. It therefore seems possible that the types of transportation structures bear and moose may be willing to use in Vermont may be different than the relationships described in both Shilling et al's (2012) framework and our modified Table 8 framework.

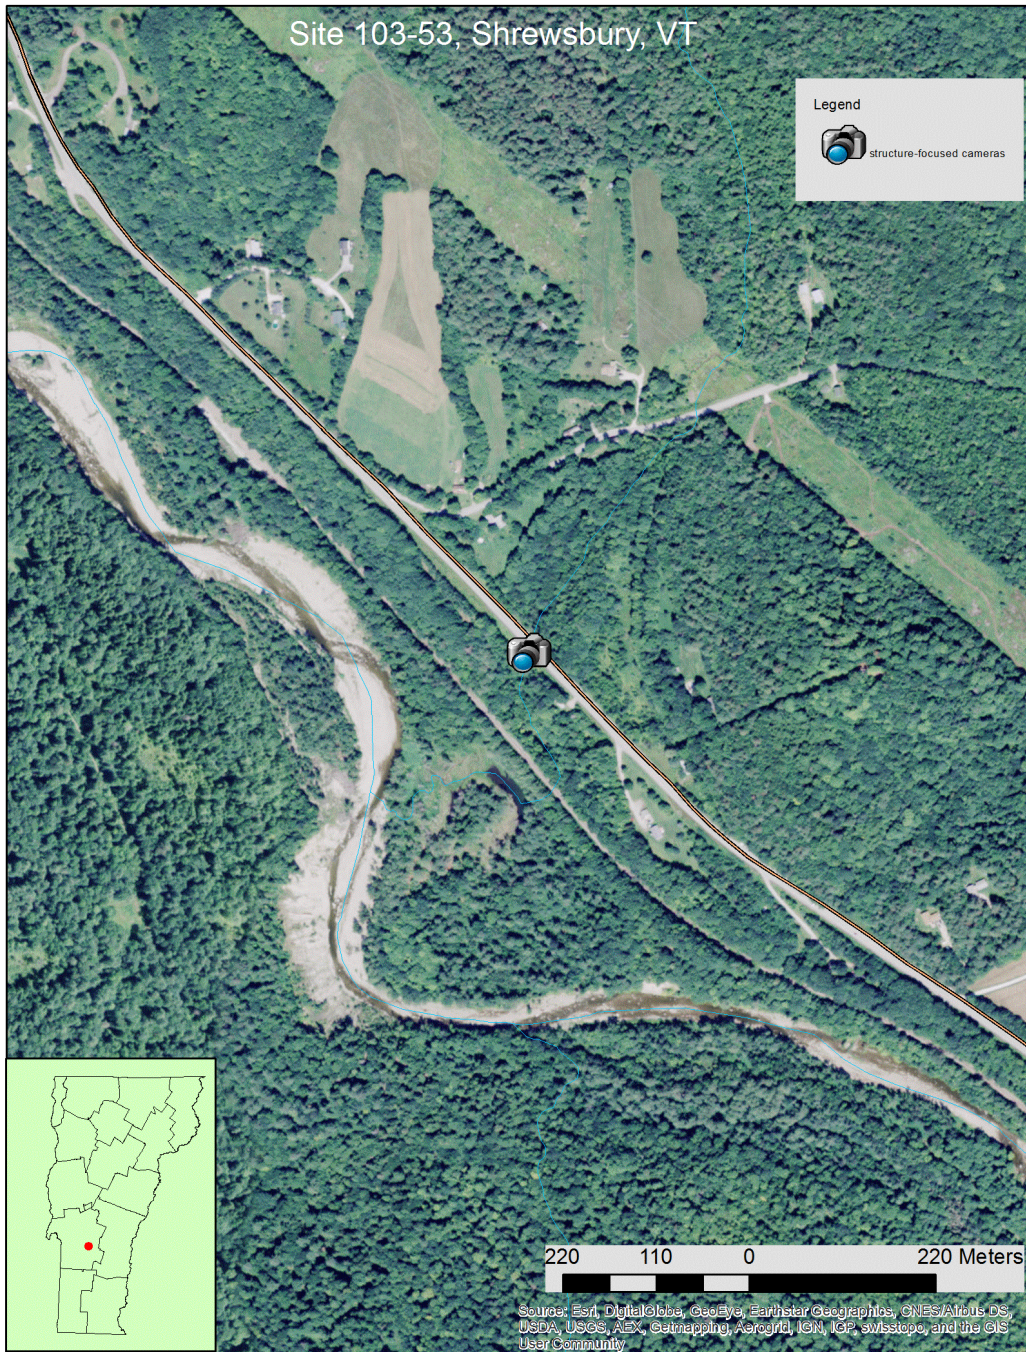
## Site 103-53

Structure type	box culvert
Structure width	15'
Height	10'
Length	280'
Size class	Medium/Large
Bankfull width/structure width ratio	0.8
Road elevation above streambank	60'
Road AADT	5000
Local structural connectivity	diffuse
Distance to nearest forest block N or E	421m
Distance to nearest forest block S or W	94m

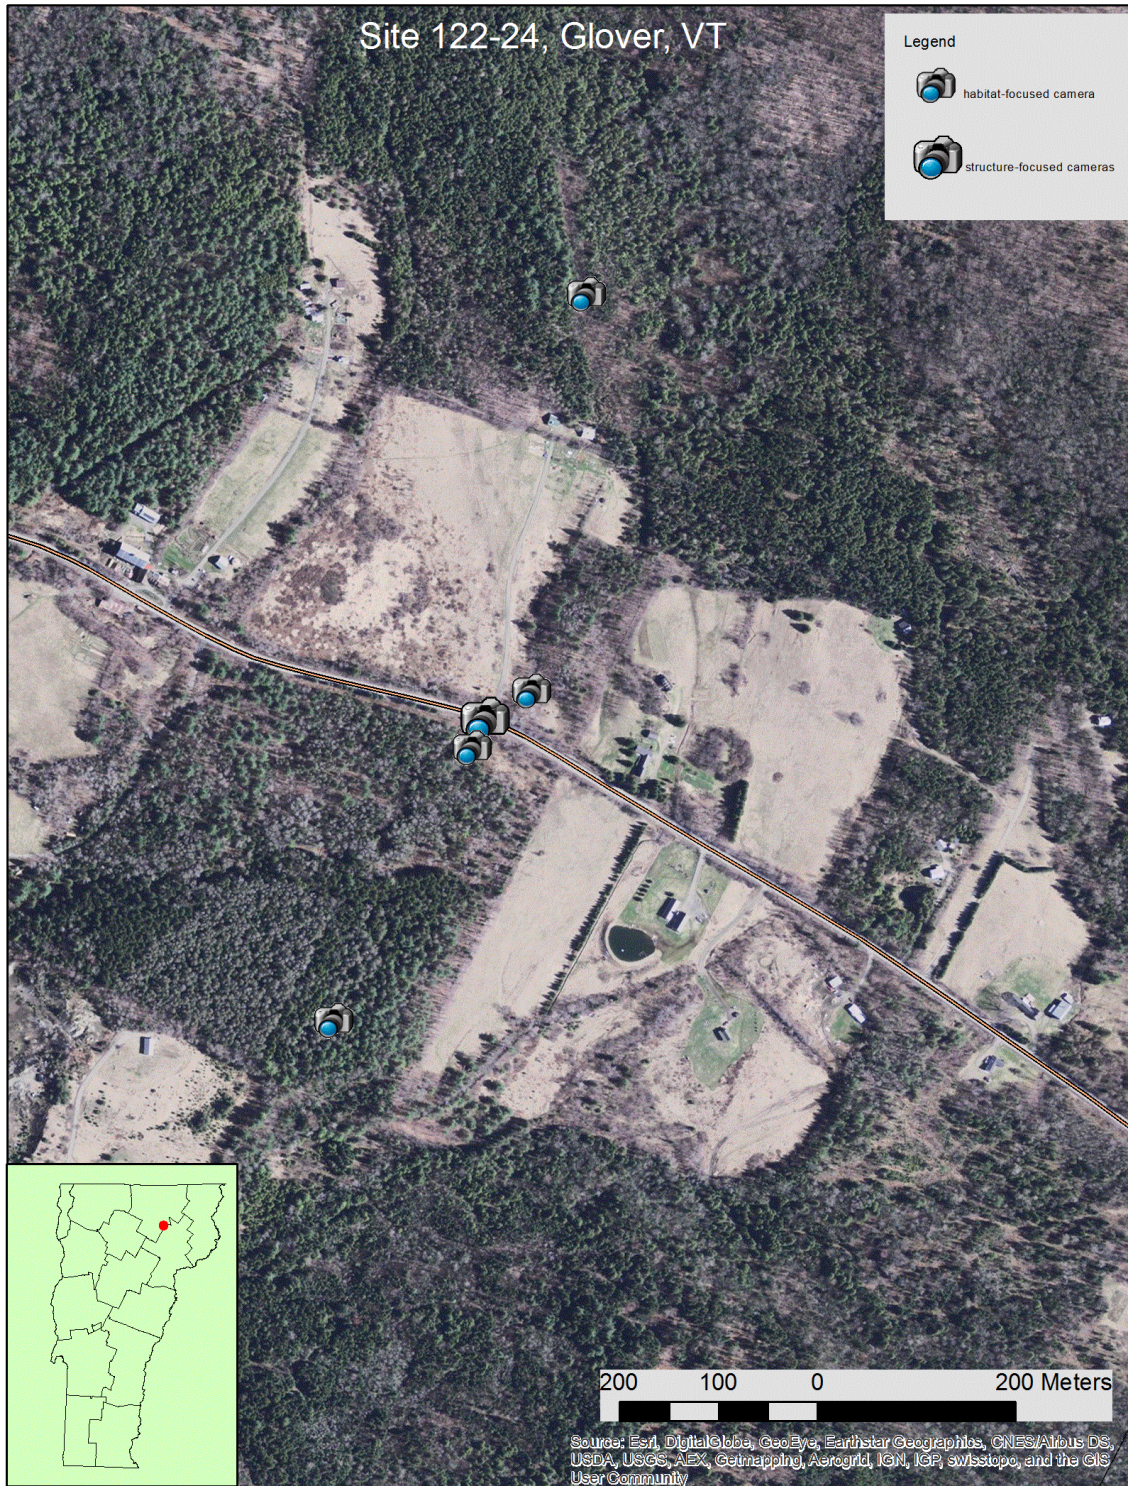
# Site 122-24

Structure type	Box culvert
Structure width	4'
Height	4'
Length	36'
Size class	small
Bankfull width/structure width ratio	0.6
Road elevation above movement surface	9.5
Road AADT	520
Local structural connectivity	pinched
Distance to nearest forest block N or E	25m
Distance to nearest forest block S or W	15m

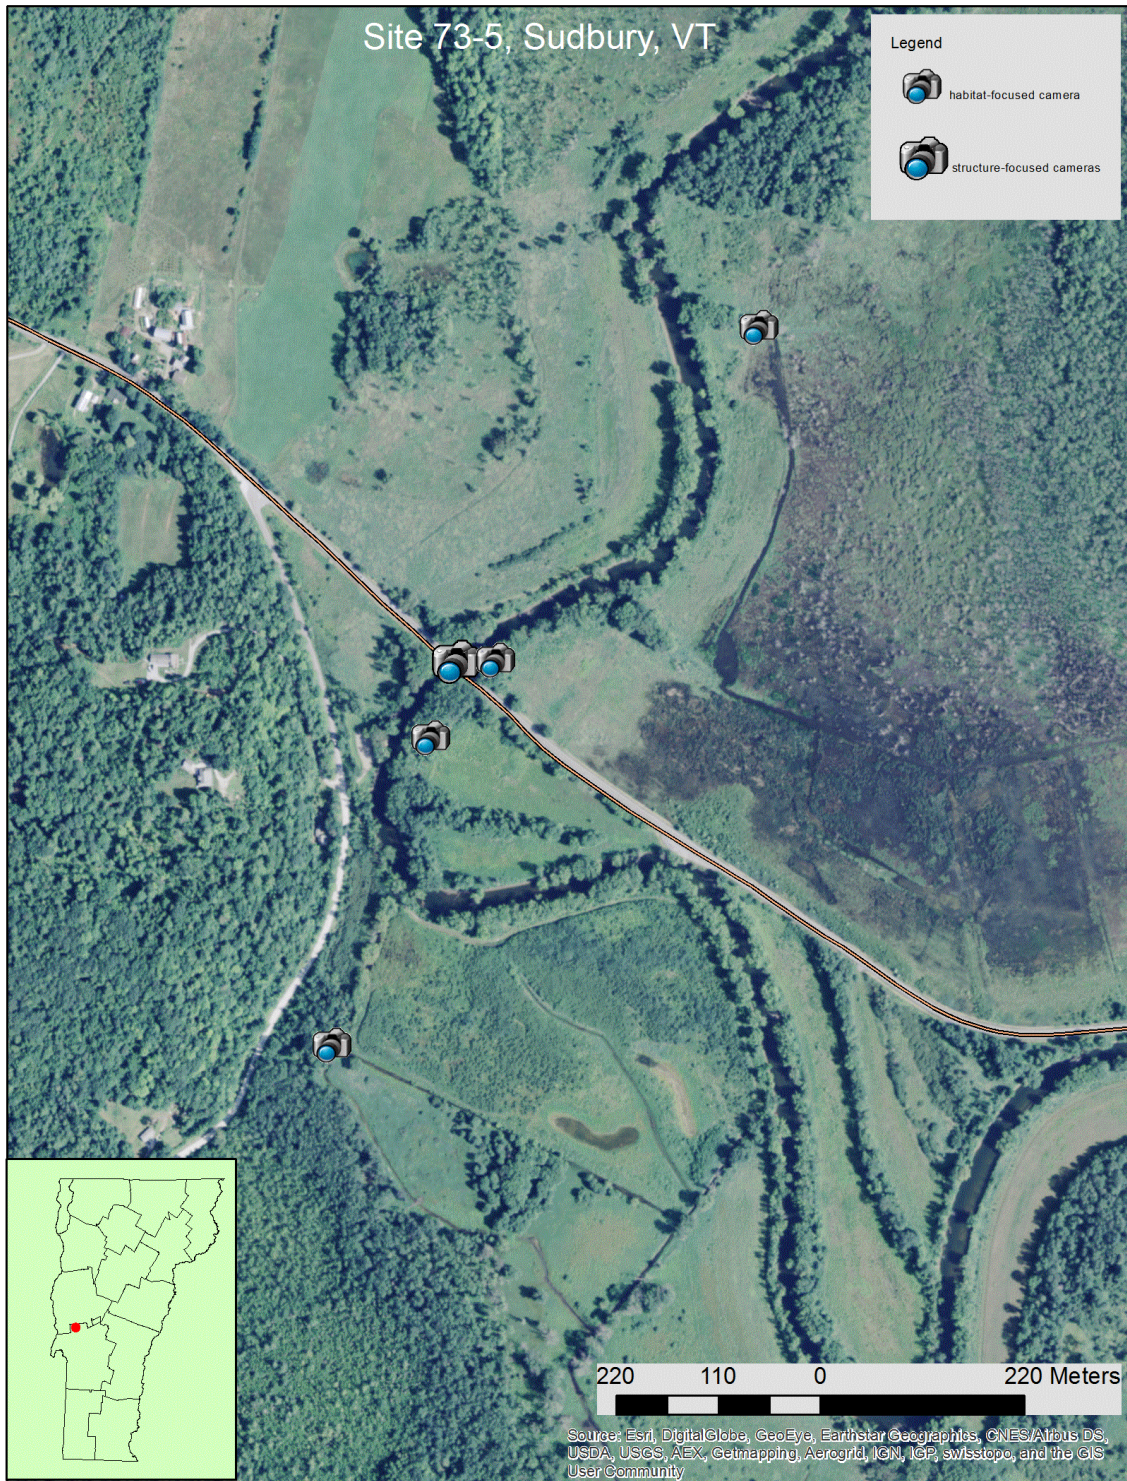
# Site 73-5

Structure type	bridge span
Structure width	235'
Height	5 – 7'
Length	32'
Size class	Medium/large
Bankfull width/structure width ratio	1.2
Road elevation above streambank	9.0'
Road AADT	1000
Local structural connectivity	diffuse
Distance to nearest forest block N or E	445m
Distance to nearest forest block S or W	306m

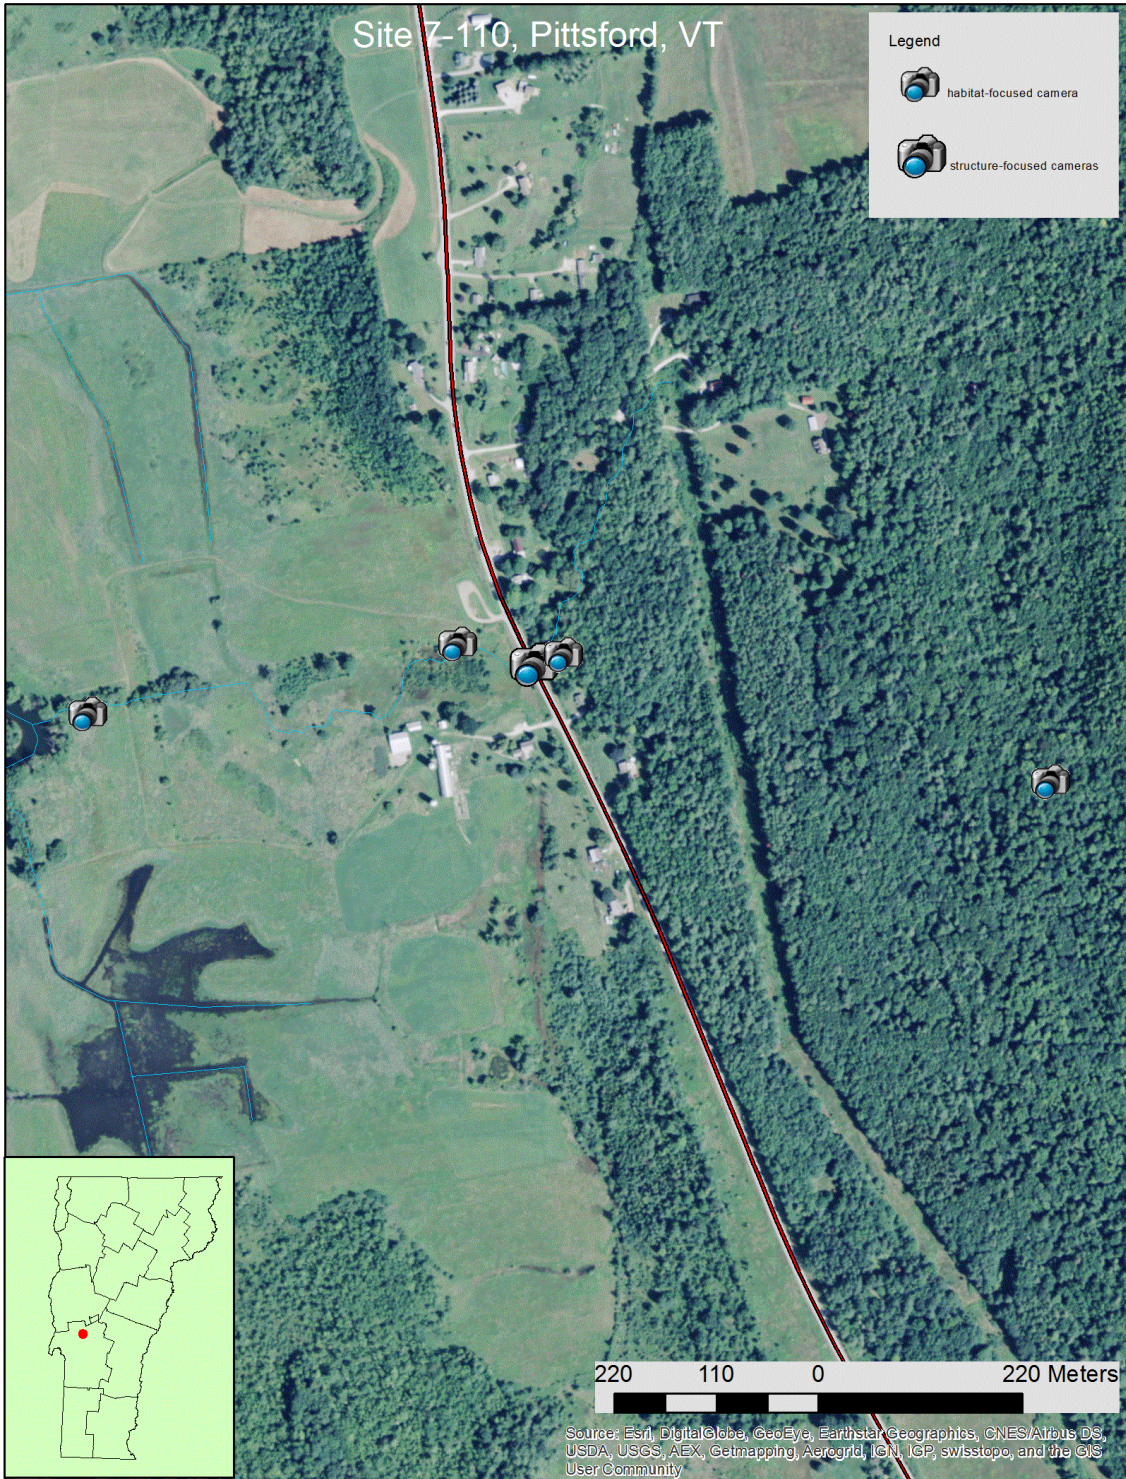
# Site 7-110

Structure type	box culvert
Structure width	5'
Height	6'
Length	60.2'
Size class	small
Bankfull width/structure width ratio	0.6
Road elevation above streambank	15.8'
Road AADT	7200
Local structural connectivity	fragmented
Distance to nearest forest block N or E	50m
Distance to nearest forest block S or W	1900m

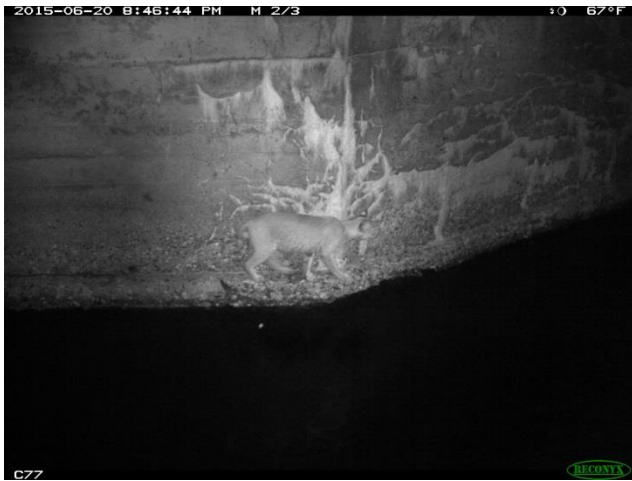
Bobcat at 4a-13 in Ira crossing on a narrow concrete shelf
