The Vermont Culvert Geomorphic Compatibility Screening Tool

February 2008

Vermont Agency of Natural Resources
Department of Environmental Conservation
River Management Program
Waterbury, VT

Milone & MacBroom, Inc.
South Burlington, VT

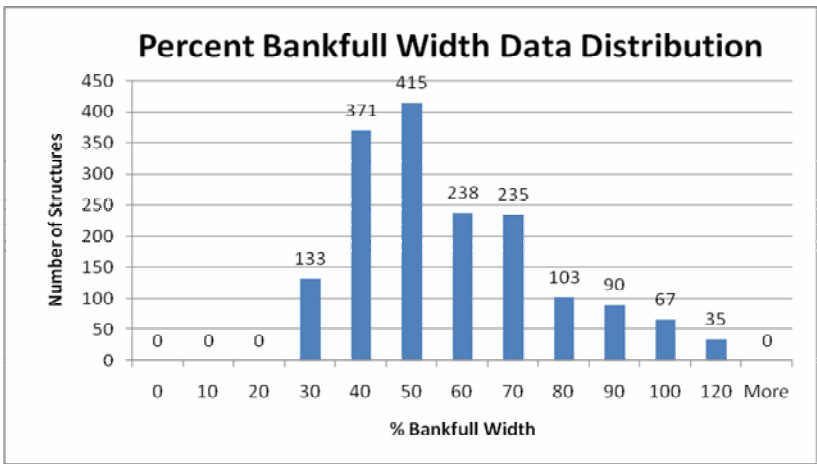
FIGURE 3-1
The Distribution of % Bankfull Width in Assessed Vermont Culverts

The scoring system for %BFW is based primarily on common design guidelines, and the shape of the distribution of the %BFW variable in the Vermont culvert data (Figure 3-1). A score of 5 was set at %BFW \geq 120%, which has recently been included in Massachusetts design standards (MARSCP, 2006) for new structures (Table 3-1). Although this desirable standard has been widely researched and reported for adequate fish passage, it is a width associated with a naturally functioning channel that includes normal hydraulics and sediment/debris transport.

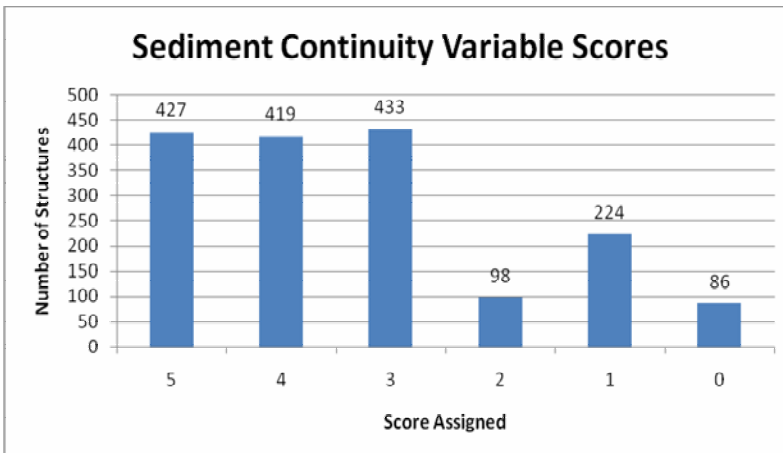
FIGURE 3-3
The Distribution of Sediment and Debris Continuity Scores for Assessed Vermont Culverts

The distribution of the sediment and debris continuity variable scores (Figure 3-3) shows that approximately a quarter of assessed Vermont structures substantially disrupt natural movement of material (score ≤ 2).

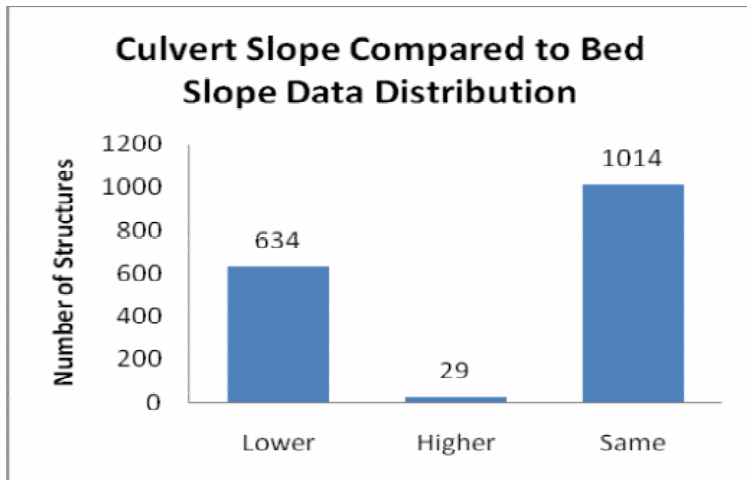
FIGURE 3-4
The Distribution of Structure Slope versus Channel Slope Variable for Assessed Vermont Culverts

The relationship between the slope of a culvert and the channel is an important consideration for geomorphic compatibility, as well as if the structure is located near a break in slope in the valley. A culvert that has a lower slope than the stream channel may cause sediment and debris to aggrade upstream of the structure and can exacerbate transport problems due to undersized structures and filled floodplains. A culvert with a steeper slope than the stream channel increases transport and water velocities, which could lead to downstream scour. Just under half (40%) of assessed Vermont culverts have a slope that differs from the channel (Figure 3-4).

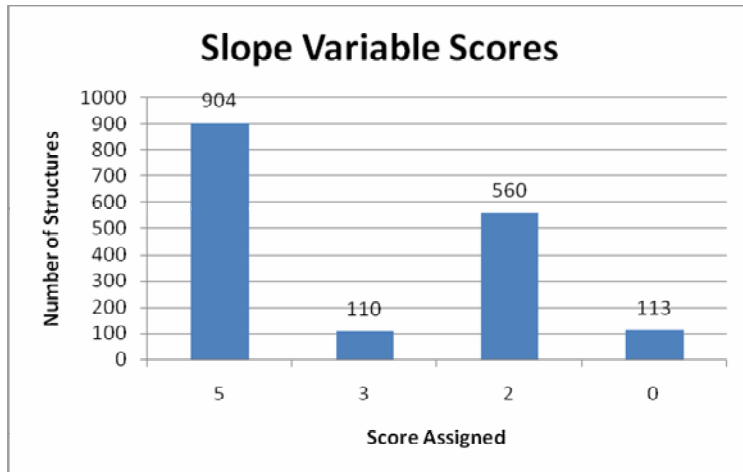
FIGURE 3-6
The Distribution of Slope Scores
for Assessed Vermont Culverts

The distribution of slope scores shows that just under half of the assessed culverts in Vermont have different slopes than the channel, with 100 of those structures also being located at a break in valley slope (Figure 3-6).

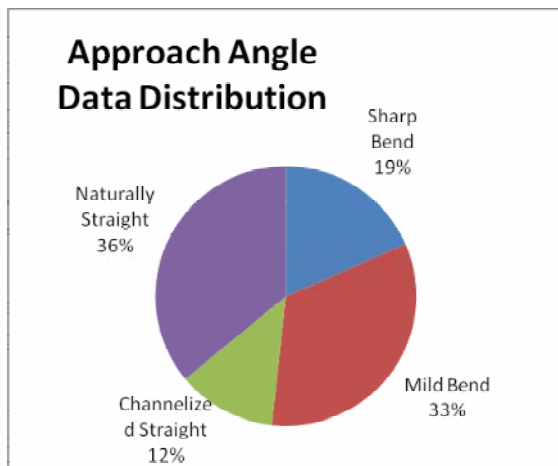
FIGURE 3-7
The Distribution of Approach Angle Variable for Assessed Vermont Culverts

The approach angle is important for geomorphic compatibility as mis-alignment can cause reduction of flow and sediment/debris transport through the structure. Skewed approach can cause scour, deposition, and likely channel adjustment, in addition to the possibility of structure failure. Assessment data show 20% of assessed Vermont culverts have a sharp bend between culvert and channel, while 30% have a mild bend (Figure 3-7).

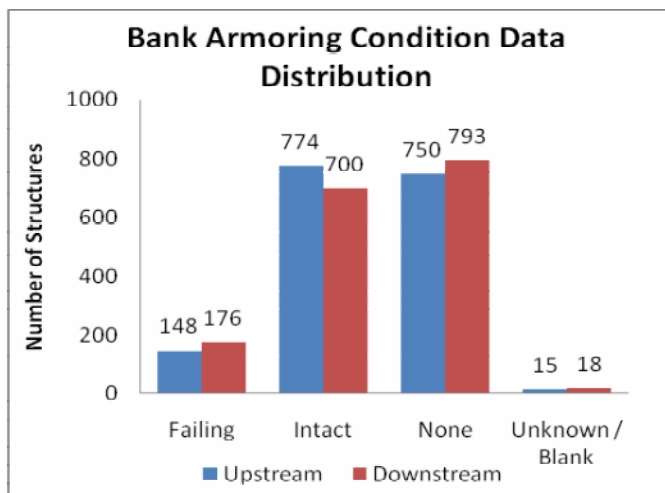
FIGURE 3-10
The Distribution of the Bank
Armoring Condition Variable
for Assessed Vermont

The bank armoring condition variable is also reported for upstream and downstream of the culvert. Condition categories include failing, intact, or none (none present). Data show approximately the same number of structures with upstream and downstream armoring within each category (Figure 3-10). Failing armor indicates an on-going erosion problem and suggests the potential for long-term incompatibility. The failing conditions occurs in 9% of structures at the upstream culvert end and 10% of structures at the downstream end.

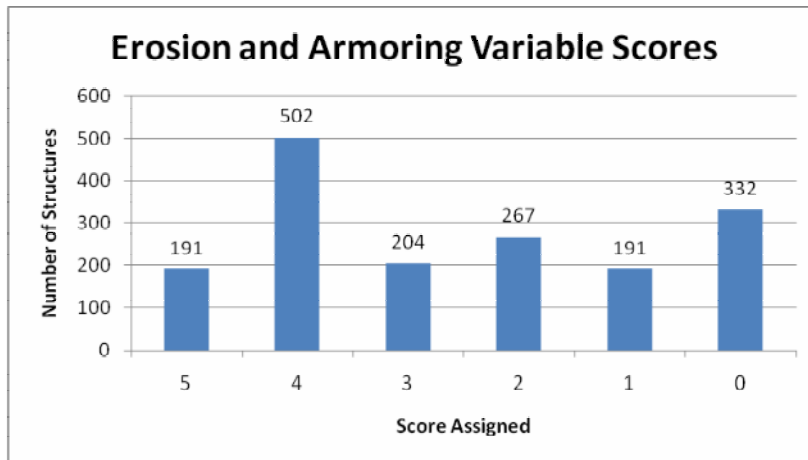
FIGURE 3-11
The Distribution of Erosion and Armoring Upstream and Downstream Scores for Assessed Vermont Culverts

The distribution of the bank erosion and armoring scores (Figure 3-11) indicates that 41% of structures have high erosion or failing armoring (score \leq 2).

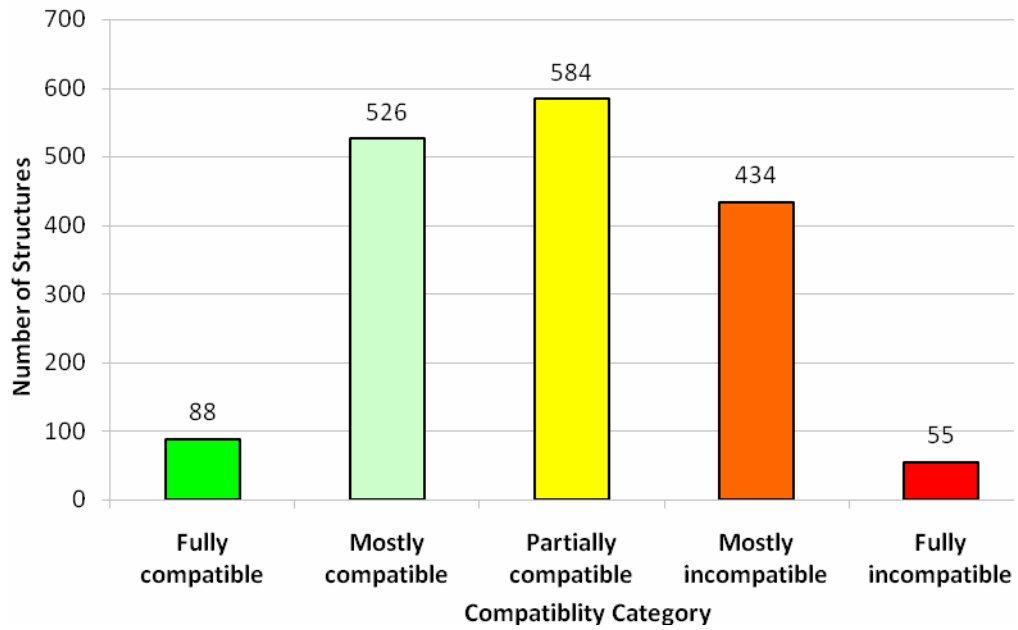
FIGURE 4-1
The Distribution of Culvert Geomorphic Compatibility Screen Scores for Assessed Vermont Culverts

The culvert geomorphic compatibility screen scores indicate that 5% of structures are fully compatible and 3% of structures are fully incompatible with the stream channel (Table 4-1). The 55 structures representing the 3% that are most incompatible are severely disrupting natural form and processes and are likely to be at risk of failure. These culverts represent an immediate opportunity to improve natural processes, channel stability, aquatic habitat, and public safety. The majority (i.e., 1,544) of structures are classified within the three intermediate levels of compatibility as expected. These structures span a range from mostly compatible to mostly incompatible, and thus some information about the relationship between culvert and channel is available even for the middle of the data distribution (Figure 4-1).

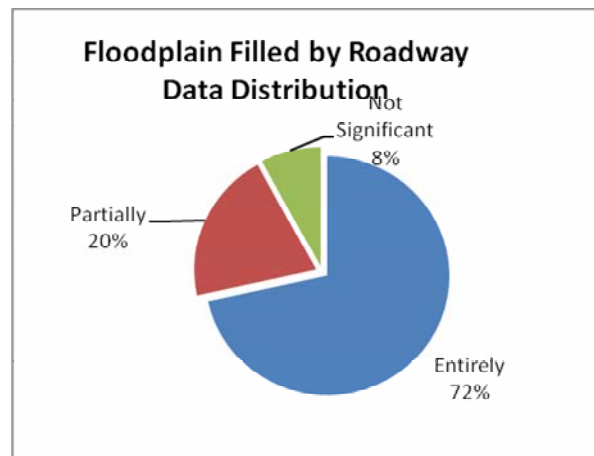
The inclusion of the floodplain fill variable was explored in multiple ways to see how it influenced the overall screen scoring presented above. When scoring this variable out of a total of 5, even if only allowing a maximum value of 2, this variable strongly skewed the overall scores down, as seen in the table below. If scoring this variable out of 2, the effect is not seen as strongly. It is recommended that if this variable is included in the future it should be scored with a maximum of 2 out of 2 to dampen

its strong effects.

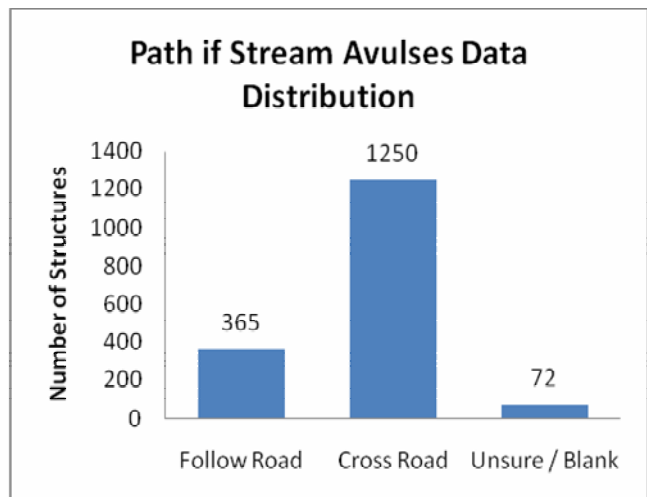
The path if the stream avulses has a different relationship to geomorphic processes than most of the other variables used in the screening tool. This is a potential hazard that is a symptom of an incompatible structure. Therefore this variable would not add much information to the screen describing the actual geomorphic condition by describing altered channel form or process. Another concern with this particular variable is the vague nature of the information, and that the majority of the structures are in the Cross Road category which would skew the scoring.
